# COUNTY OF LOS ANGELES

## DEPARTMENT OF PUBLIC WORKS

### **BOARD MOTION OF FEBRUARY 14, 2017, AGENDA ITEM 42-A DAM SAFETY PROGRAM**

**COUNTY OF LOS ANGELES  
DEPARTMENT OF PUBLIC WORKS  
DAM SAFETY PROGRAM  
REPORT TO THE BOARD  
MARCH 15, 2017**

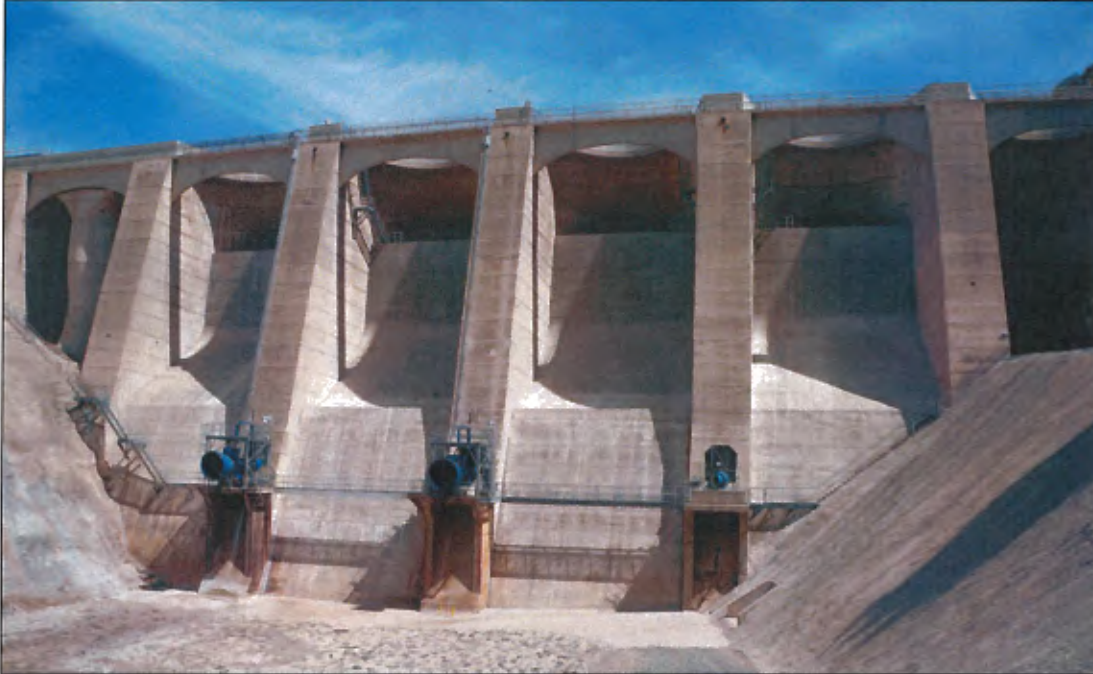
## BIG DALTON DAM

The dam structure has been analyzed and found to be capable of withstanding the maximum credible earthquake. A seismic rehabilitation was completed in 1999 to buttress the dam arches with mass concrete.

Parapet walls on Arches 2, 5, and 6 were increased in height in 1999 to create an auxiliary spillway on the crest of the dam. Hydraulic analysis has determined a combined spillway capacity of 8,310 cubic feet per second (cfs), which exceeds the probable maximum flood of 8,280 cfs.

New outlet works including valves, actuators, and control system were installed in 2000. Outlet works are operational for flood control and stormwater capture operations. A sluice gate rehabilitation project is planned to be in construction in 2018.

The dam is monitored with adequate instrumentation and the dam was determined to be in acceptable condition by the DSOD during its inspection in October 2016.

The reservoir has a current capacity of 1.7 million cubic yards (cy), which is adequate to hold multiple design debris events of 460,000 cy. Approximately, 148,140 cy of sediment was removed during a sediment removal project completed in April 2008.

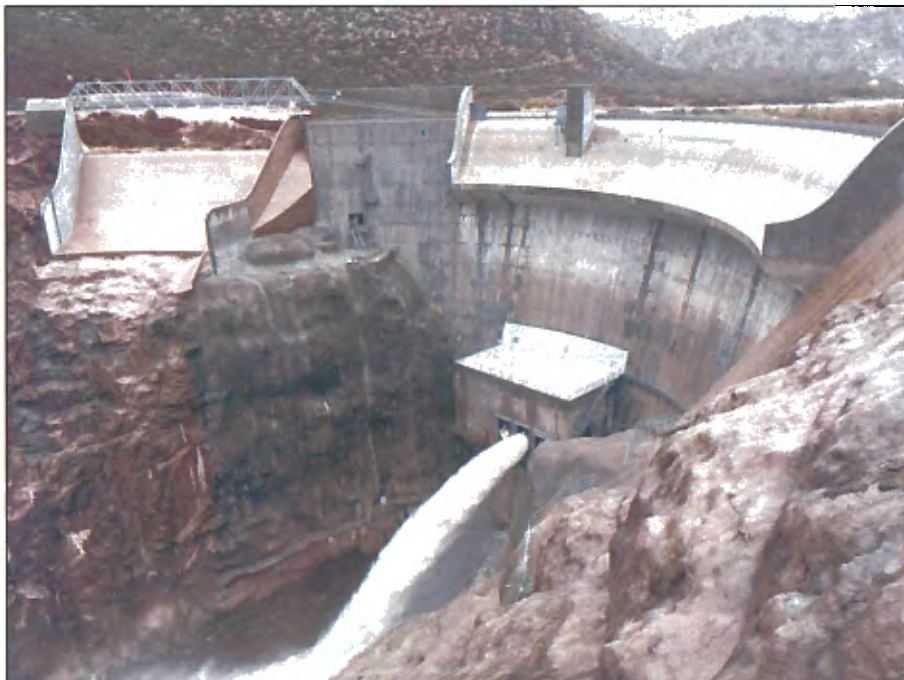
## BIG TUJUNGA DAM

The dam structure has been analyzed and found to be capable of withstanding the maximum credible earthquake. A seismic rehabilitation project was completed in 2012 to buttress dam with mass concrete.

Crest spillway was completed in 2012 to increase spillway capacity. Hydraulic analysis determined the spillway capacity is 113,035 cfs, which exceeds the probable maximum flood of 111,570 cfs calculated for this location

New outlet works including valves, actuators, and control system were installed in 2012. Outlet works are operational for flood control and stormwater capture operations.

The dam is monitored with adequate instrumentation and the dam was determined to be in acceptable condition by DSOD during inspection in February 2016.

There is currently 2.1 million cy of accumulated sediment in the reservoir. Since the 2009 Station Fire, 1.3 million cy of additional sediment has been deposited in the reservoir. Design of a project to remove sediment is nearly complete and permitting is in progress. A four year sediment removal project is scheduled to begin in 2018.

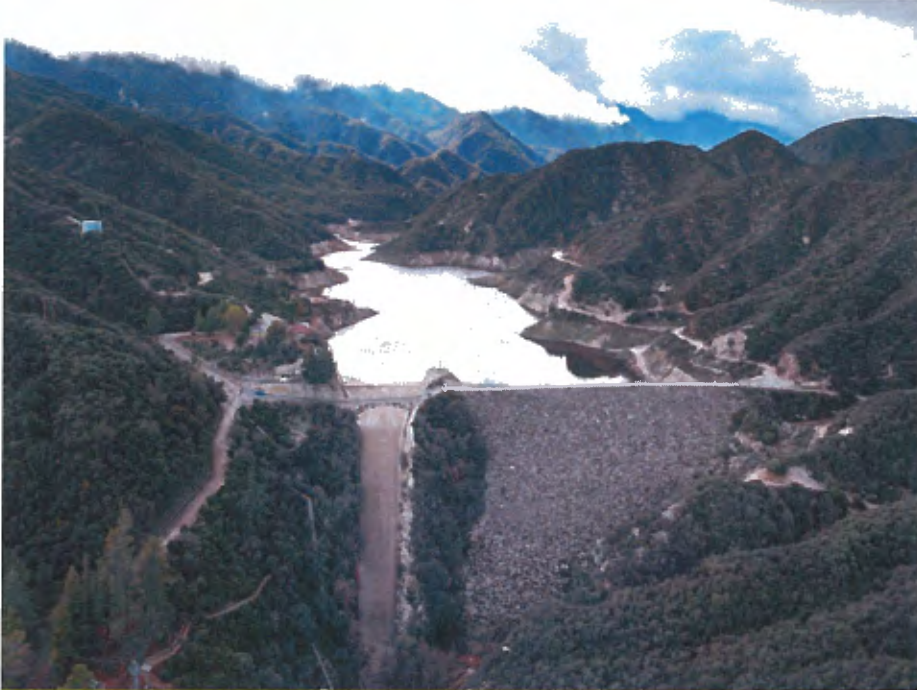
## COGSWELL DAM

The dam structure has been analyzed and found to be capable of withstanding the maximum credible earthquake.

In 1990, a parapet wall was constructed across the dam crest to increase its spillway capacity. Analysis determined the spillway has capacity to pass the probable maximum flood of 59,900 cfs.

The outlet works are currently operational for flood control and stormwater capture. An inlet-outlet works rehabilitation project is planned for construction between 2019-21.

The dam is monitored with adequate instrumentation and the dam was determined to be in acceptable condition by the DSOD during its inspection in October 2016.

The reservoir currently has 2.9 million cy of sediment in the reservoir, 1.4 million of that has been deposited since the 2009 Station Fire. A sediment removal project to remove up to 3.3 million cy is scheduled between 2018-20.

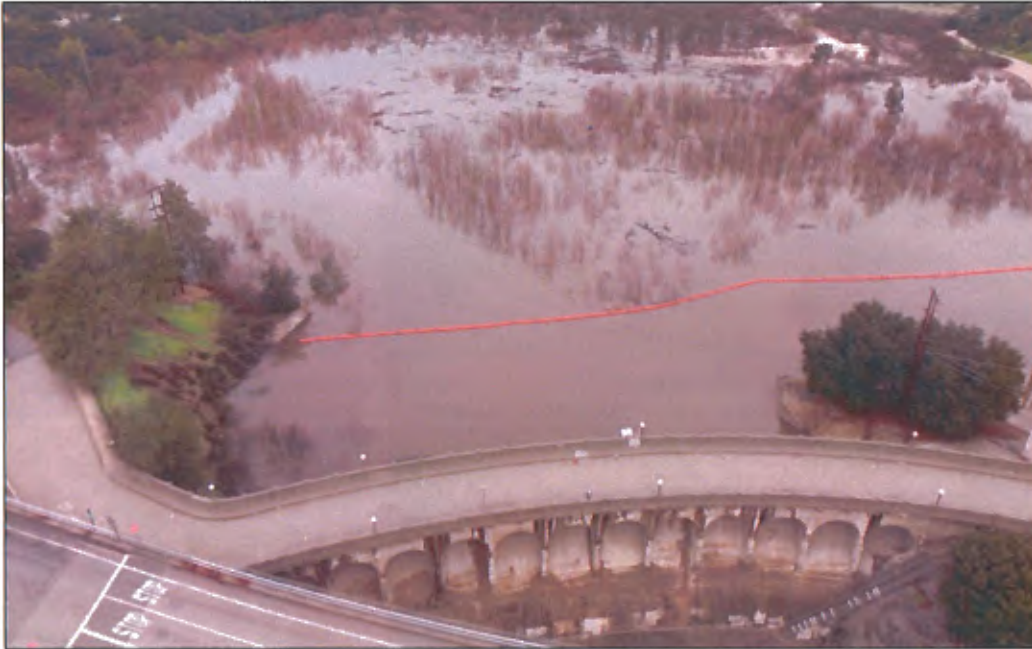
## DEVIL'S GATE DAM

The dam structure has been analyzed and found to be capable of withstanding the maximum credible earthquake. Rehabilitation was completed in 1997 with a mass concrete buttress installed on the downstream side of the dam and the foundation was grouted.

Outlet works are operational for flood control and stormwater capture operations.

The dam is monitored with adequate instrumentation and the dam was determined to be in acceptable condition by the DSOD during its inspection in October 2016. A monitoring report was also submitted to DSOD in fall 2016.

A sediment cleanout project to remove up to 2.4 million cy of excess sediment from the reservoir is scheduled to start in late 2017. The project is expected to take 3 to 5 years.

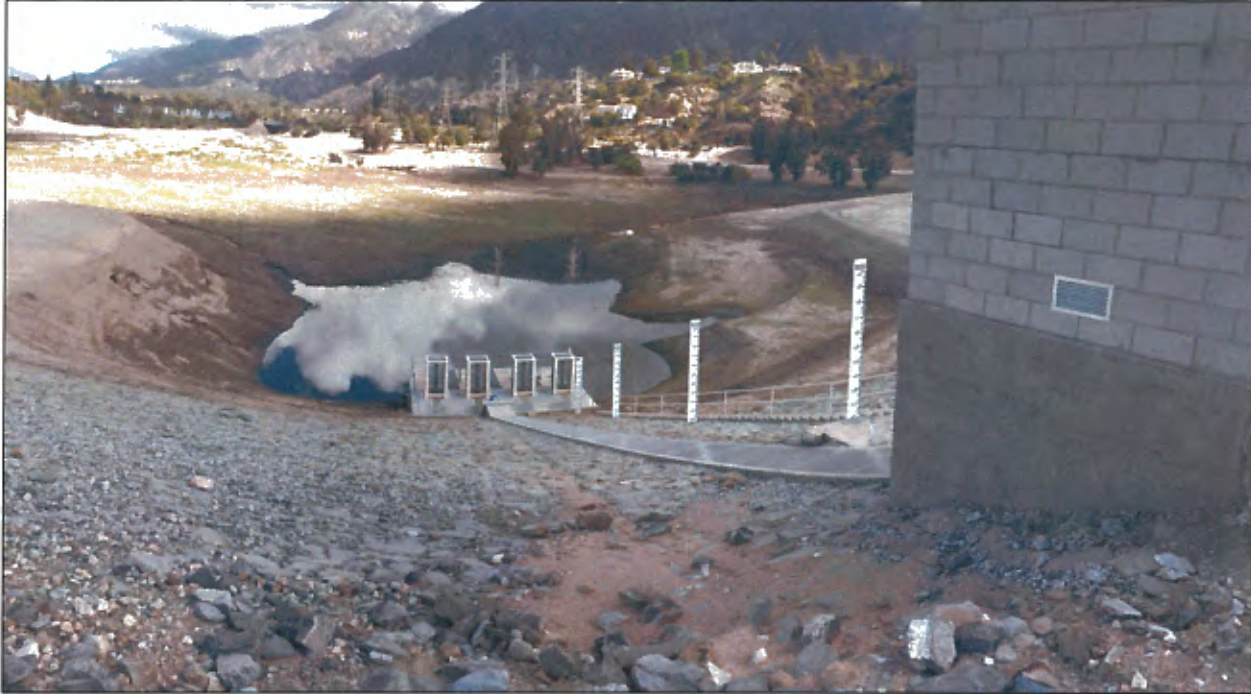
## EATON WASH DAM

The dam structure has been analyzed and found to be capable of withstanding the maximum credible earthquake. In 2015, the seismically deficient outlet tower was demolished and a new hydraulic power system was installed for gate valve operations.

The dam is monitored with adequate instrumentation and the dam was determined to be in acceptable condition by DSOD during its inspection in October 2016.

The reservoir has a current capacity of 1.0 million cy, which is inadequate to capture two design debris events totaling 1.4 million cy. Work on a sediment removal project will be initiated following the completion of more urgent reservoir cleanout projects.

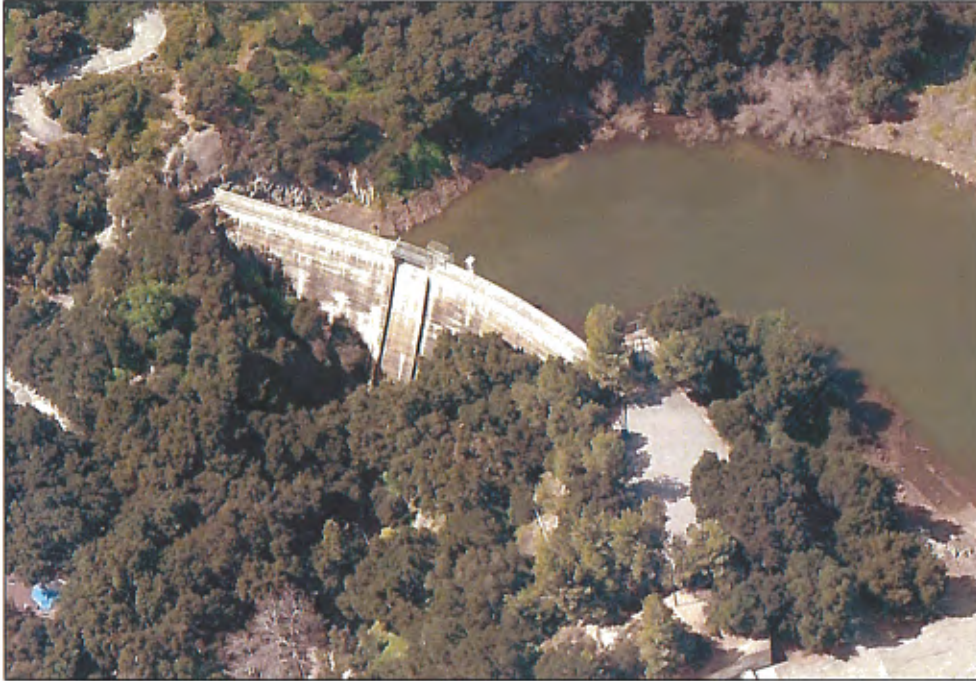
## LIVE OAK DAM

The dam structure has been analyzed and found to be capable of withstanding the maximum credible earthquake. A rehabilitation project was completed in 1982, which included grouting the three transverse contraction joints, installing grout curtains in each abutment, and installing additional drainage to reduce uplift pressure.

The dam is monitored with adequate instrumentation and the dam was determined to be in acceptable condition by the DSOD during its inspection in October 2016.

The dam currently has over 380,000 cy of available capacity, more than two times the design debris event of approximately, 150,000 cy. Approximately, 80,667 cy of sediment was removed during a sediment removal project completed in November 2008.

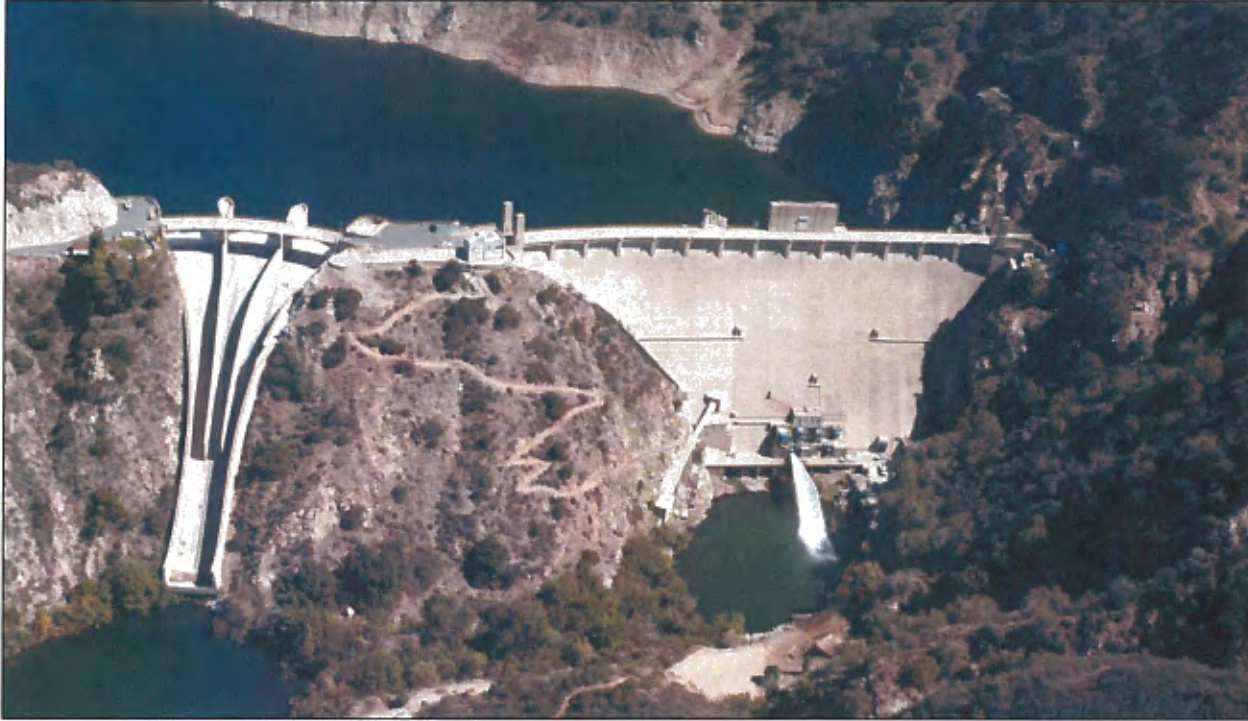
## MORRIS DAM

The dam structure has been analyzed and found to be capable of withstanding the maximum credible earthquake.

The dam is monitored with adequate instrumentation, and the dam was determined to be in acceptable condition by the DSOD during its inspection in October 2016.

Sediment inflow into Morris Dam is limited as the majority of upstream area is controlled by San Gabriel and Cogswell Dams. Currently, there is approximately, 36 million cy of capacity in the reservoir. No cleanouts are scheduled in the foreseeable future

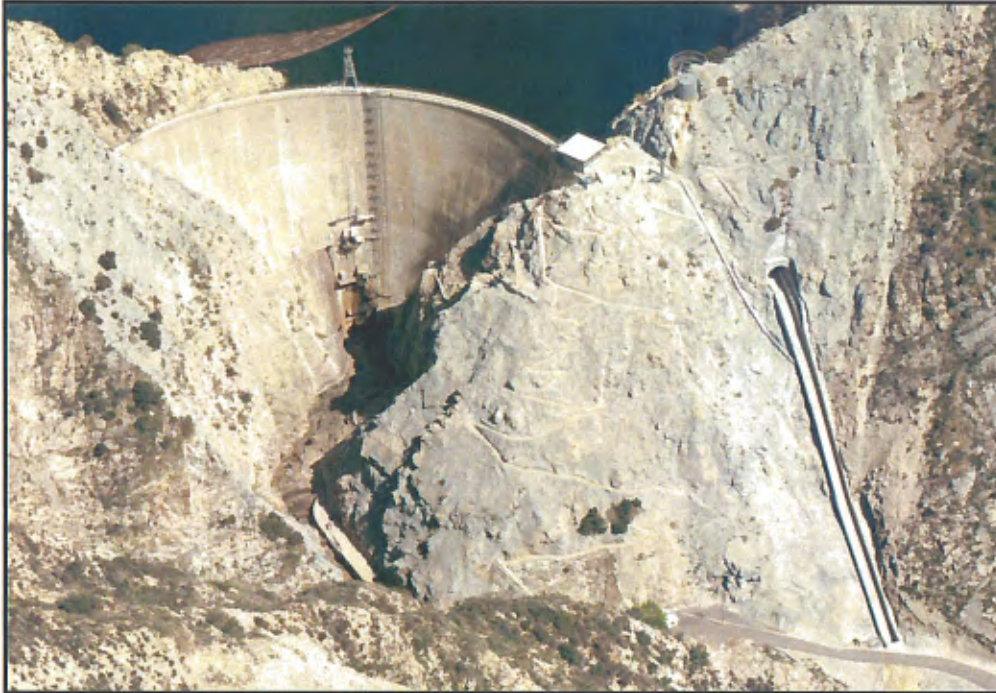
## PACOIMA DAM

The dam structure has been analyzed and found to be capable of withstanding the maximum credible earthquake. On January 17, 1994, Pacoima Dam was severely shaken by the Northridge Earthquake. A complete seismic rehabilitation was performed to strengthen the dam and abutments.

The outlet works are operational and in satisfactory condition for flood control and stormwater capture operations. An inlet-outlet works rehabilitation project is planned for construction in 2020.

The dam is monitored with adequate instrumentation and the dam was determined to be in acceptable condition by the DSOD during its inspection in October 2016.

Project design and permitting are in progress to remove 3 to 5.4 million cy of sediment. Currently, half of the reservoir capacity is filled with sediment and there is significant risk for sediment to buildup and clog the intake structures and damage the outlet works. Sediment removal activities are planned to start in Spring 2019 and take up to 5 years to complete.

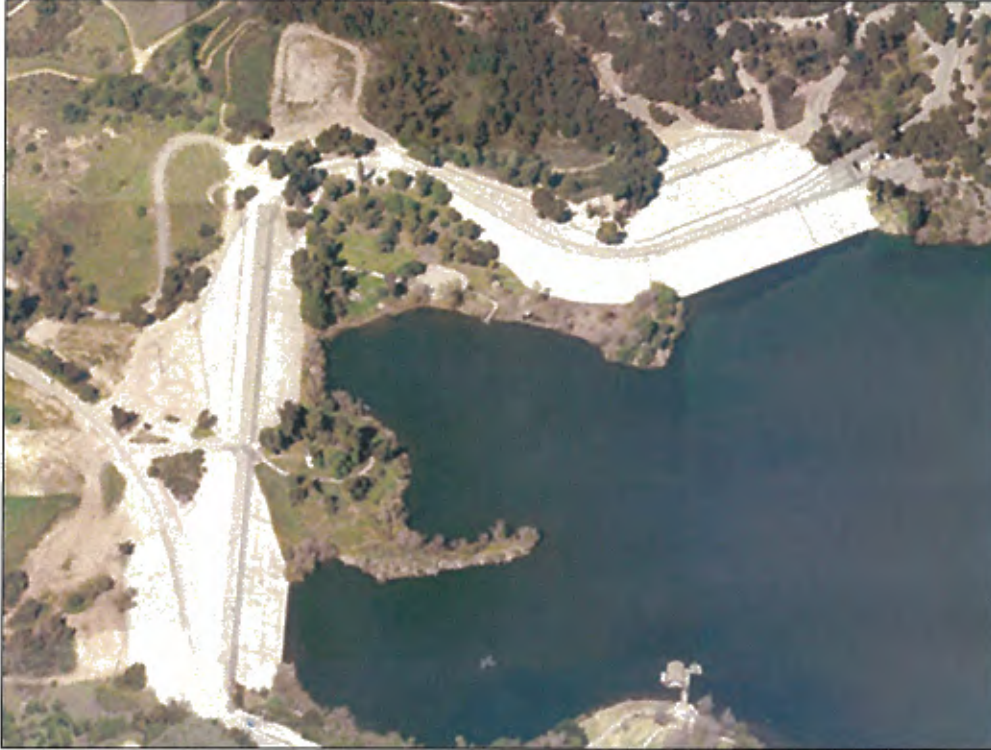
## PUDDINGSTONE DAM

The dam structure has been analyzed and found to be capable of withstanding the maximum credible earthquake at a restricted reservoir level. DSOD restriction limits the reservoir to elevation 945 ft, which is 25 feet below the spillway elevation site. Rehabilitation projects may be planned upon further evaluations, and could restore capacity for flood control and stormwater capture.

The dam is monitored with adequate instrumentation and the dam was determined to be in acceptable condition by the DSOD during its inspection in October 2016.

Sediment inflow into Puddingstone Dam is limited as the majority of the upstream area is either developed or controlled by other dams. No sediment removal project is scheduled at this time.

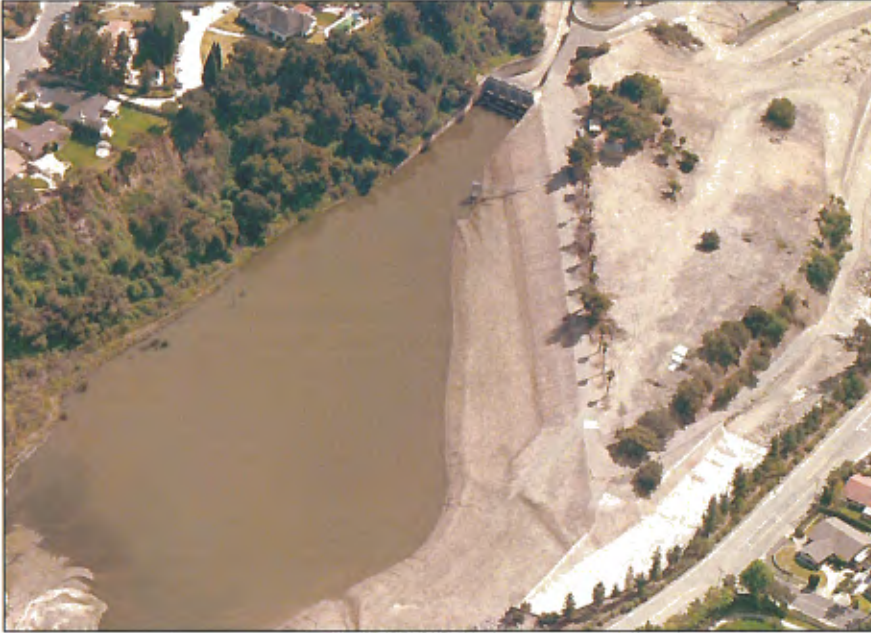
## PUDDINGSTONE DIVERSION DAM

The dam structure has been analyzed and found to be capable of withstanding the maximum credible earthquake.

The dam is monitored with adequate instrumentation and the dam was determined to be in acceptable condition by the DSOD during its inspection in October 2016.

Approximately, 139,000 cy of sediment were removed from the reservoir during the 2008 Sediment Removal Project. Approximately, 30,600 cy of sediment have entered the reservoir since the 2008 Sediment Removal Project. The reservoir has a current capacity of 569,834 cy, which is inadequate to capture two design debris events totaling 755,039 cy.

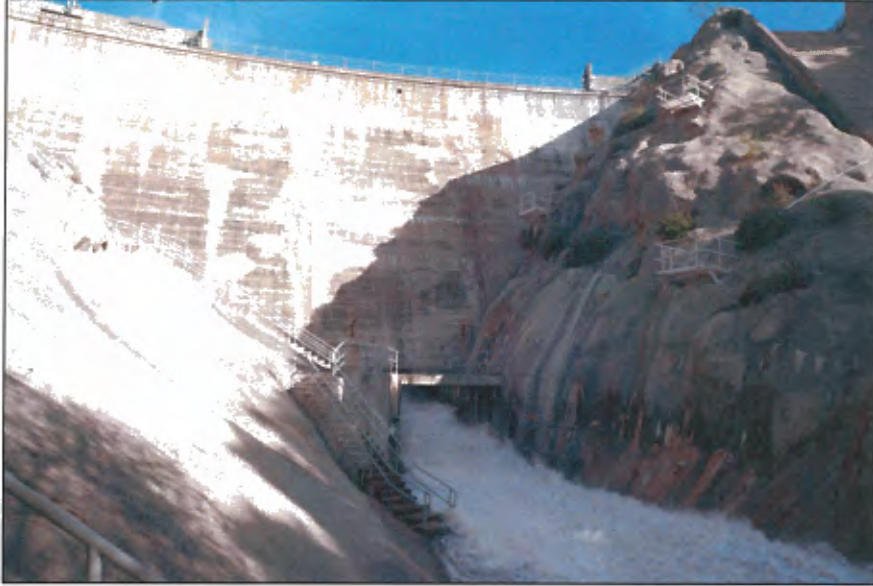
## SAN DIMAS DAM

The dam has been analyzed and found to be capable of withstanding the maximum credible earthquake. In 1980, remedial measures included grouting both abutments, installing rock bolts, tendons, and inclinometers were completed to strengthen the dam for seismic conditions.

The dam is monitored with adequate instrumentation and the dam was determined to be in acceptable condition by the DSOD during its inspection in October 2016.

Approximately, 348,600 cy of sediment were removed from the reservoir during a sediment removal project in 2009, bringing the available capacity to over 2.5 million cy. No recent fires have occurred in the reservoirs watershed in the past five years.

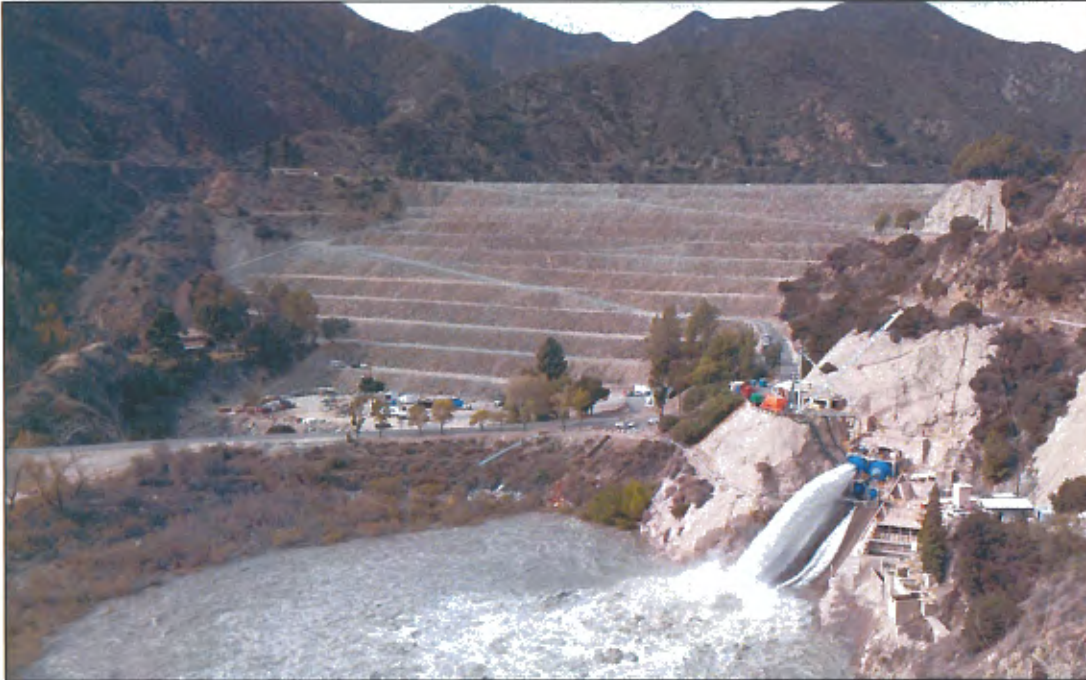
## SAN GABRIEL DAM

The dam is monitored with adequate instrumentation and the dam was determined to be in acceptable condition by the DSOD during its inspection in October 2016.

Sediment within the reservoir has accumulated to a level near the intake structure, that could result in damage to the outlet works and hydroelectric generators. A project to remove 5 million cy over five years is scheduled to begin between 2019 and 2021, once the permitting and plans and specifications are completed.

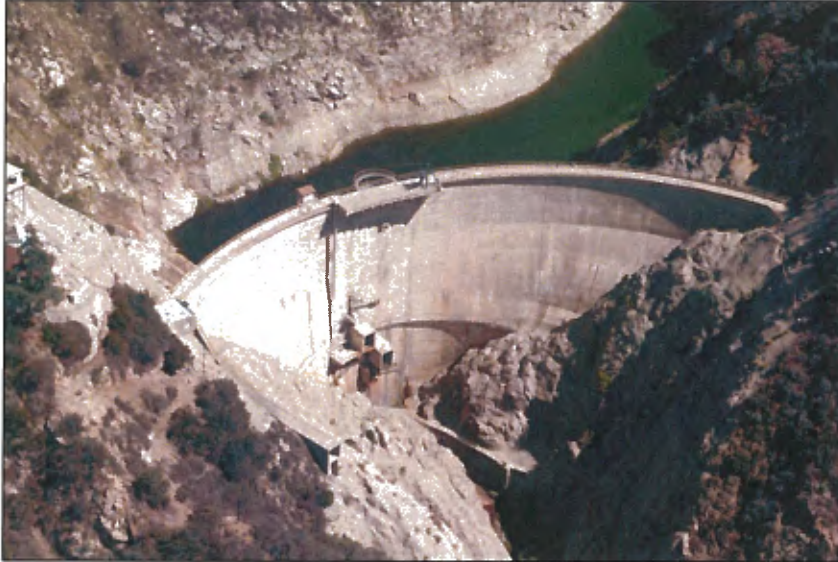
## SANTA ANITA DAM

The dam structure has been analyzed and found to be capable of withstanding the maximum credible earthquake at a restricted reservoir level. Per the DSOD seismic standards, a new riser on the sluiceway outlet of the dam limits the maximum reservoir storage to an elevation of 1,230 ft. This riser was installed as part of the 2013 Riser Modification and Sediment Removal Project. Additional rehabilitation projects would be necessary to restore additional reservoir storage.

The dam is monitored with adequate instrumentation and the dam was determined to be in acceptable condition by the DSOD during its inspection in February 2016.

Approximately, 330,000 cy of sediment were removed from the reservoir in 2013 during the Riser Modification and Sediment Removal Project. Sediment elevation in the reservoir was reduced from 1,212 ft to 1,173 ft during the cleanout and an additional 185.4 AF of storage was restored.

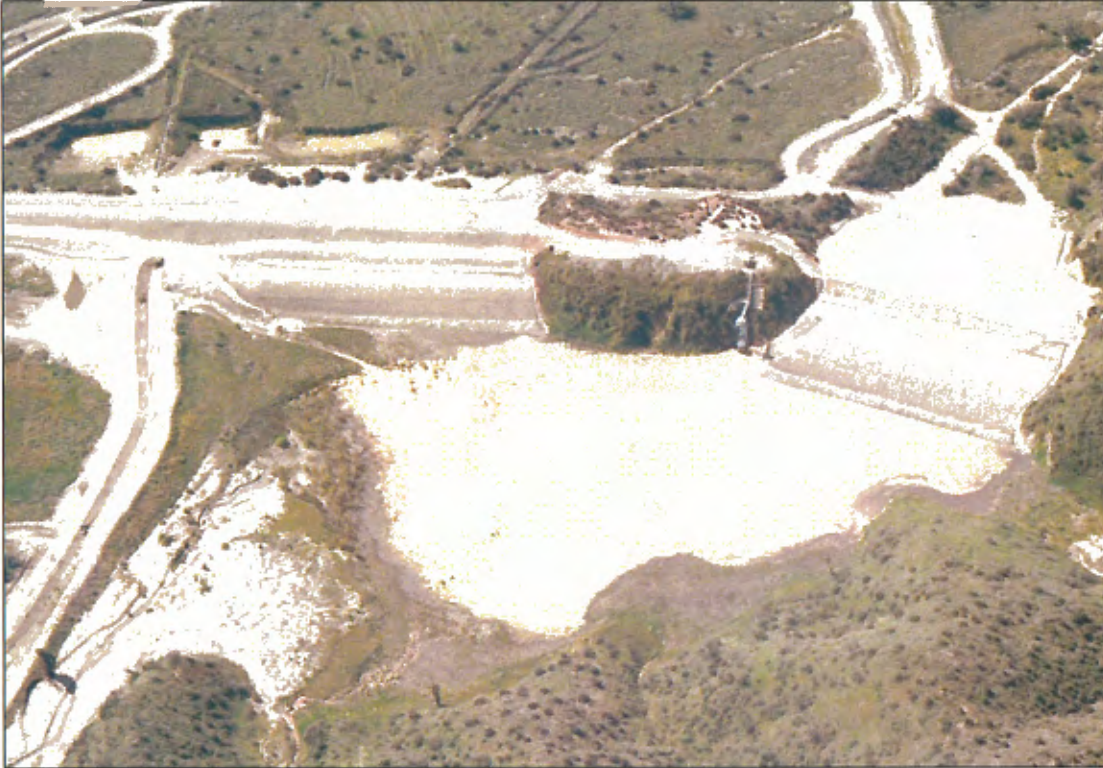
## THOMPSON CREEK DAM

The dam structure has been analyzed and found to be capable of withstanding the maximum credible earthquake. A rehabilitation project was completed in 2001 to buttress embankments with compacting fill

The dam is monitored with adequate instrumentation, and the dam was determined to be in acceptable condition by the DSOD during its inspection in October 2016.
