October 12, 2020

RE: Re-Assessment of VM-29 at Via Marina, As Needed Services

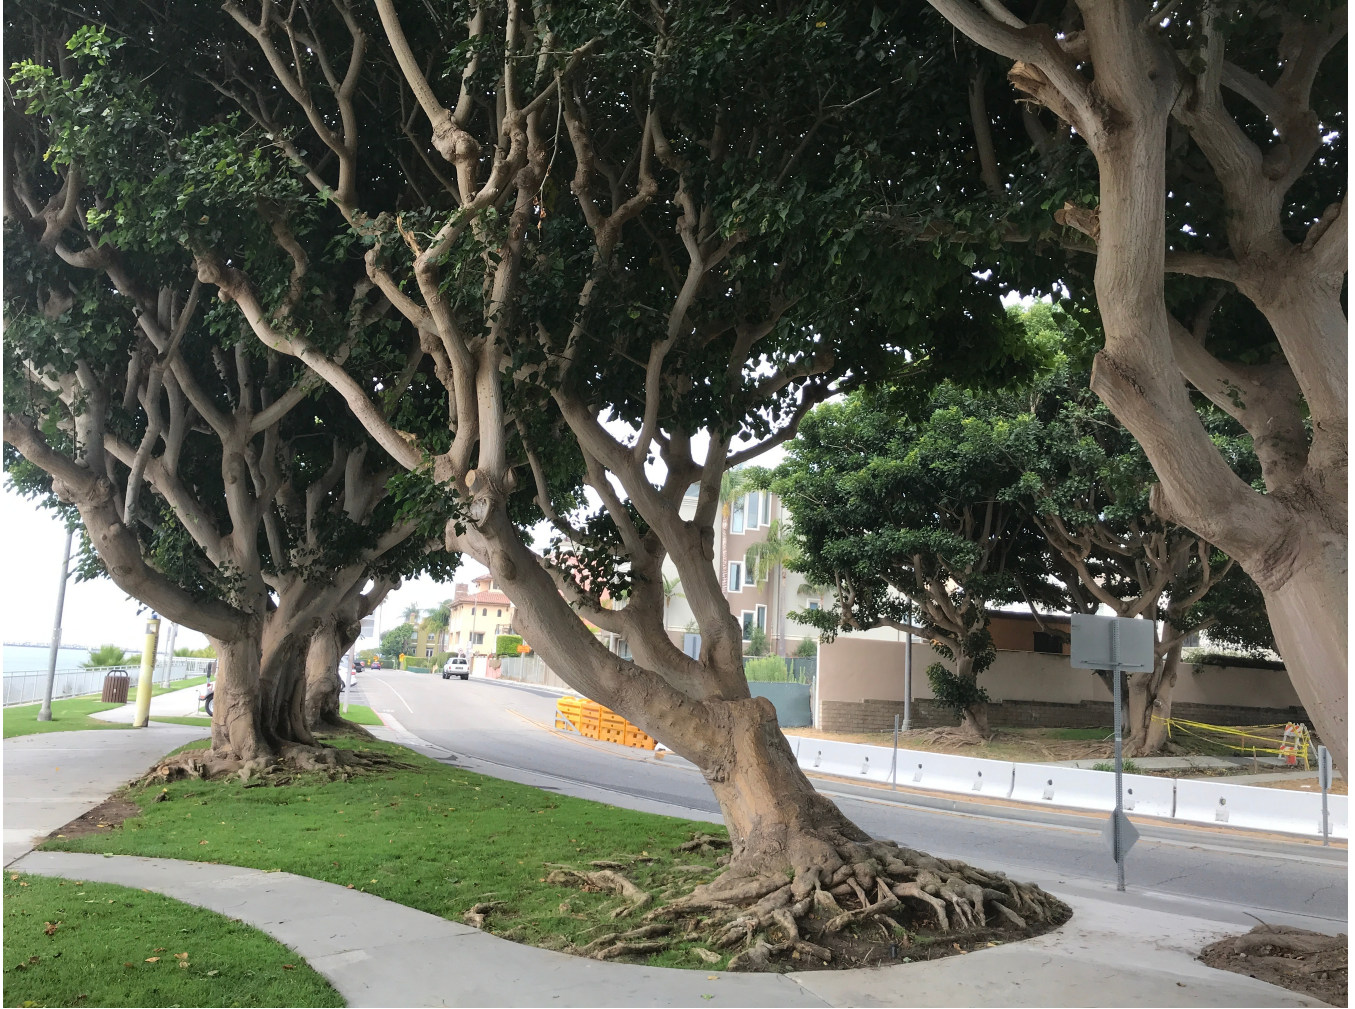
- An original tree risk assessment was conducted in July 2020 and the tree presented with a history of failures. Tree was leaning, with a poor root system on the tension side, and the site has signs of recent disturbance. No significant root plate lifting was evident at that time (Photo 1) and, based on potential targets, previous mitigation recommendations included end weight reduction and structural pruning.
- Recent photographic evidence show a dramatic change in the structural stability of the tree, including soil heave, root plate lifting, and increased lean (Photo 2)

Photo 1: July 2020 showing previous root pruning with minimal lift

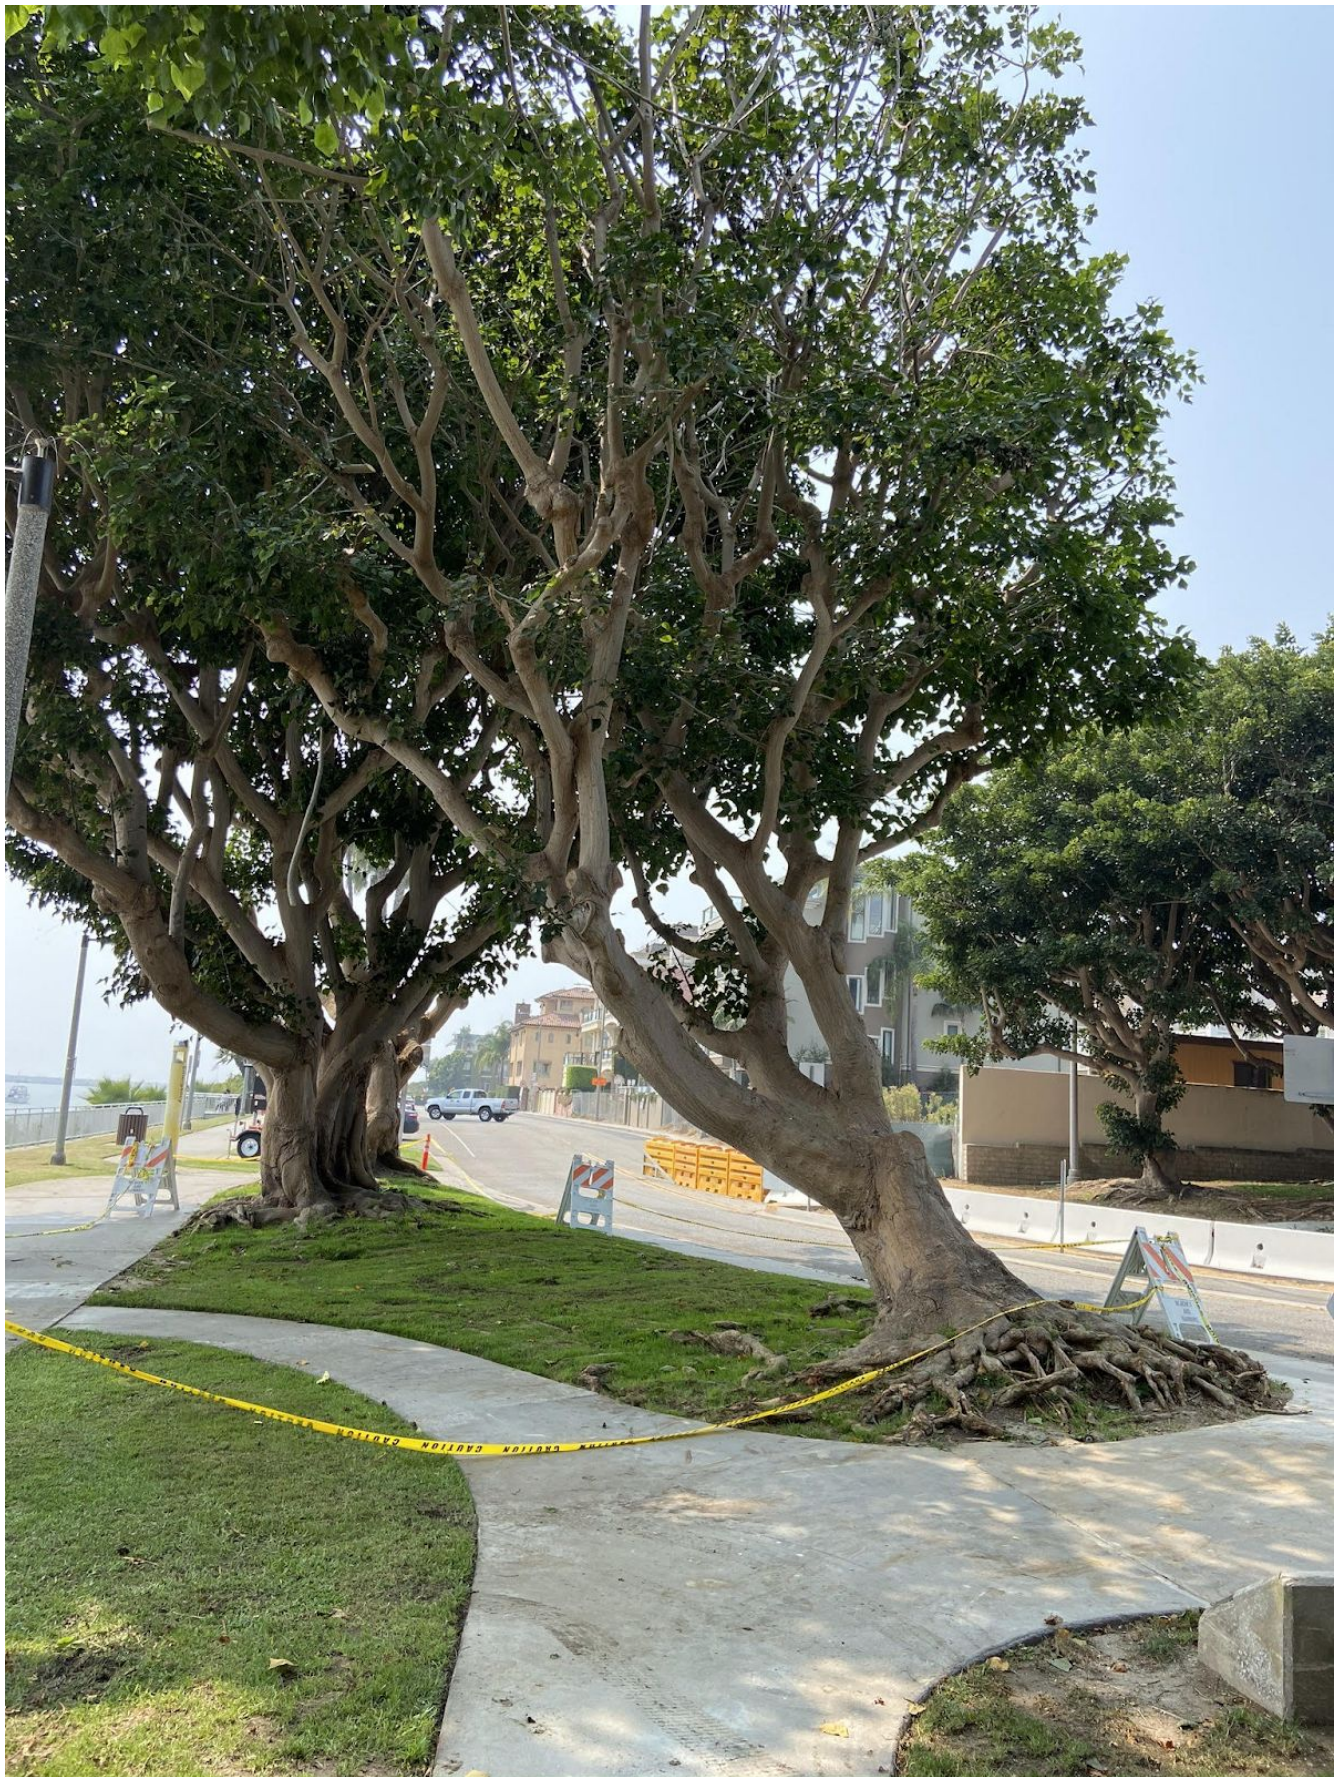
Photo 2: September 2020 showing significant change in soil heave and root plate lift

Based on recent changes to the tree's condition and stability, mitigation recommendations for VM-29 is to remove the tree and eliminate the risk of failure.
