PROPERTY CONDITION ASSESSMENT REPORT (PCAR)

MARINA CITY CLUB
4333 ADMIRALTY WAY
MARINA DEL REY, CALIFORNIA

HOA CONSTRUCTION CONSULTING

APRIL 16, 2021

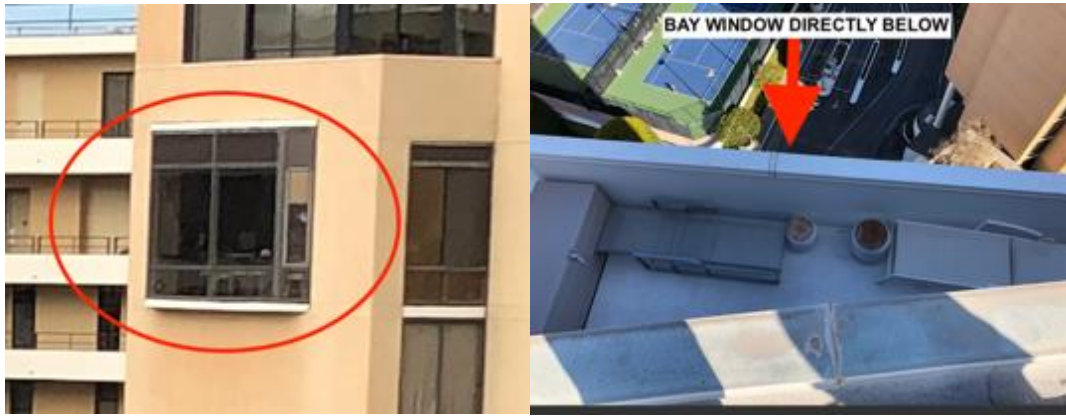
The above left photo shows the existing window condition. The photo on the right looks down on the top of the bay window. Note the photo on the right does not show any means of installing a hanging scaffold davit arm apparatus. The space directly above the bay window is an upper balcony, second-floor penthouse unit. This configuration is present for 12 end unit bay windows.

The penthouse bay window cleaning issue could, unfortunately, call for a complicated or expensive solution. HCC recommends continuing to research the first four options above with a strong preference for Option 1. Cal/OSHA has indicated that Option 1 could be viable, but MCC would need to have a licensed Scaffold Inspection and Testing (SIT) company submit a full plan. Contracting companies Lynn Safety and SkyRyder might be able to provide a design-build solution for Option 1.

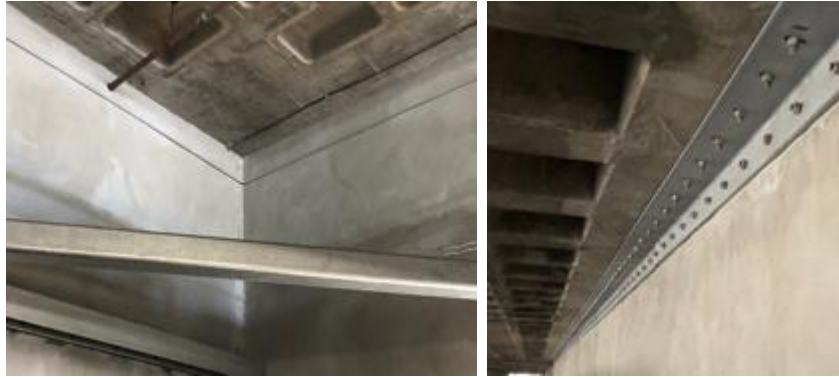
The Promenade Parking Structure was recently repaired due to significant concrete spalling, retaining wall safety concerns, and required seismic retrofitting. These repairs were observed

during the walkthrough. No repairs were observed on the top-level deck, which is the recreation deck. The following images show some of the repairs.

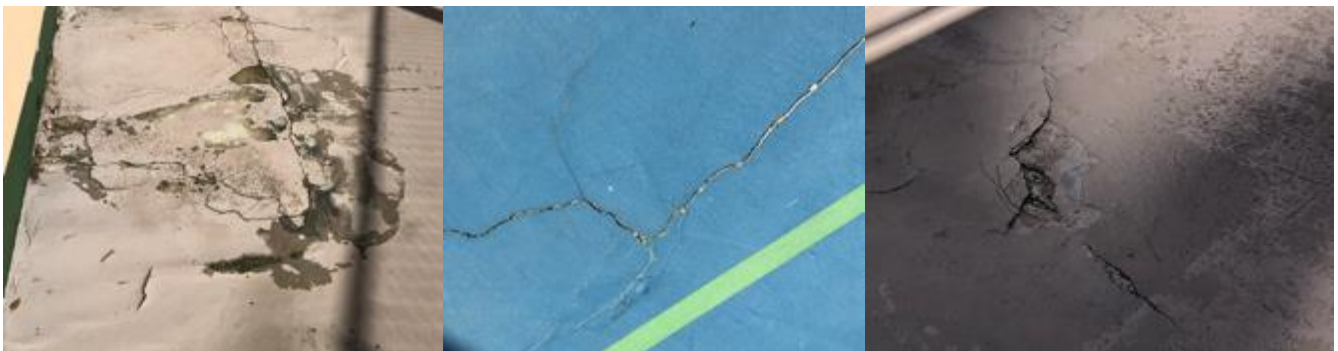
The DTR report goes into detail regarding waterproofing and concrete spalling issues with the recreation deck and other areas. The key takeaway is that nearly all of the waterproofing throughout the property on the recreation deck and tennis courts is failing in some way with water penetrating the structure. Not only does water create a leaking nuisance to residents but it also is the leading cause of concrete spalling and degradation of structural steel components. Over time, this can cause significant damage to the building's structural integrity. The following photos are of the condition of the waterproofing, which is well beyond its useful life cycle.

Recommendations in the DTR report for the recreation deck area should be addressed as a part of the Center Tower and Common Amenities Project. The waterproofing of the tennis courts and areas that flank the Center Tower should also be redone. All courts should be stripped down to structural concrete, the concrete spalling repaired, and the court re-installed. Rusted posts and anchors should be repaired or replaced.

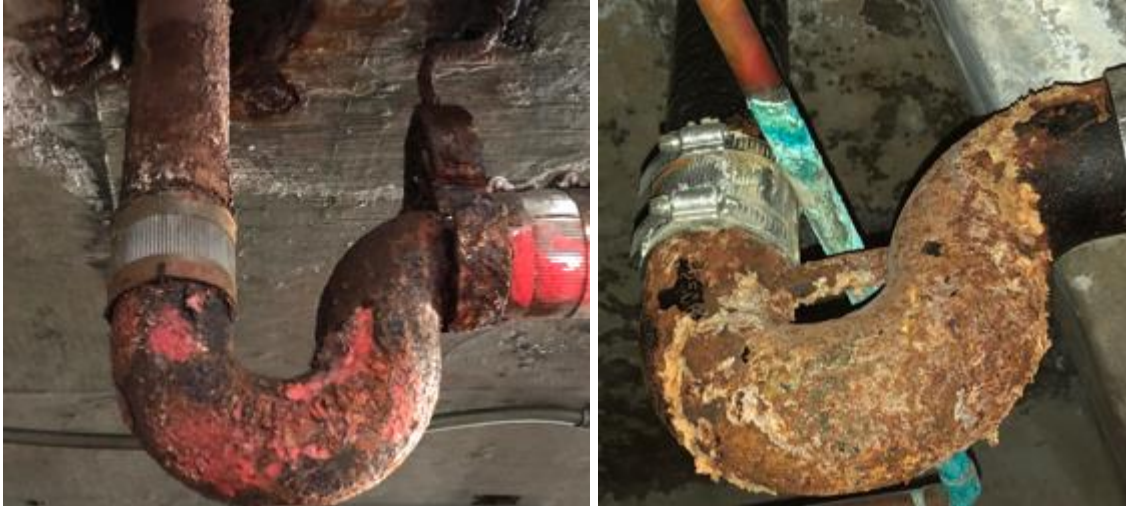
The following two photos are of drain pipes in common areas. The photo on the left shows the significant corrosion and pitting of a waste pipe. The photo on the right shows the similar condition of a supply pipe. The copper supply pipe appears to be contacting the cast iron and

the coupler. In this situation, when two dissimilar metals come into contact, a chemical reaction occurs and increases degradation of the pipe. The copper pipe shows significant corrosion. The green buildup (i.e., patina) on the pipe could indicate that water is leaking from the pipe and oxidizing in contact with air. These conditions have been found in many locations throughout the property. In previous site visits during exploratory investigations, walls within units were opened and similar conditions were found.

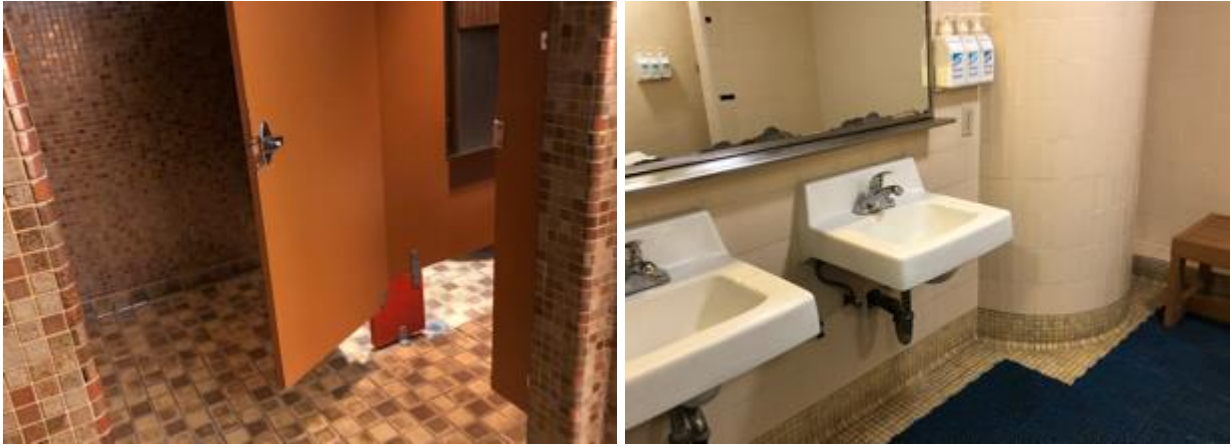
During the walkthrough on March 17th–19th, 2021, observers found there are still a significant number of items from the original CASp/ADA Survey that have yet to be completed. Previous Board members and MCC management staff told HCC that the work shown in the survey had been added to a 15-year implementation plan.

While some requirements have been implemented, others are still pending. It appears that some path-of-travel requirements were implemented on the ground level in the use of additional paint markings. Upon recent observation, the bathrooms mentioned above have not been brought into conformance. The following photos were taken during the site visit and show two of the bathrooms with the original finishes, which were typical of all bathrooms mentioned. The restaurant bathrooms appear to have been updated in the last 10–15 years but, according to the ADA Compliance Team report, they also fail to meet the minimum ADA code requirements.

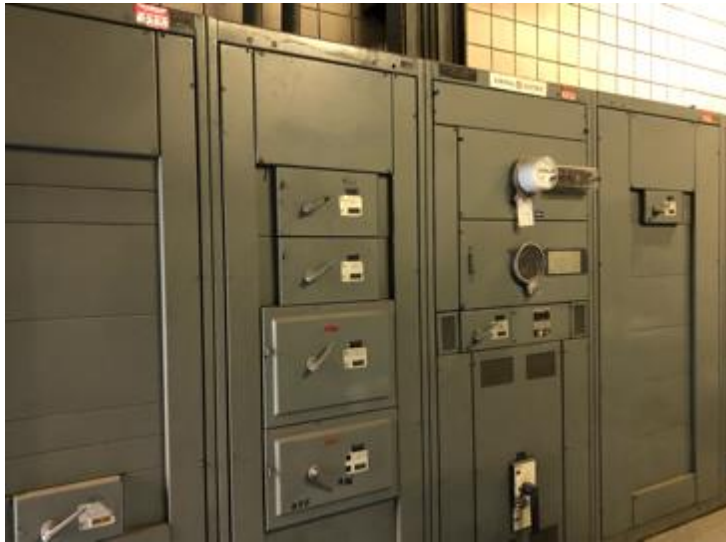
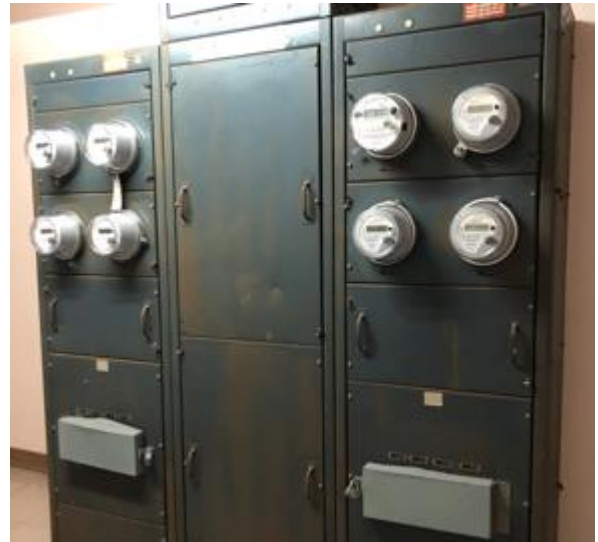
During the walkthrough, all major power service entrances were observed. Mark Baldus was in attendance during the walkthrough and provided information about previous work on the system. Below are two example photos of equipment that REX Engineering observed. The photo on the left of is of the main service entrance in the East Tower. The photo on the right shows typical individual unit meters from the Center Tower. Every unit has its own meter at a central location near the elevators of every floor for each tower building.

The property has three backup emergency power generators, one in each tower. The building operations crew exercises these generators once per month. Backup emergency power is limited to stairwell and garage lighting. Common area lighting is on 60–90-minute backup batteries. The elevators have no emergency backup power.

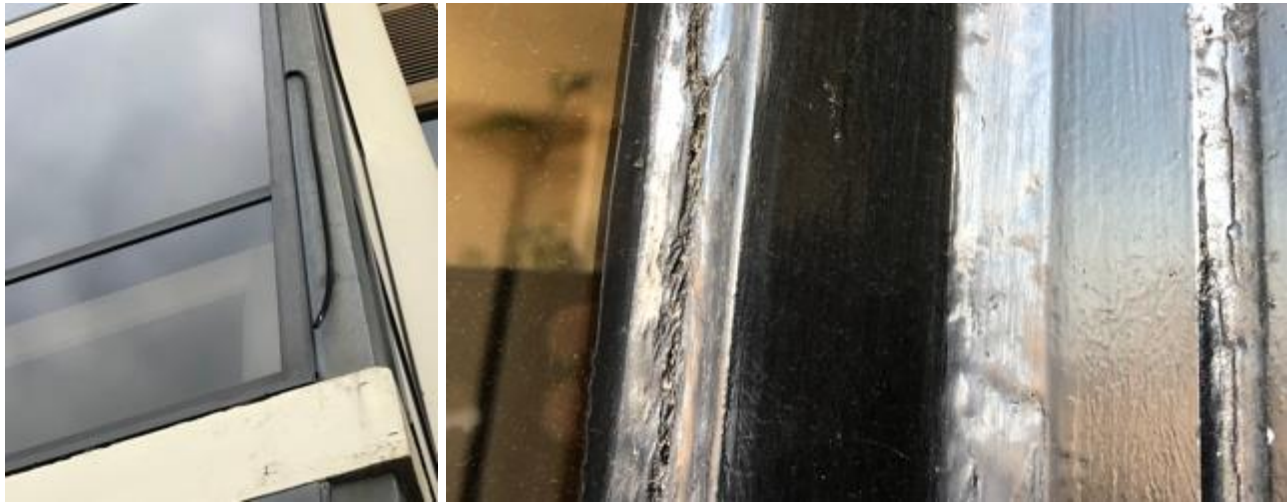
The following two photos represent the general window sealant condition. The photo on the left was shot from a ground level position on the East Tower and shows the sealant hanging from the window joint. The sealant detached from the window, leaving a pathway for water to enter the building envelope. The photo on the right was taken from an upper unit on the Center Tower. Cracking of existing sealants is a chronic problem throughout the entire property.

At the conclusion of the site walkthrough, all parties agreed that only limited maintenance seemed to have been done on the windows to rectify items in any of the reports. Building operations reports to address water leaking issues on a per-occurrence as-needed basis. The sealant composition is unknown and laboratory testing is needed to confirm its composition and whether sealants contain hazardous materials.

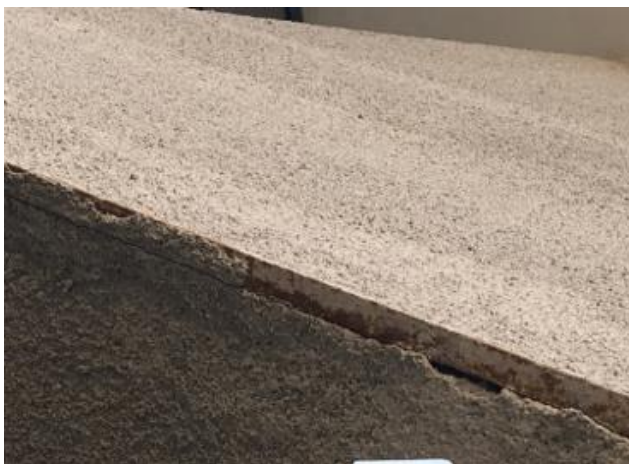
The photo on the left is an example of the corner of an exterior stucco surface. The stucco surface has deteriorated and is crumbling off of the building. The exposed opening allows water to enter the building.

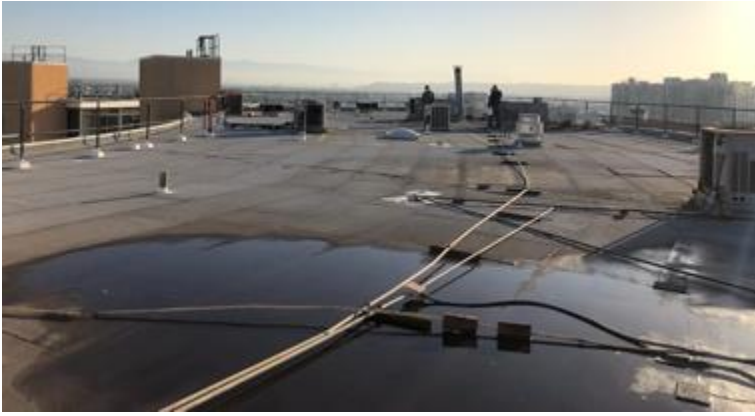
The roof surfaces on both the Center and East Towers appear to continue to suffer aggregate loss. There was also existing ponding water in various locations.

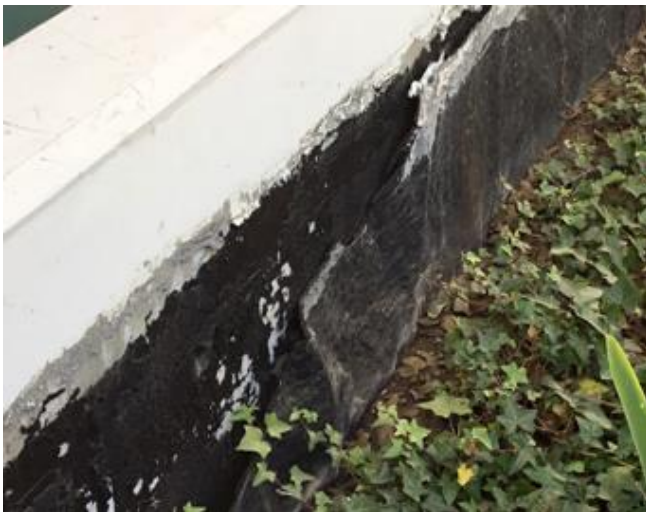
Waterproofing is necessary to move water to a drain and prevent it from leaking onto the deck below. The photo to the left shows waterproofing failure in one of the planter boxes in a Plaza deck area. This condition is typical throughout the property in planter areas. Similar planter boxes are located adjacent to all tennis court areas on above-grade deck areas.

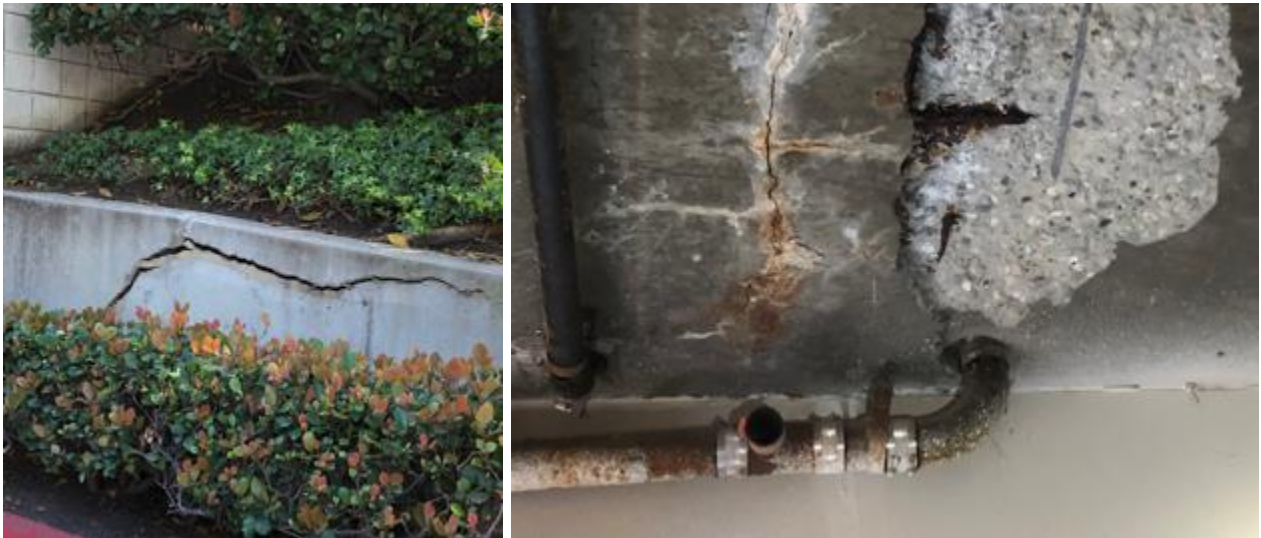
The following photo on the below left shows a failed landscape retaining wall. Failure is likely due to a combination of factors, including concrete spalling from corroding rebar and landscape irrigation that keeps the area wet most of the time.

The photo on the below right is the underside deck of the Center Tower mechanical and cooling tower structure (Boiler Room). The ceiling is supplementally supported by shoring (not shown) located in the center of the lower room. The concrete and structural rebar is in poor condition and repairs are necessary. See the KCE report for additional details.

The damage shown the above photos may be found in numerous areas throughout the property. A complete concrete spalling survey should be performed to identify all locations.
