RE: Evaluation of Construction Impacts on *Erythrina caffra* trees at Via Marina, As Needed Services

Evaluation of Construction Impacts of *Erythrina caffras* at Via Marina.

Marina Del Rey, CA
Site Visit Summary

Evaluation of Construction Impacts at Via Marina Marina Del Rey, CA

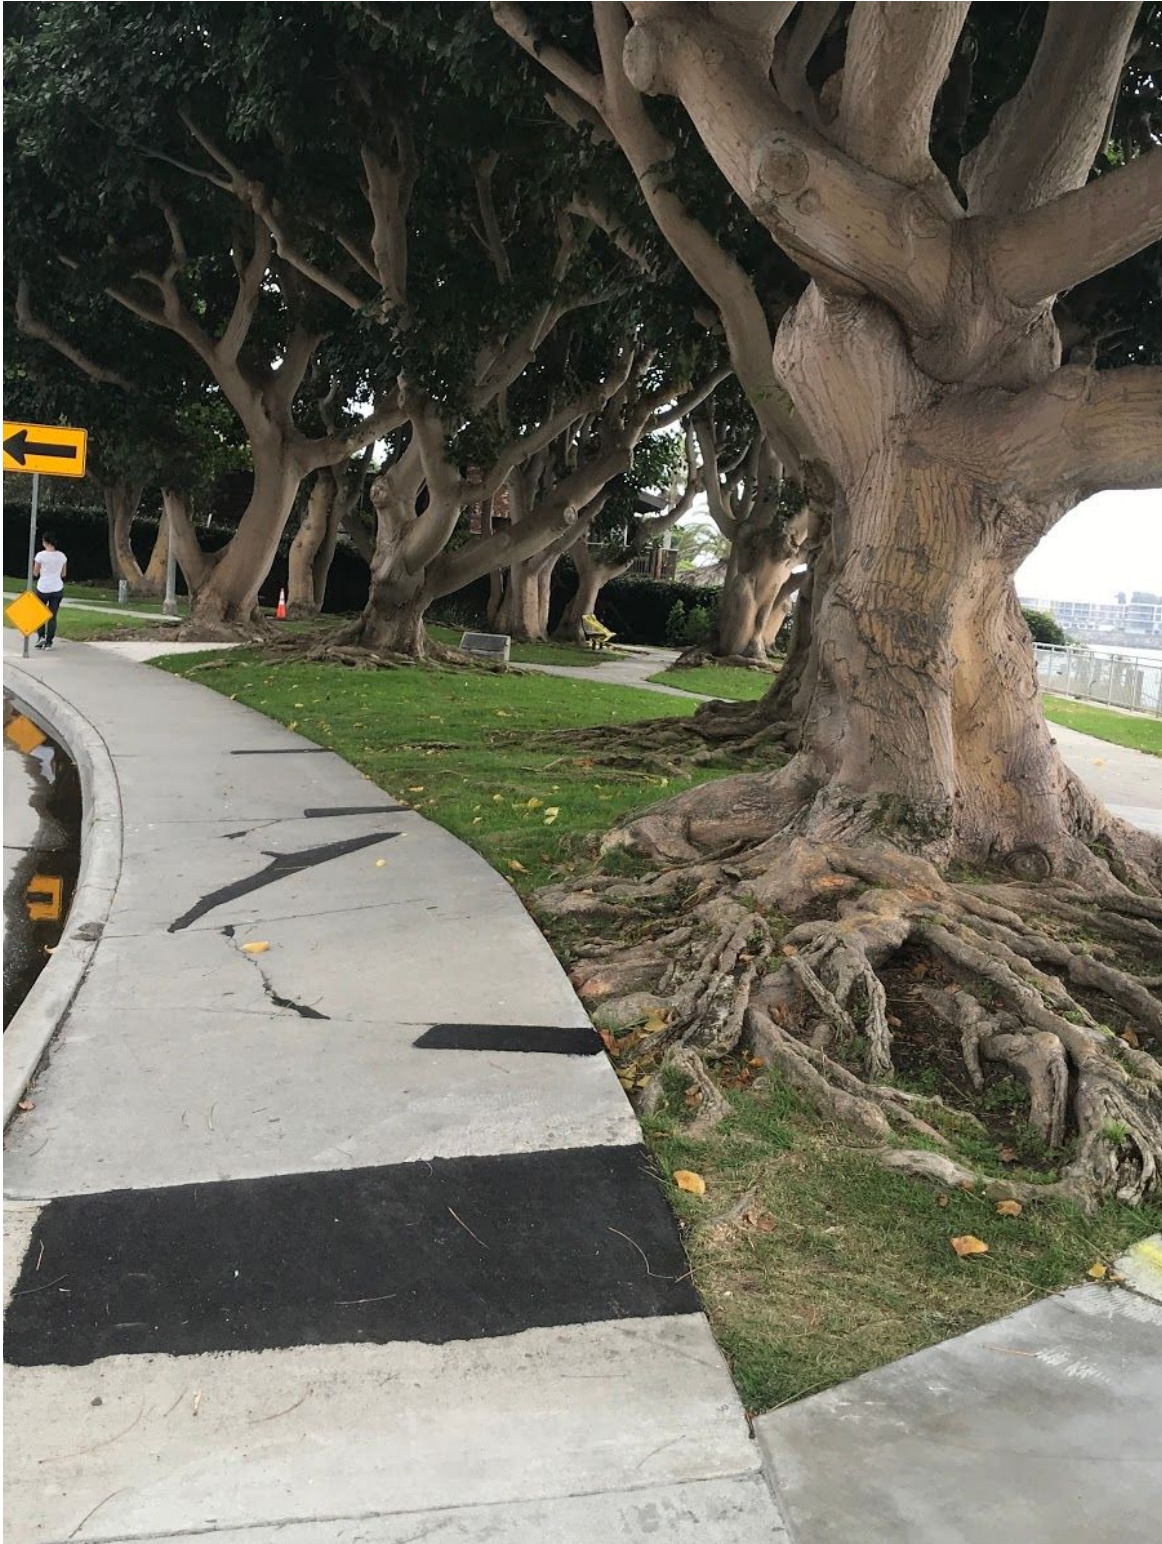
VM-27 *Erythrina caffra* (Photo 1) is in Fair condition. This tree's roots were severed by approximately 50%. The SRZ and CRZ of tree VM-27 has been compromised by construction activities. Several large scaffold branches of adjacent coral trees have been failing in recent months.

Photo 1 – VM-27, major structural roots causing sidewalk to lift.

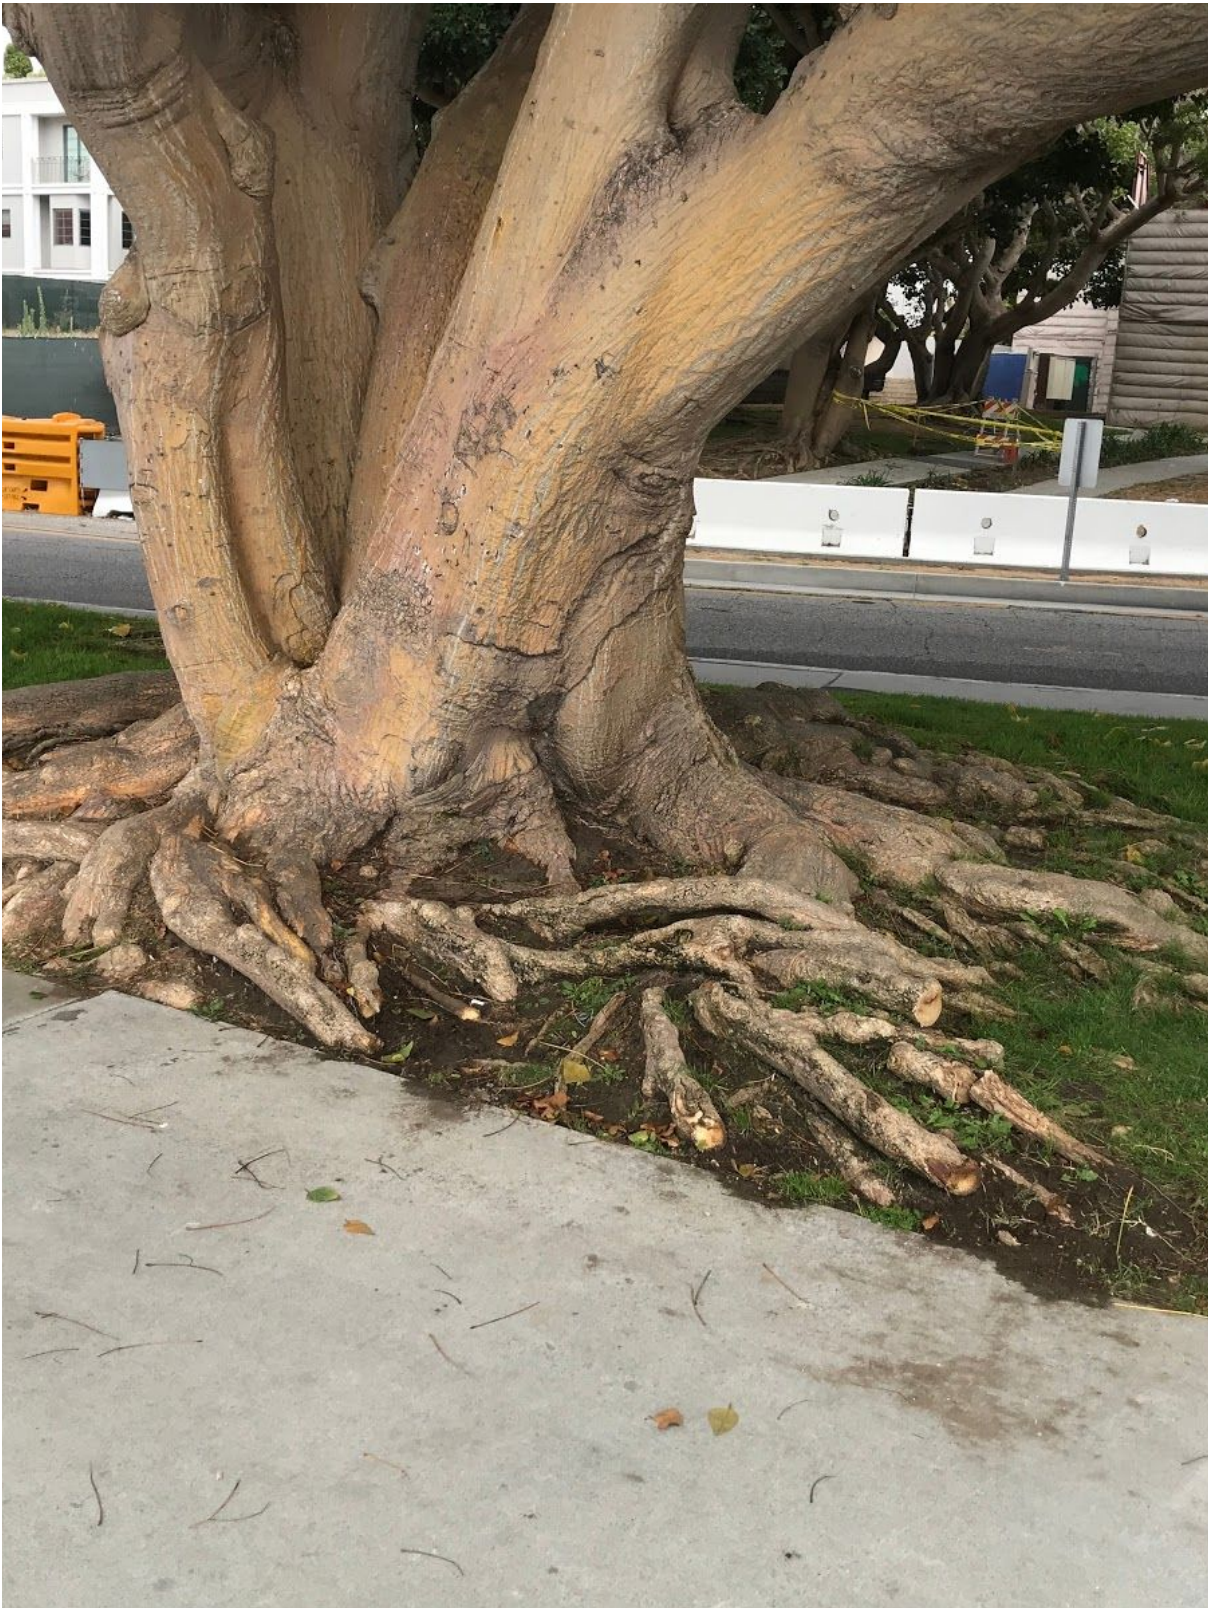
VM-28 *Erythrina caffra* (Photo 2) is in fair condition. This tree's roots were severed by approximately 50% during sidewalk construction that was less than two feet from the trunk. Some of these roots are greater than 3 inches in diameter. The Structural Root Zone (SRZ) of VM-28 has been significantly compromised by construction activities. Large previous failures to adjacent trees were observed.

Photo 2 – Tree VM-28, Large structural roots (>2”) being pruned for new construction to sidewalk.

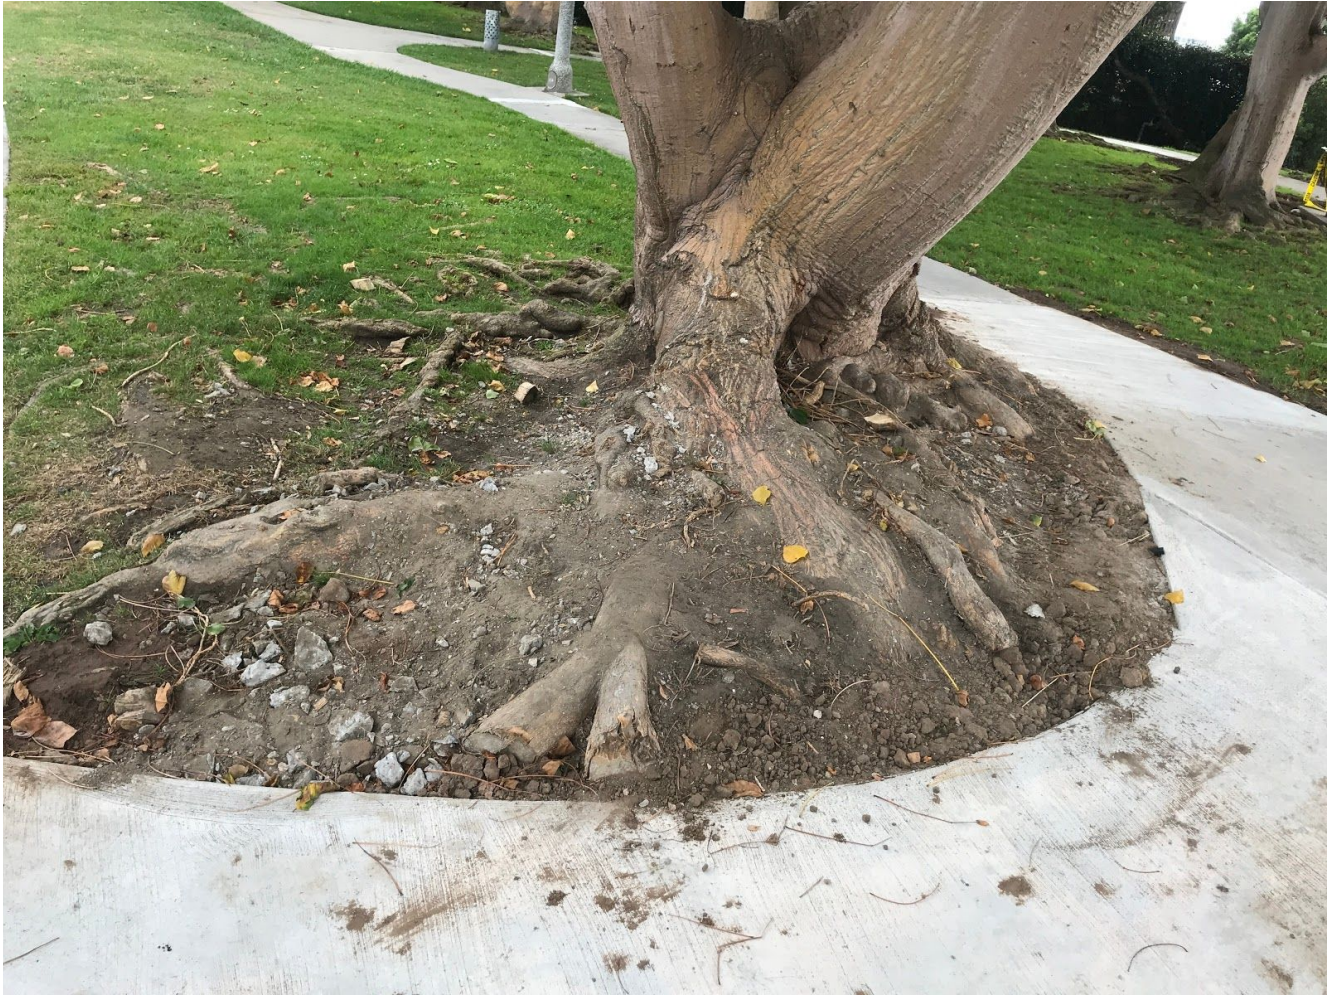
VM-30 *Erythrina caffra* (Photo 3) is in Fair condition. This tree's roots were severed by approximately 70% during sidewalk construction in a U-shape, approximately 3 feet from the trunk. The structural root zone (SRZ) has been significantly compromised.

Photo 3 – Tree VM-30, large structural roots (>3”) being pruned more than 50%.

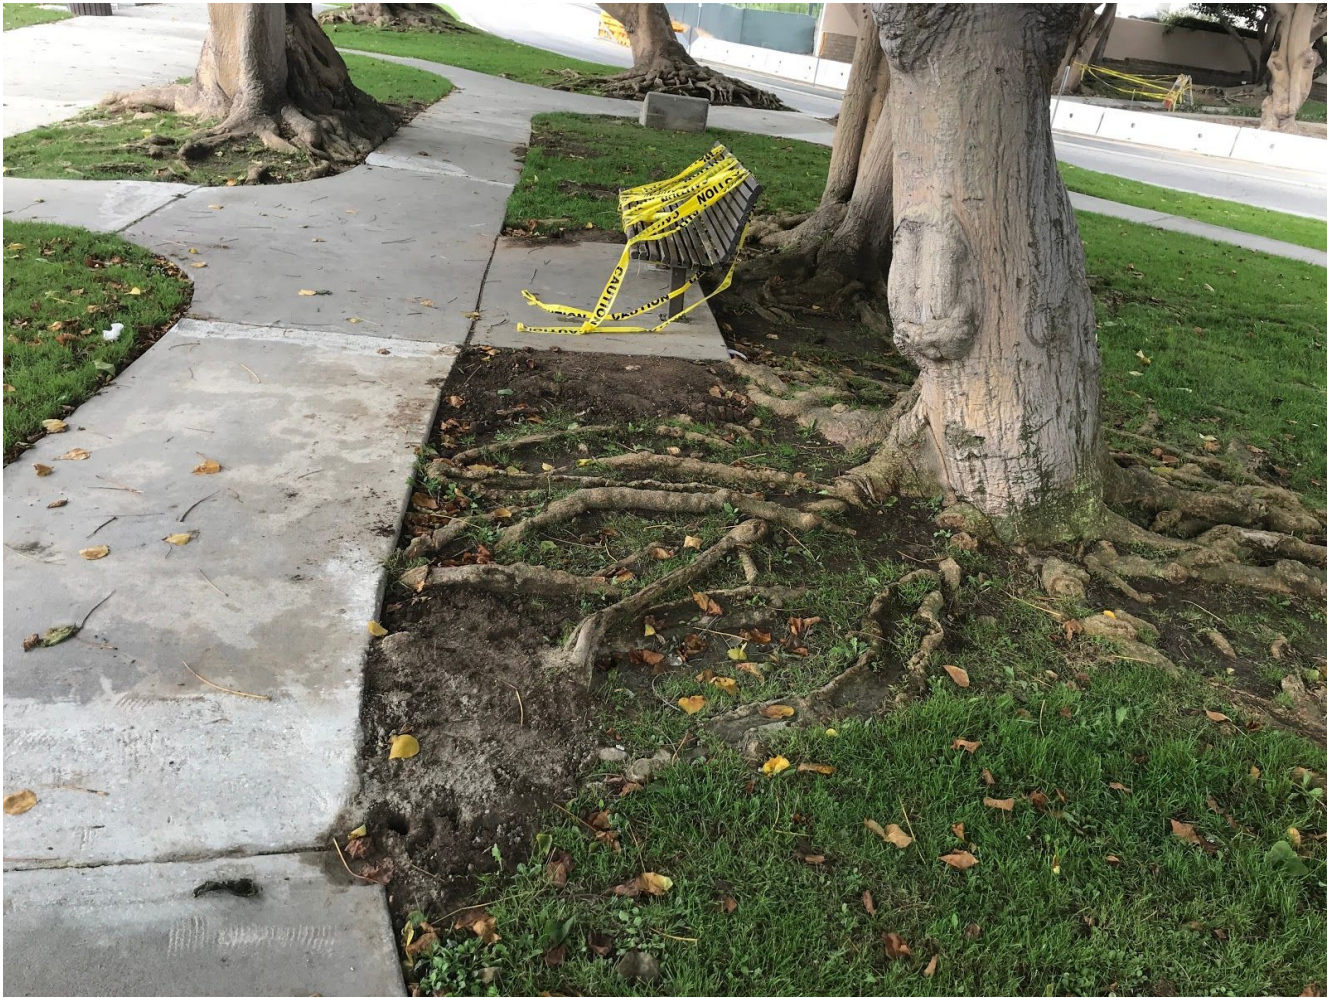
VM-33 *Erythrina caffra* (Photo 4) is in fair condition. The CRZ of this tree was severed by approximately 25%. The SRZ has not been impacted by sidewalk construction. Retain, Monitor and selective pruning to compensate for root loss is recommended.

Photo 4 – Tree VM-33 large roots causing lifting and damage to sidewalk.

Tree VM-33 had minimal impacts from the construction activities and should be retained and monitored. Further improvements to the area should avoid mechanical trenching for new irrigation, grade changes and soil compaction.
