Daily Tree Protection Monitoring Log

Aubrey Austin Park Improvement Project, Marina del Rey

Date: 10/02/2024

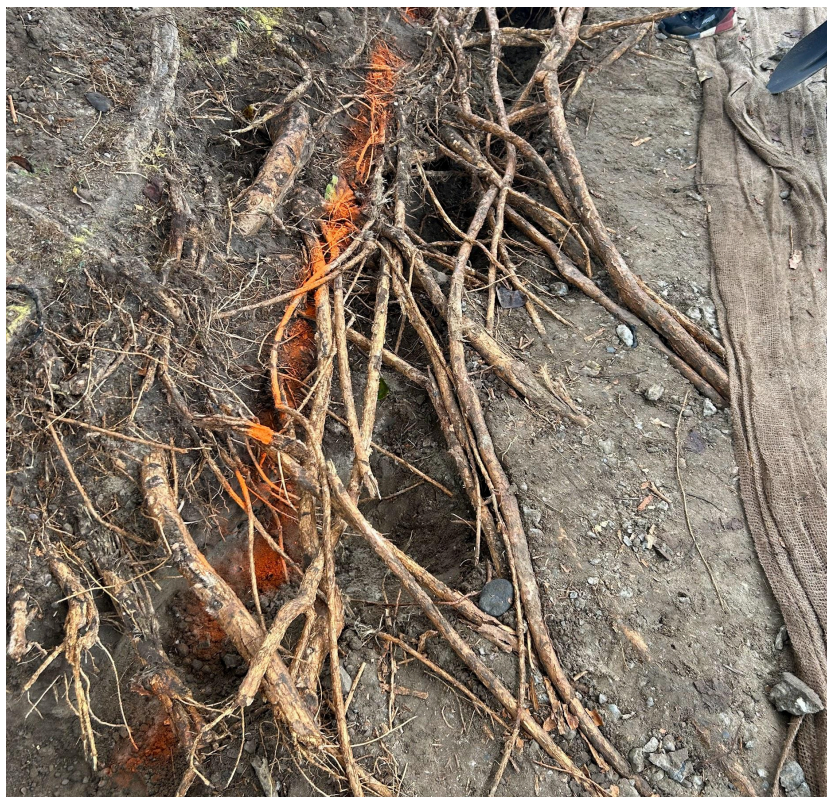
VM-38 showing shallow feeder roots less than three inches in diameter

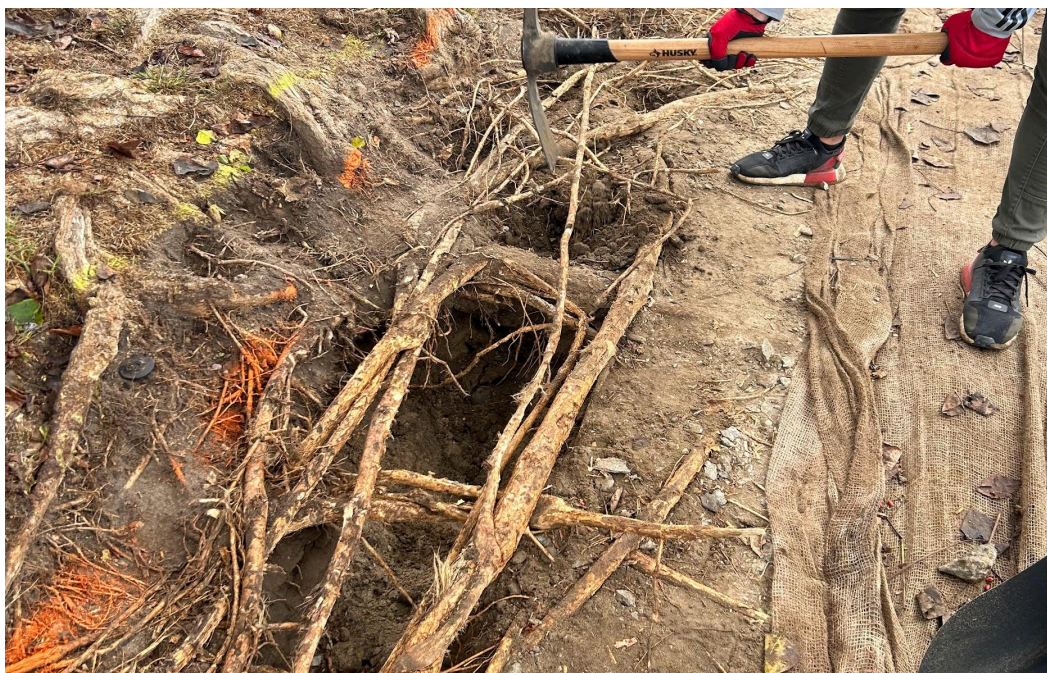
Larger structural root of VM-34 that would need pruning

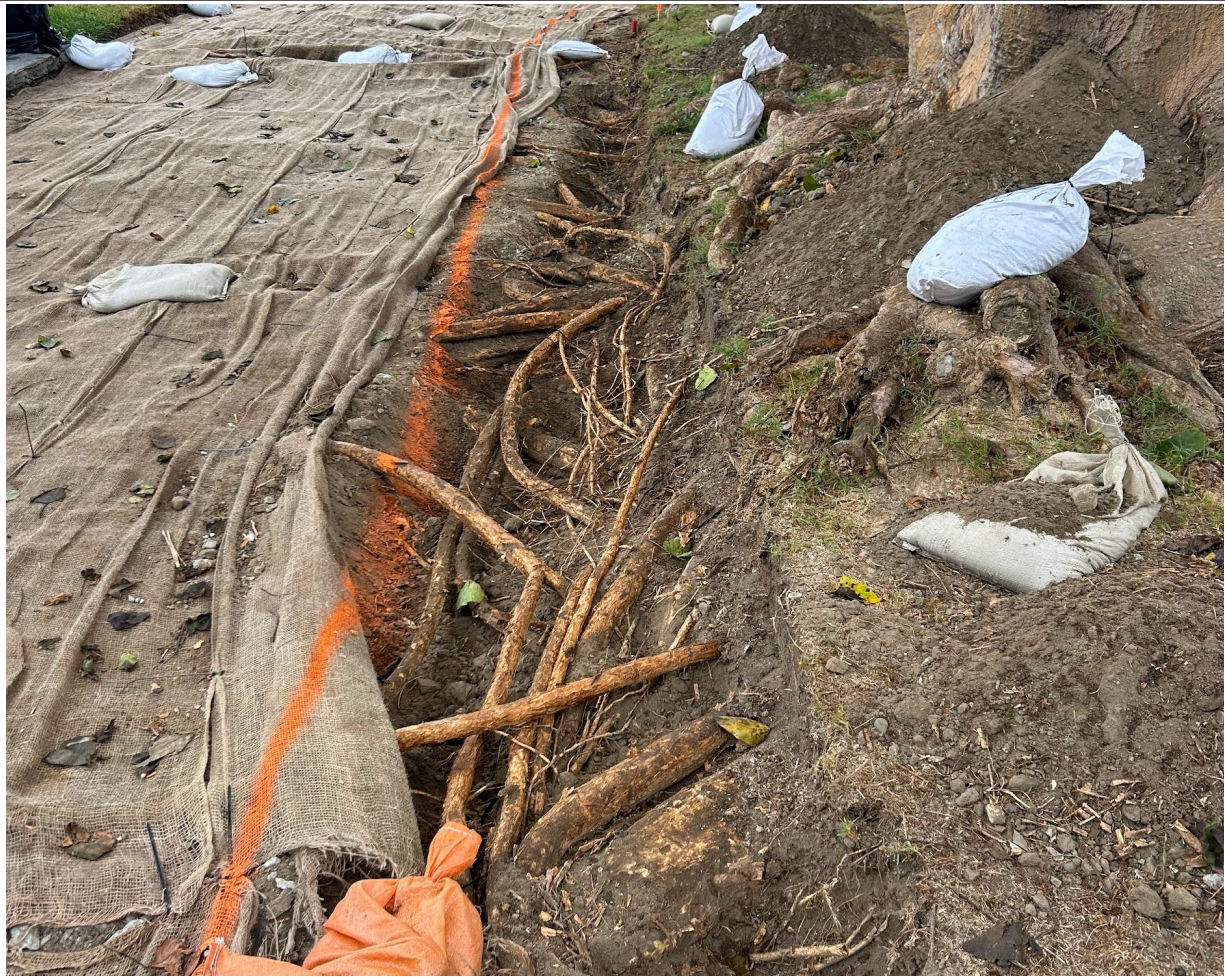
Monitoring Activities Summary <i>(Describe construction activities/equipment monitored, locations, and any protective measures taken):</i> <p><i>Observed the exposed trench near VM-28 with Cesar that demonstrated significant large structural roots that would need to be cut, confirming the need for removal of the tree to grade and install the new roadway. The excavation of roots along VM-34 showed numerous feeder roots under three inches in diameter with several structural roots four inches or greater in diameter. All roots are shallow and most were positioned along the previous hardscape with very few extending under the old roadway. Since VM-34 is set back further from the roadway footprint and the roots are shallow, it is likely that selective root pruning will allow the tree to remain. It was discussed with Cesar the potential to avoid cutting off the exposed surface roots near the root plate by setting the forms as far as possible from the root plate while maintaining the specified width of the roadway. No trenching was performed for tree VM-31 as this tree had been designated for removal based on the amount of large structural roots that would need to be cut; compromising the stability and health of the tree., according to the current plans</i></p> <p><i>We also walked the footprint for the new walkway path along VM-41 and determined similar hand trenching will be needed to expose the cutline for the root pruning. The shallow depth and slope of foundation for the sidewalk will likely cause minimal impacts on the tree. We will need to see what roots are exposed before determining the final impacts for this tree.</i></p> <p><i>Based on the current design, coral trees VM-27 , VM-28, and VM-31 are recommended for removal. They will not safely withstand the excavation and root pruning. . For any removal, there is an approval process from LA Beaches and Harbors. As with all trees, liability will remain with the tree owner if the decision is to retain the trees.</i></p>

Dense structural and feeder roots of VM-28. Tree will need removal

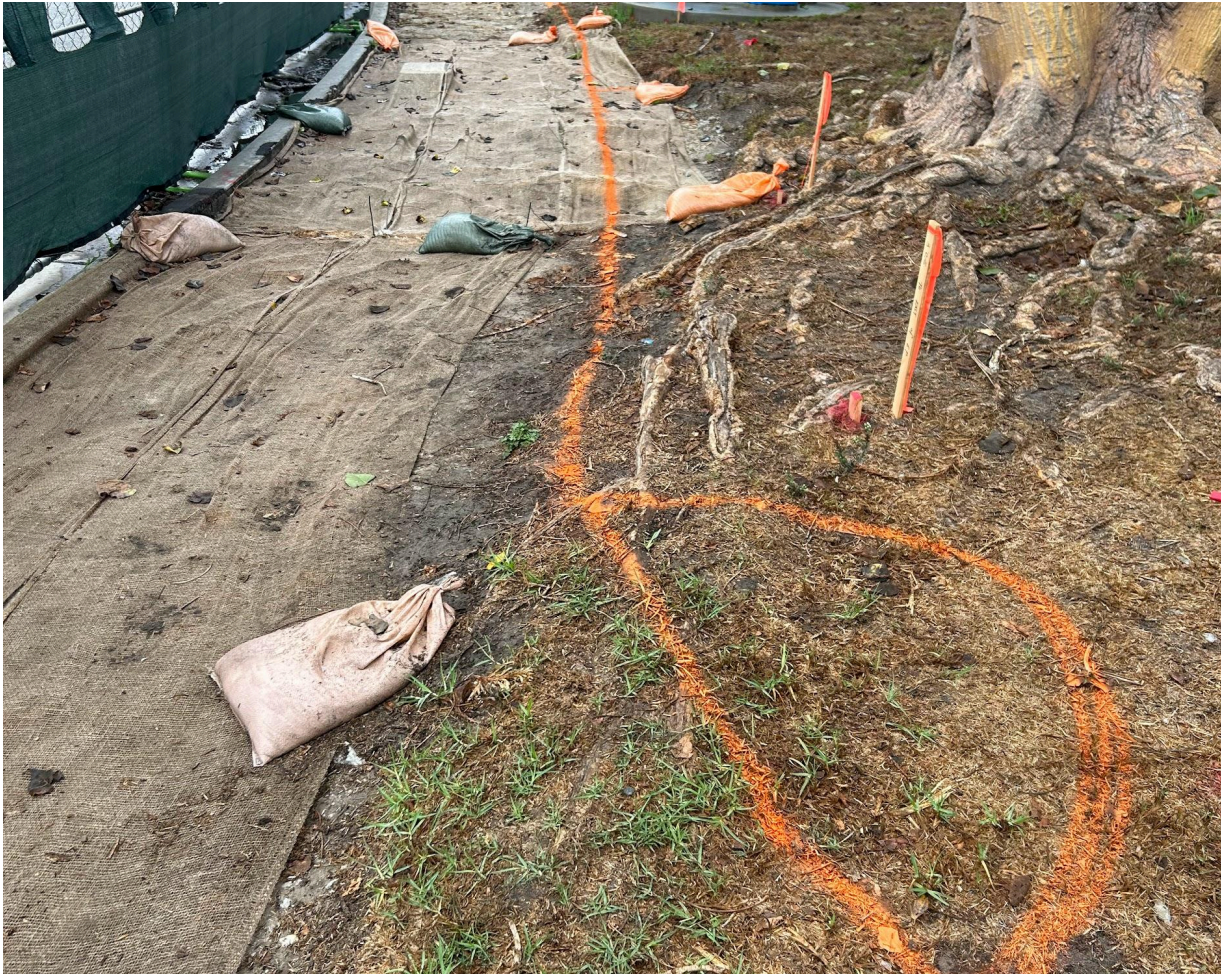
Area around VM-41 that will need hand excavation to determine root pruning options
