September 1, 2026

Porsche Nauls, Section Manager  
Planning and Environment Section  
Planning Division  
County of Los Angeles  
Department of Beaches and Harbors  
13837 Fiji Way  
Marina del Rey, CA 90292

**SUBJECT:** Level 2 Tree Risk Assessment Report for Tree VM-32 Located in Marina del Rey, Los Angeles County, California.

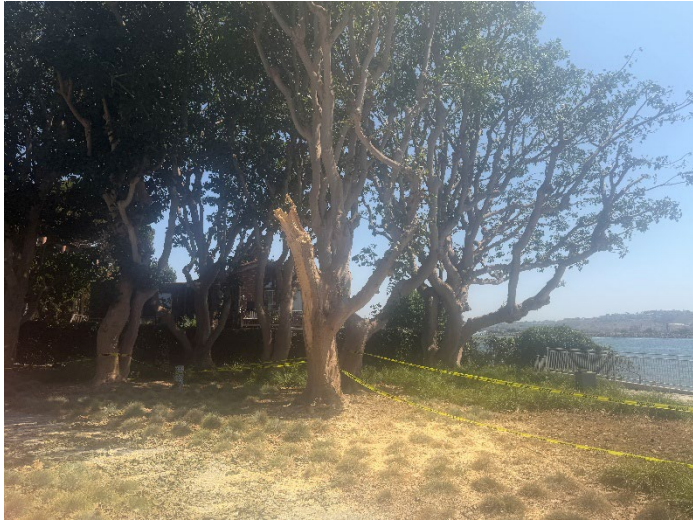
**Photo 1.** VM-32 Coastal Coral Tree (*Erythrina caffra*)

The observed event was not limited to the loss of a small lateral limb. A large co-dominant stem failed, removing a substantial portion of the crown and producing a long, open longitudinal rupture through the retained attachment and stem. The jagged remnant, exposed wood, and loss of crown mass are directly visible. The event therefore provides realized evidence of failure at the tree’s mature multi-stem architecture and materially changes the condition documented during the Level 1 screening.

Incident overview showing the failed large co-dominant stem and the occupied park and pedestrian setting. The failed crown extended into the public-use area. **Note:** lower right is previous location of Tree VM-31 (a Coral Tree that also experienced large limb failure)

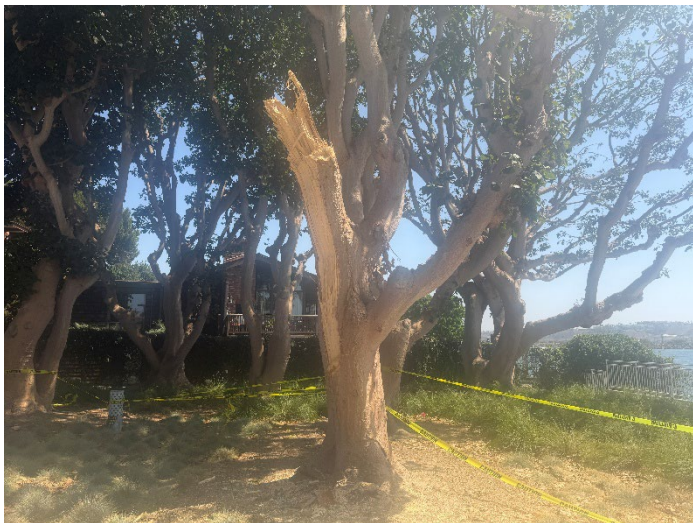
**Photo 2.** VM-32 Coastal Coral Tree

Jagged fracture surface and lost attachment. Corrective removal of damaged material cannot restore the former co-dominant architecture.

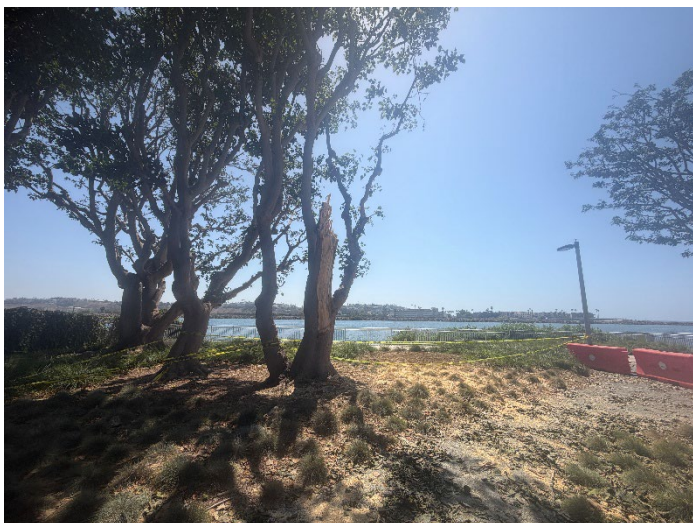
**Photo 3.** VM-32 Coastal Coral Tree

Close-up of post-management of failed limb. Note additional cambial wound from management activities (chainsaw) contributing to additional tree stress. These ancillary injuries cannot typically be avoided when abating hazard conditions.

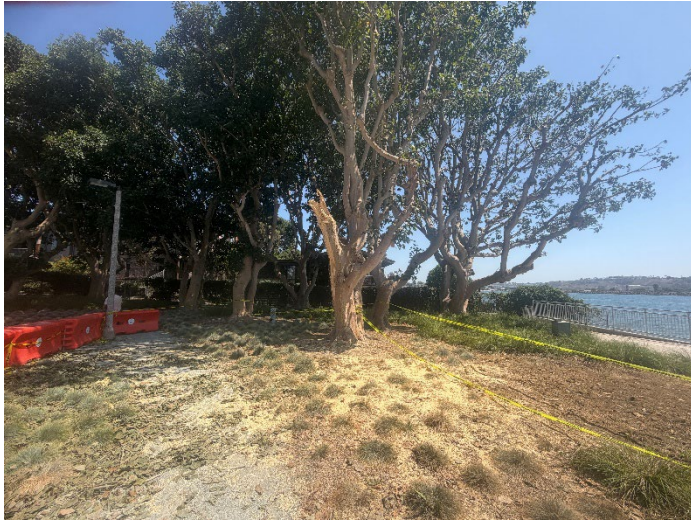
**Photo 4.** VM-32 Coastal Coral Tree

Wider target and canopy context showing the retained asymmetric architecture, caution controls, adjacent walkway, landscaping, and nearby residential improvements.

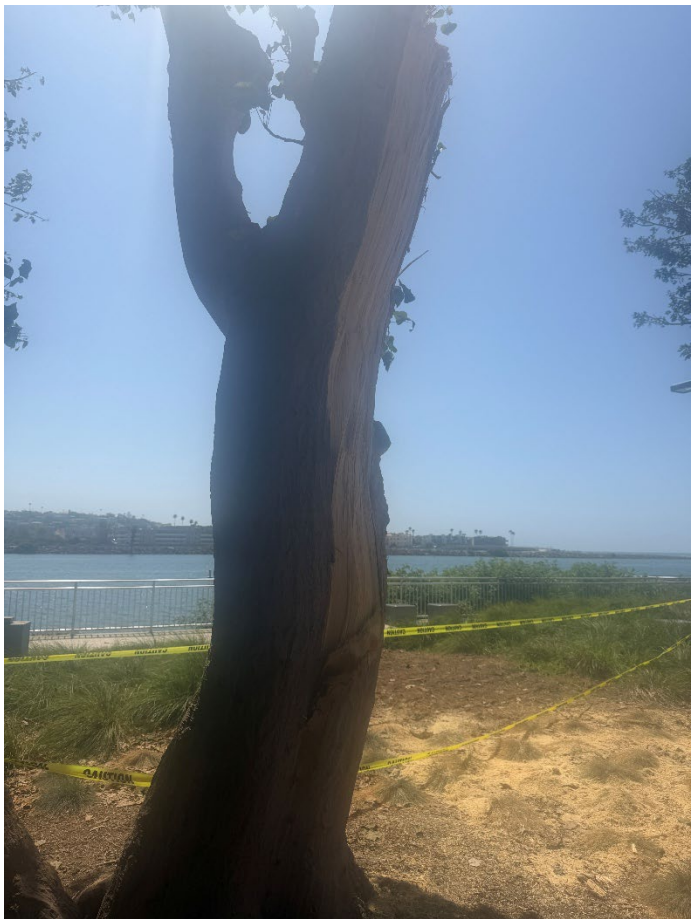
**Photo 5.** VM-32 Coastal Coral Tree (*Erythrina caffra*)

Close view of the extensive longitudinal rupture and exposed wood extending down the retained stem.
