Safer Alternatives to Copper Antifouling Paints: Nonbiocide Paint Options

Prepared for:
Cal/EPA's Department of Toxic Substances Control and
U.S. Environmental Protection Agency Region IX

Prepared by:
Katy Wolf
Institute for Research and Technical Assistance

February 2012

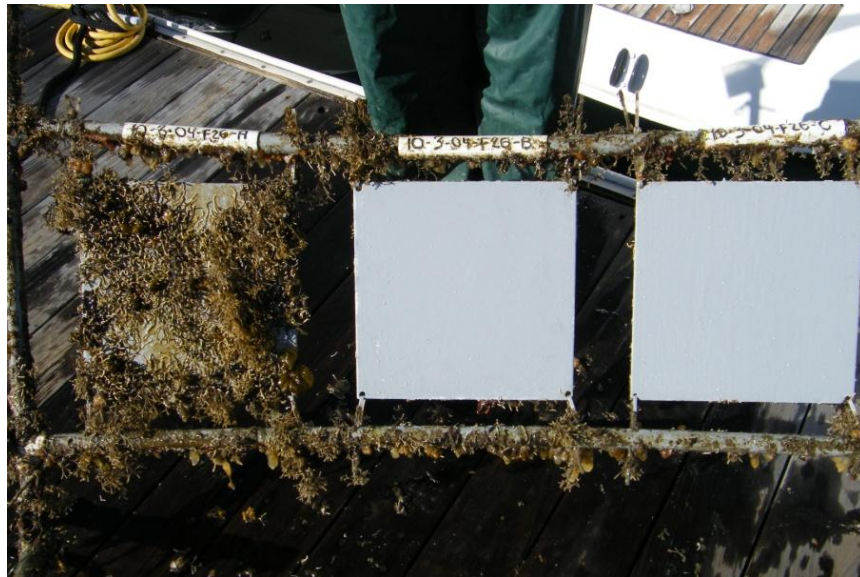
Figure 3-6. XZM 480 Paint During Panel Testing

The panel testing data sheets in Appendix A show that the fouling ratings on the no clean panel are fairly high whereas the fouling ratings on the other two panels that were cleaned regularly are low. The coating condition on the panels that were cleaned is somewhat high (a few 2s and 3s on the data sheets). The notes indicate that the coating is scratched and this follows from the fact that the coating is very soft and easily removed. A picture of the three panel assembly for the paint in January 2011 is shown in Figure 3-6. This coating was selected for the boat testing phase and an MSDS for the product is shown in Appendix B. As discussed later, the company developed a hardener to add to the paint and it was more durable when it was applied to the boat with the hardener additive.

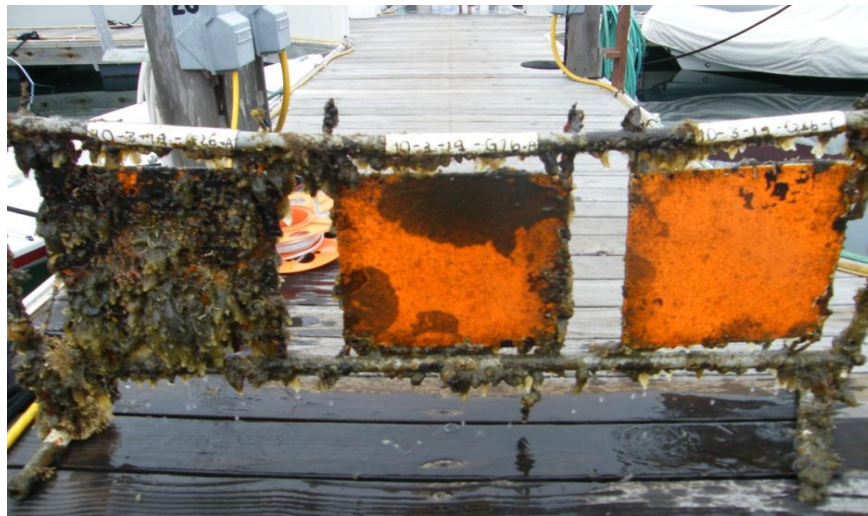
The same situation was apparent in the case of virtually all of the hard nonbiocide paints. Cleaning with the carpet could not adequately remove the fouling no matter how long the cleaning went on. Furthermore, aggressive and prolonged cleaning with the carpet would simply imbed the fouling into the coating rather than remove it. The panels would end up stained with fouling that could not be completely removed. Figures 3-8 and 3-9 show pictures of the three panel assemblies of hard nonbiocide paints with heavily stained middle panels. In addition, some of the coatings had to be scrubbed so hard that the coating was damaged. Cleaning with a more aggressive tool, like an abrasive pad, could remove the paint much more effectively. In some cases, however, even the more aggressive pad did not adequately remove the fouling and a periodic power tool cleaning would have helped considerably.

Figure 3-8. Hard Nonbiocide Paint with Stained Middle Panel

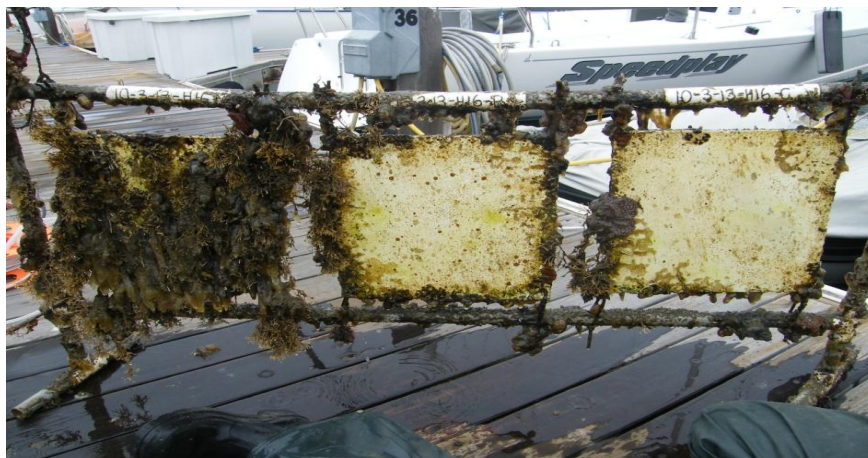
Figure 3-9. Another Hard Nonbiocide Paint with Stained Middle Panel

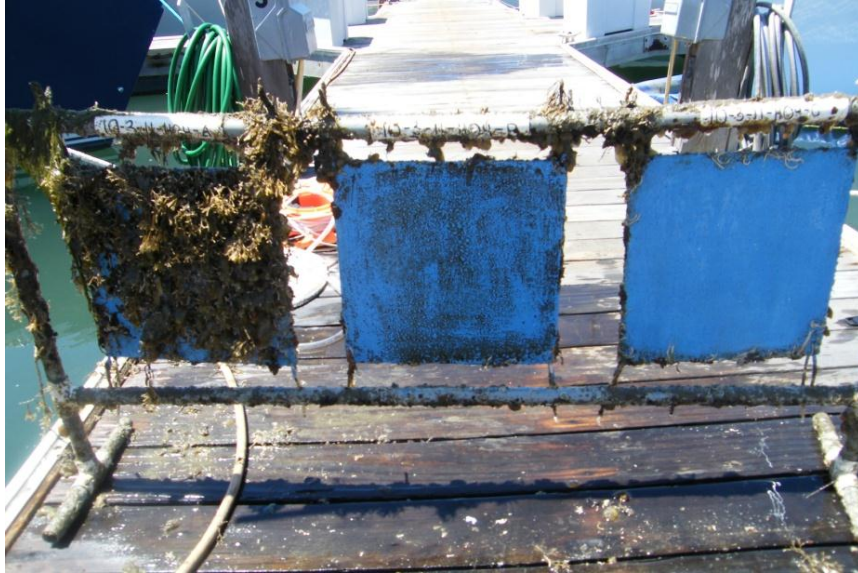
Figure 3-10. HullSpeed 3080 Paint During Panel Testing

This paint was formulated with epoxy to be as hard as possible. Both panels that were cleaned were heavily stained reflecting the problem with hand tool cleaning. The cleaning tool was not aggressive enough to remove the fouling which was ground into the paint. This coating would require frequent use of a power tool to be cleaned appropriately.

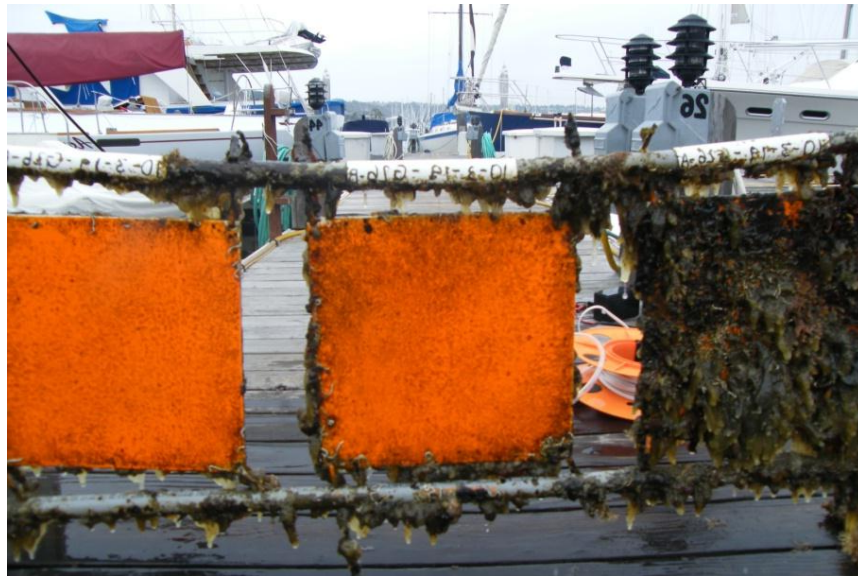
Figure 3-11. Crystal Marine Pro Paint During Panel Testing

This paint, a typical hard nonbiocide paint, was very stained by the end of the testing period. It would likely require frequent cleaning with a power tool to perform well. Figure 3-11 shows the panels containing this paint near the end of the testing.

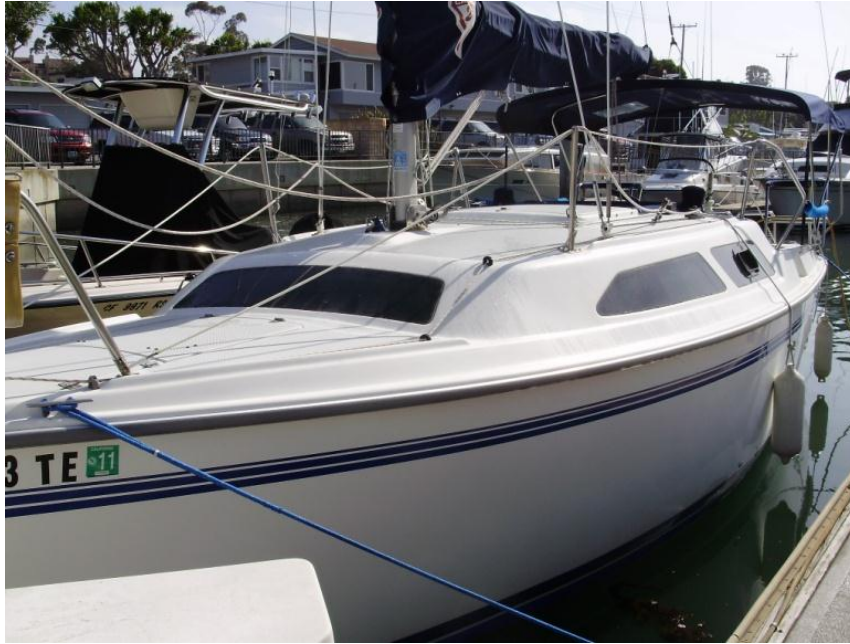
Figure 5-3. Auerbach Boat at One Year Inspection.

IRTA inspected the boat at the end of April, 2011 with the paint supplier when the paint had been on the boat for nine months. The supplier dived in the water and examined the boat hull and its appearance was very good. A picture of the boat during this inspection is shown in Figure 5-3. IRTA and the supplier had provided cleaning guidance to the diving company that maintains the boat. The company was told to clean the boat with gentle tools like a soft carpet and to maintain a schedule of approximately 15

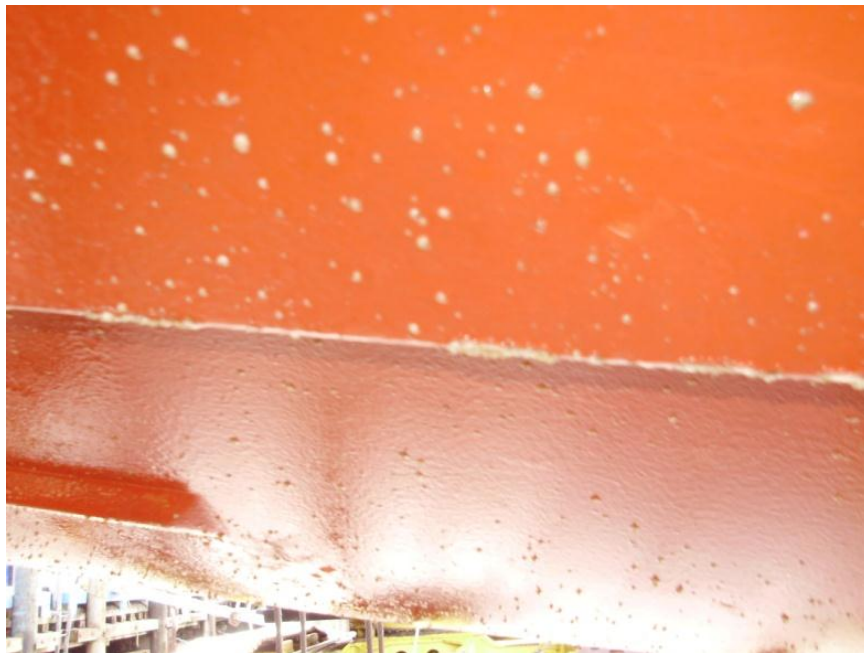
Figure 5-7. Small Barnacles on Port of San Francisco Boat Hull

April, some months after it had been launched. The Port arranged for the boat to be lifted out of the water on a crane so the bottom could be inspected. Figure 5-6 shows the boat suspended by the crane. The boat had not been used during the period and there were small barnacles on the hull. These are shown in Figure 5-7. The boat was usually driven at fairly high speed and it was taken out for a period and the bottom was inspected again to see if the fouling remained. Figure 5-8 shows the hull after the boat was driven at high speed; it shows that nearly all the fouling was removed during normal use. This
