# PROPERTY CONDITION ASSESSMENT REPORT (PCAR)

MARINA CITY CLUB 4333 ADMIRALTY WAY MARINA DEL REY, CALIFORNIA

**DATE** APRIL 16, 2021

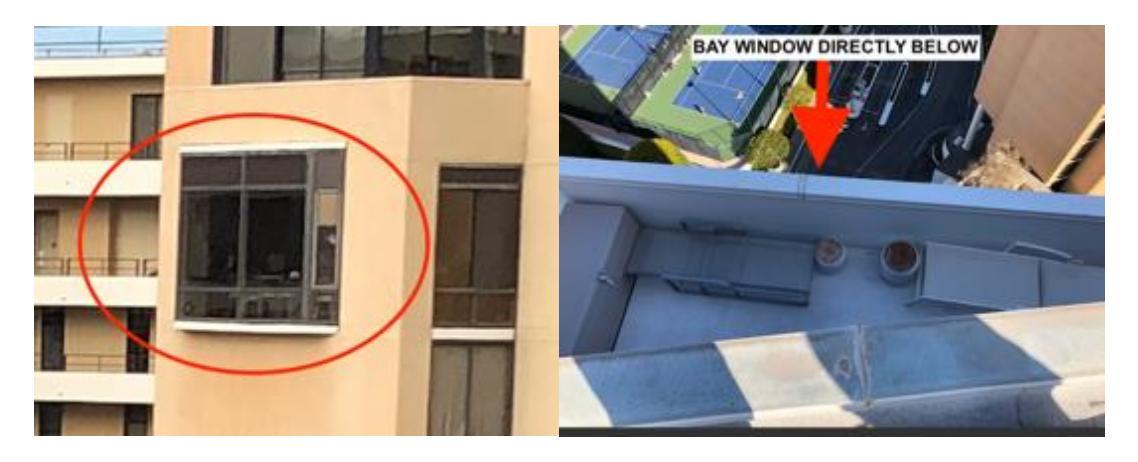
The above left photo shows the existing window condition. The photo on the right looks down on the top of the bay window. Note the photo on the right does not show any means of installing a hanging scaffold davit arm apparatus. The space directly above the bay window is an upper balcony, second-floor penthouse unit. This configuration is present for 12 end unit bay windows.

The penthouse bay window cleaning issue could, unfortunately, call for a complicated or expensive solution. HCC recommends continuing to research the first four options above with a strong preference for Option 1. Cal/OSHA has indicated that Option 1 could be viable, but MCC would need to have a licensed Scaffold Inspection and Testing (SIT) company submit a full plan. Contracting companies Lynn Safety and SkyRyder might be able to provide a design-build solution for Option 1.

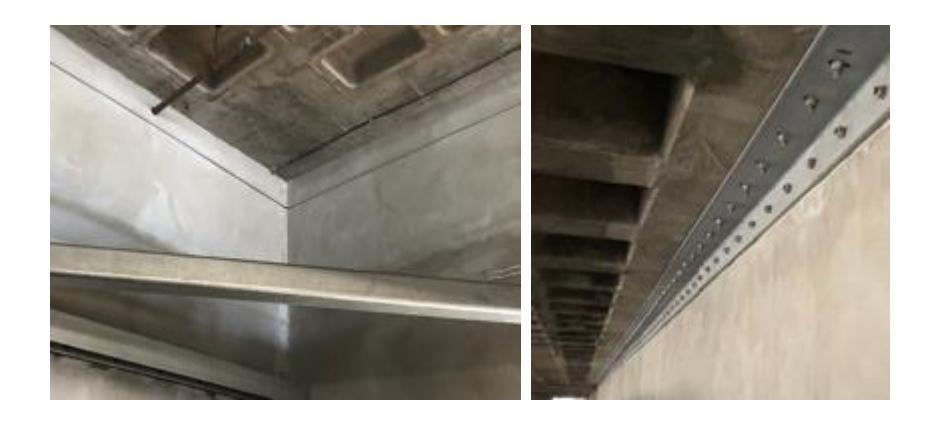
The Promenade Parking Structure was recently repaired due to significant concrete spalling, retaining wall safety concerns, and required seismic retrofitting. These repairs were observed

during the walkthrough. No repairs were observed on the top-level deck, which is the recreation deck. The following images show some of the repairs.

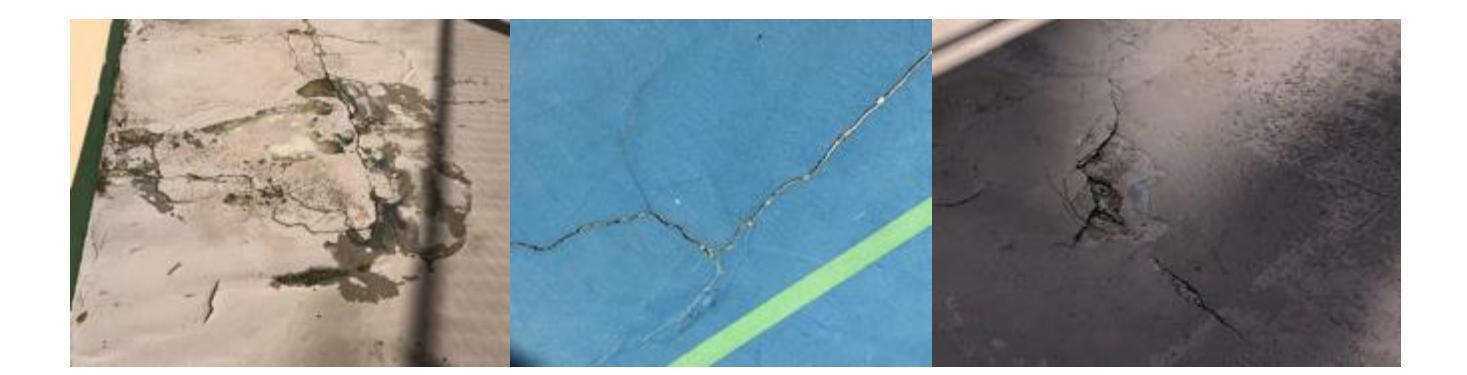
The DTR report goes into detail regarding waterproofing and concrete spalling issues with the recreation deck and other areas. The key takeaway is that nearly all of the waterproofing throughout the property on the recreation deck and tennis courts is failing in some way with water penetrating the structure. Not only does water create a leaking nuisance to residents but it also is the leading cause of concrete spalling and degradation of structural steel components. Over time, this can caused significant damage to the building's structural integrity. The following photos are of the condition of the waterproofing, which is well beyond its useful life cycle.

Recommendations in the DTR report for the recreation deck area should be addressed as a part of the Center Tower and Common Amenities Project. The waterproofing of the tennis courts and areas that flank the Center Tower should also be redone. All courts should be stripped down to structural concrete, the concrete spalling repaired, and the court re-installed. Rusted posts and anchors should be repaired or replaced.

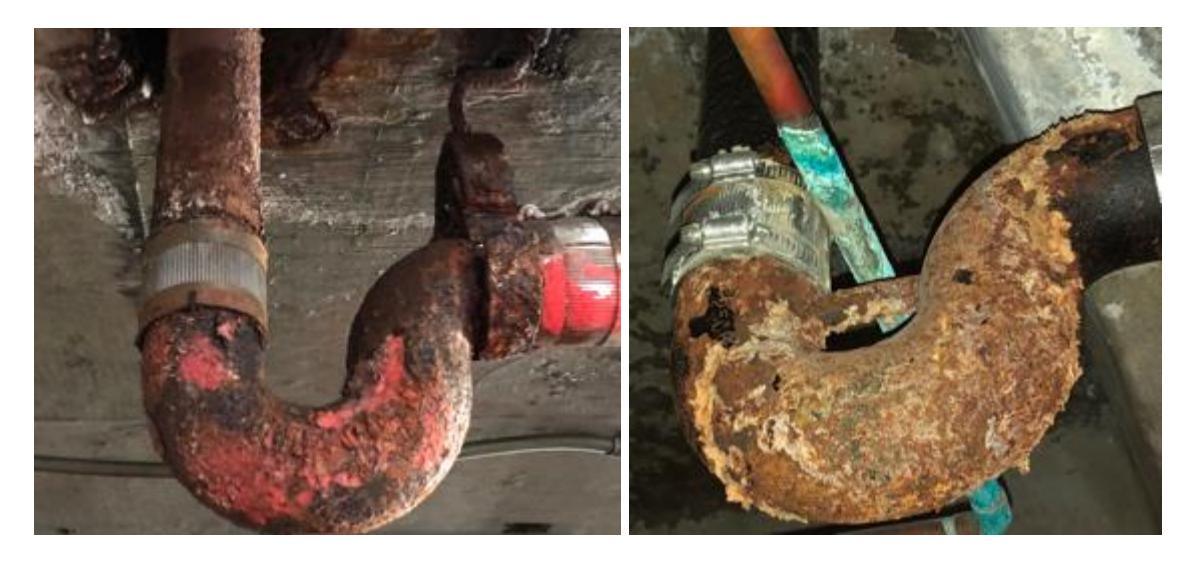
The following two photos are of drain pipes in common areas. The photo on the left shows the significant corrosion and pitting of a waste pipe. The photo on the right shows the similar condition of a supply pipe. The copper supply pipe appears to be contacting the cast iron and

the coupler. In this situation, when two dissimilar metals come into contact, a chemical reaction occurs and increases degradation of the pipe. The copper pipe shows significant corrosion. The green buildup (i.e., patina) on the pipe could indicate that water is leaking from the pipe and oxidizing in contact with air. These conditions have been found in many locations throughout the property. In previous site visits during exploratory investigations, walls within units were opened and similar conditions were found.

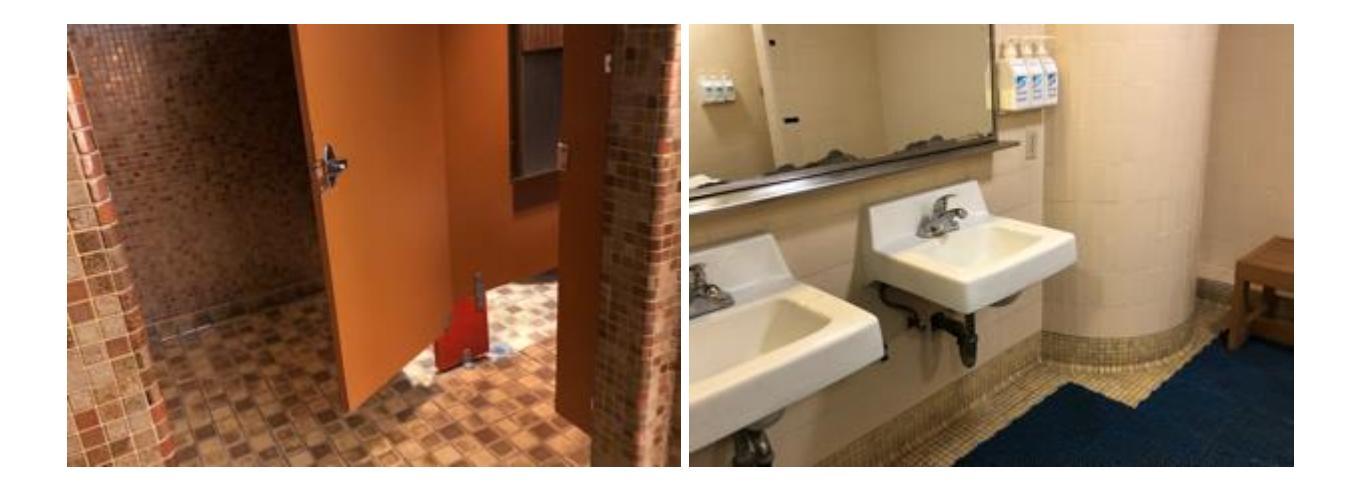
During the walkthrough on March 17<sup>th</sup>–19<sup>th</sup>, 2021, observers found there are still a significant number of items from the original CASp/ADA Survey that have yet to been completed. Previous Board members and MCC management staff told HCC that the work shown in the survey had been added to a 15-year implementation plan.

While some requirements have been implemented, others are still pending. It appears that some path-of-travel requirements were implemented on the ground level in the use of additional paint markings. Upon recent observation, the bathrooms mentioned above have not been brought into conformance. The following photos were taken during the site visit and show two of the bathrooms with the original finishes, which were typical of all bathrooms mentioned. The restaurant bathrooms appear to have been updated in the last 10–15 years but, according to the ADA Compliance Team report, they also fail to meet the minimum ADA code requirements.

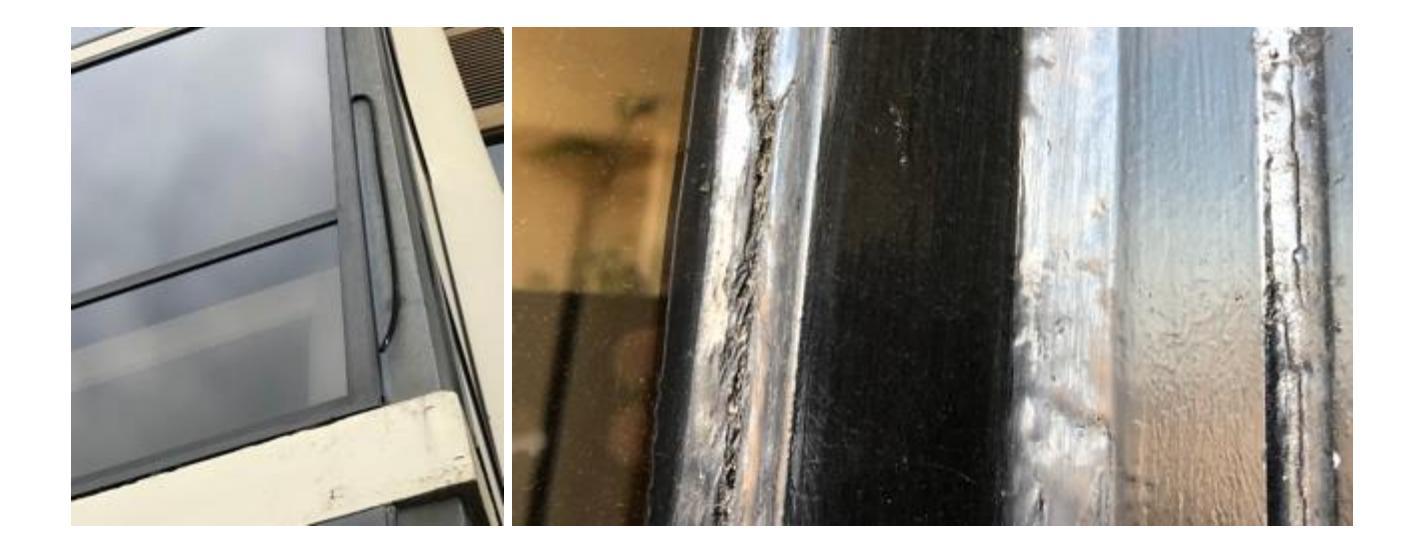
The following two photos represent the general window sealant condition. The photo on the left was shot from a ground level position on the East Tower and shows the sealant hanging from the window joint. The sealant detached from the window, leaving a pathway for water to enter the building envelope. The photo on the right was taken from an upper unit on the Center Tower. Cracking of existing sealants is a chronic problem throughout the entire property.

At the conclusion of the site walkthrough, all parties agreed that only limited maintenance seemed to have been done on the windows to rectify items in any of the reports. Building operations reports to address water leaking issues on a per-occurrence as-needed basis. The sealant composition is unknown and laboratory testing is needed to confirm its composition and whether sealants contain hazardous materials.

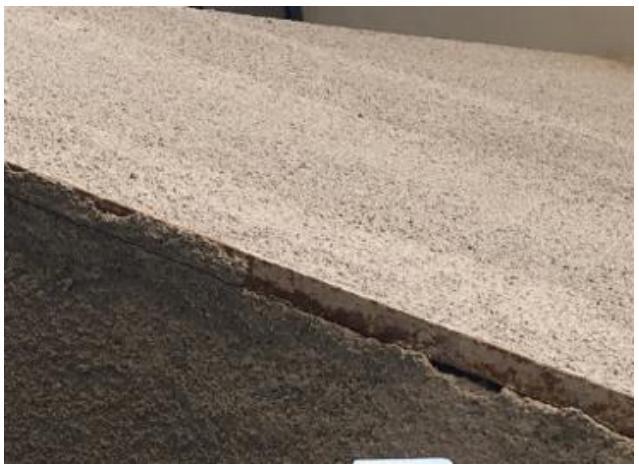
The photo on the left is an example of the corner of an exterior stucco surface. The stucco surface has deteriorated and is crumbling off of the building. The exposed opening allows water to enter the building.

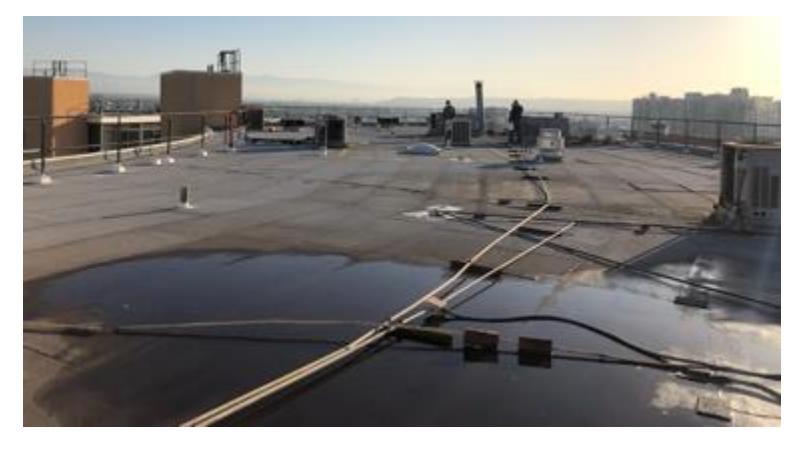
The roof surfaces on both the Center and East Towers appear to continue to suffer aggregate loss. There was also existing ponding water in various locations.

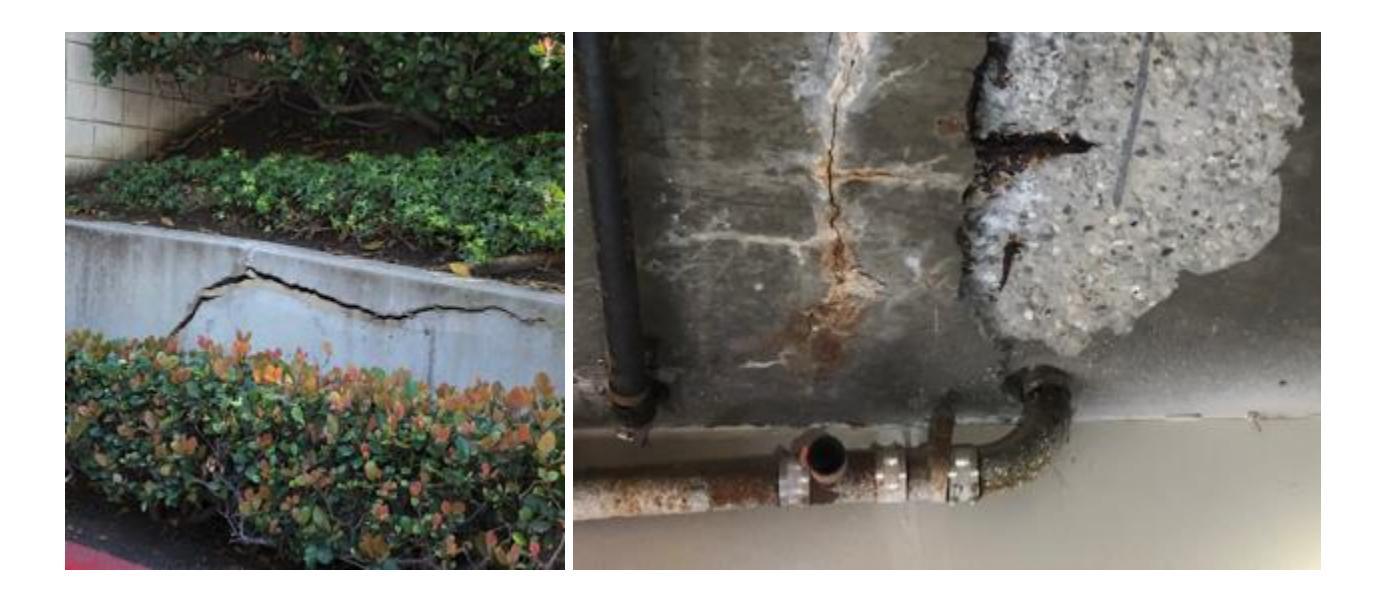
The following photo on the below left shows a failed landscape retaining wall. Failure is likely due to a combination of factors, including concrete spalling from corroding rebar and landscape irrigation that keeps the area wet most of the time.

The photo on the below right is the underside deck of the Center Tower mechanical and cooling tower structure (Boiler Room). The ceiling is supplementally supported by shoring (not shown) located in the center of the lower room. The concrete and structural rebar is in poor condition and repairs are necessary. See the KCE report for additional details.

The damage shown the above photos may be found in numerous areas throughout the property. A complete concrete spalling survey should be performed to identify all locations.
