**RE: National Register of Historic Places Nomination for
Sears, Roebuck & Company Mailorder Building Amendment**

National Register of Historic Places Registration Form

Historic name: Sears, Roebuck & Company Mail Order Building (AMENDMENT)

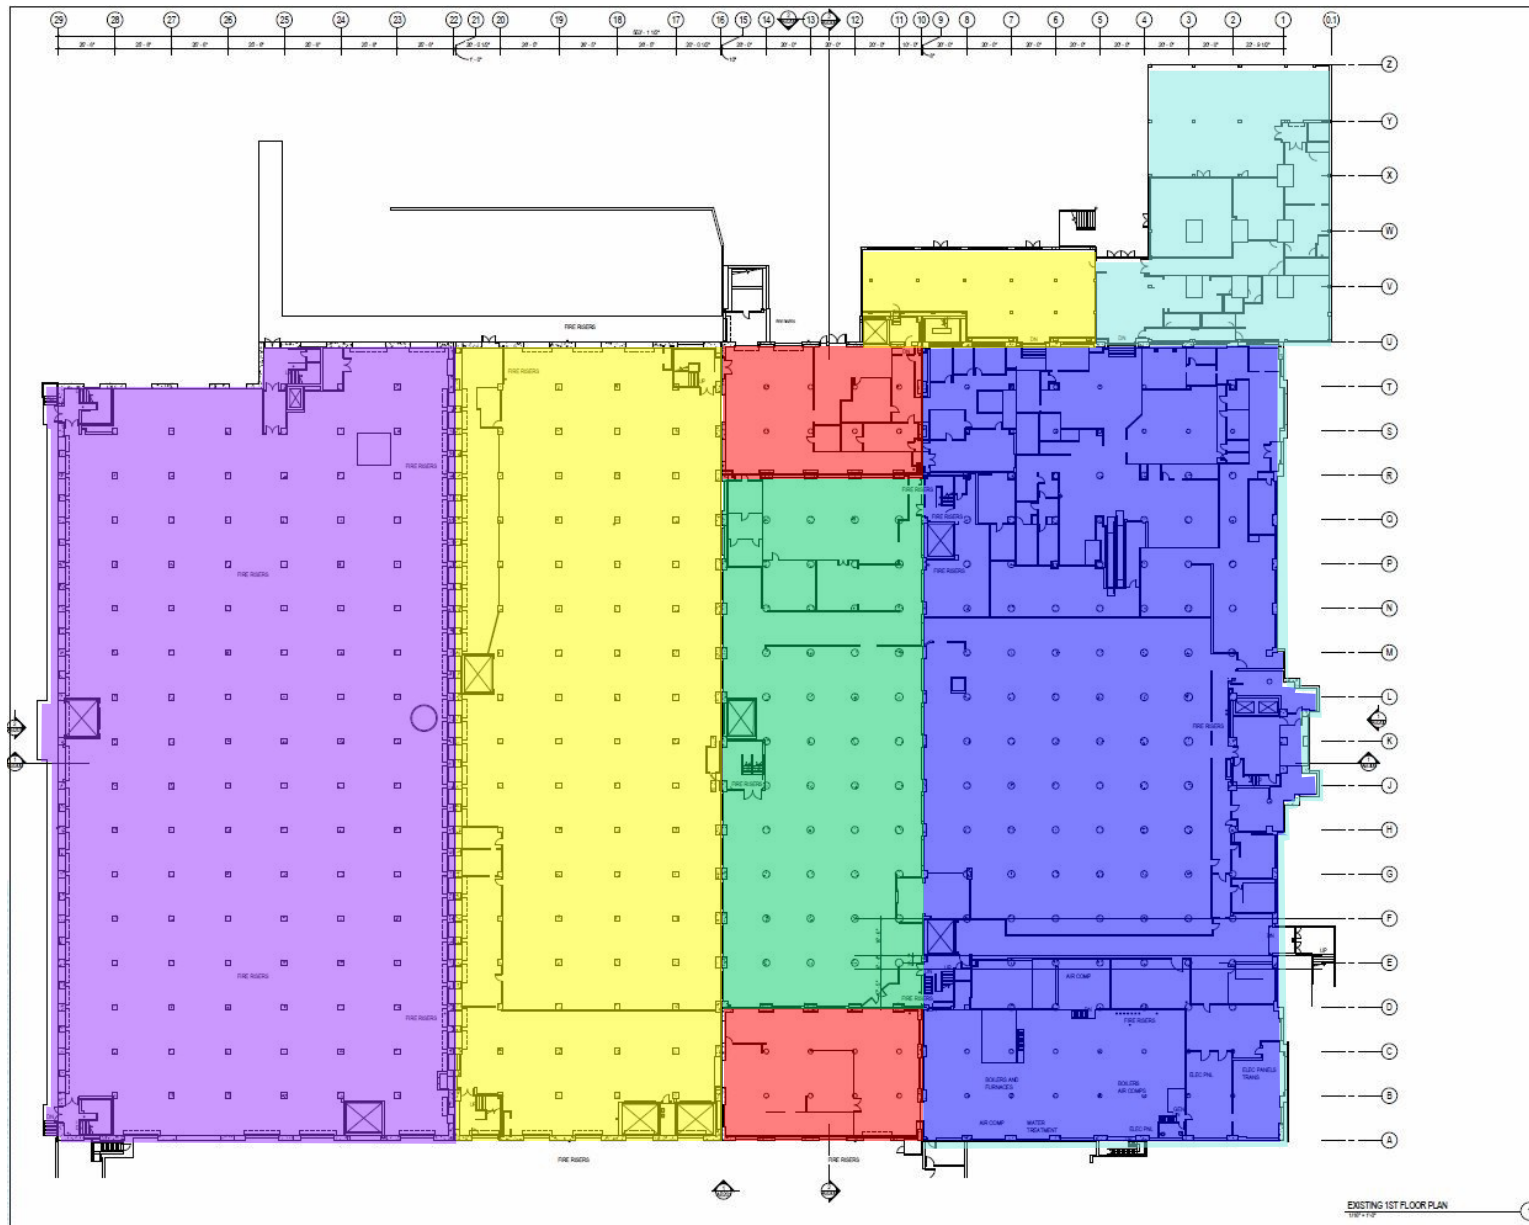
First floor

**NATIONAL REGISTER AMENDMENT
SEARS, ROEBUCK, & COMPANY MAIL ORDER BUILDING
2650 EAST OLYMPIC BOULEVARD
ATTACHMENT C: FLOOR-BY-FLOOR CONSTRUCTION HISTORY**

Legend	
	1927
	1929
	1936
	1940
	1945
	1959
	1964
	1970

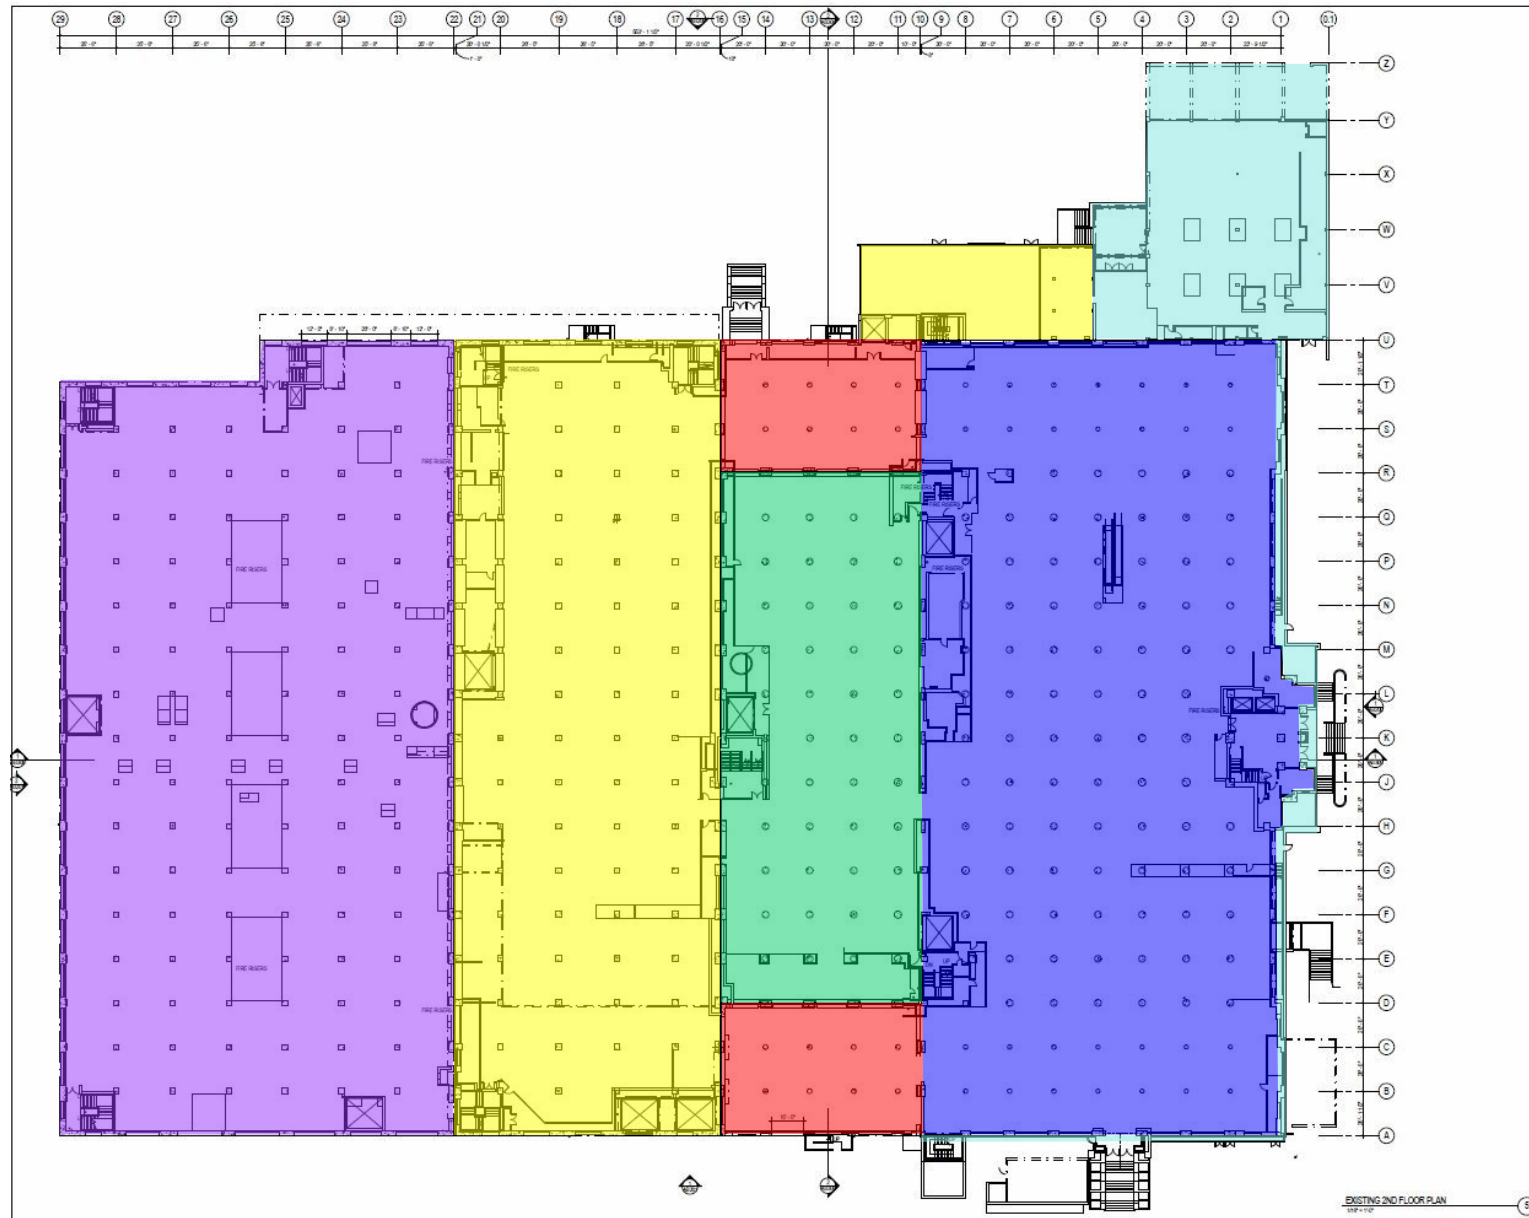
Second Floor

**NATIONAL REGISTER AMENDMENT
SEARS, ROEBUCK, & COMPANY MAIL ORDER BUILDING
2650 EAST OLYMPIC BOULEVARD
ATTACHMENT C: FLOOR-BY-FLOOR CONSTRUCTION HISTORY**

Legend	
	1927
	1929
	1936
	1940
	1945
	1959
	1964
	1970

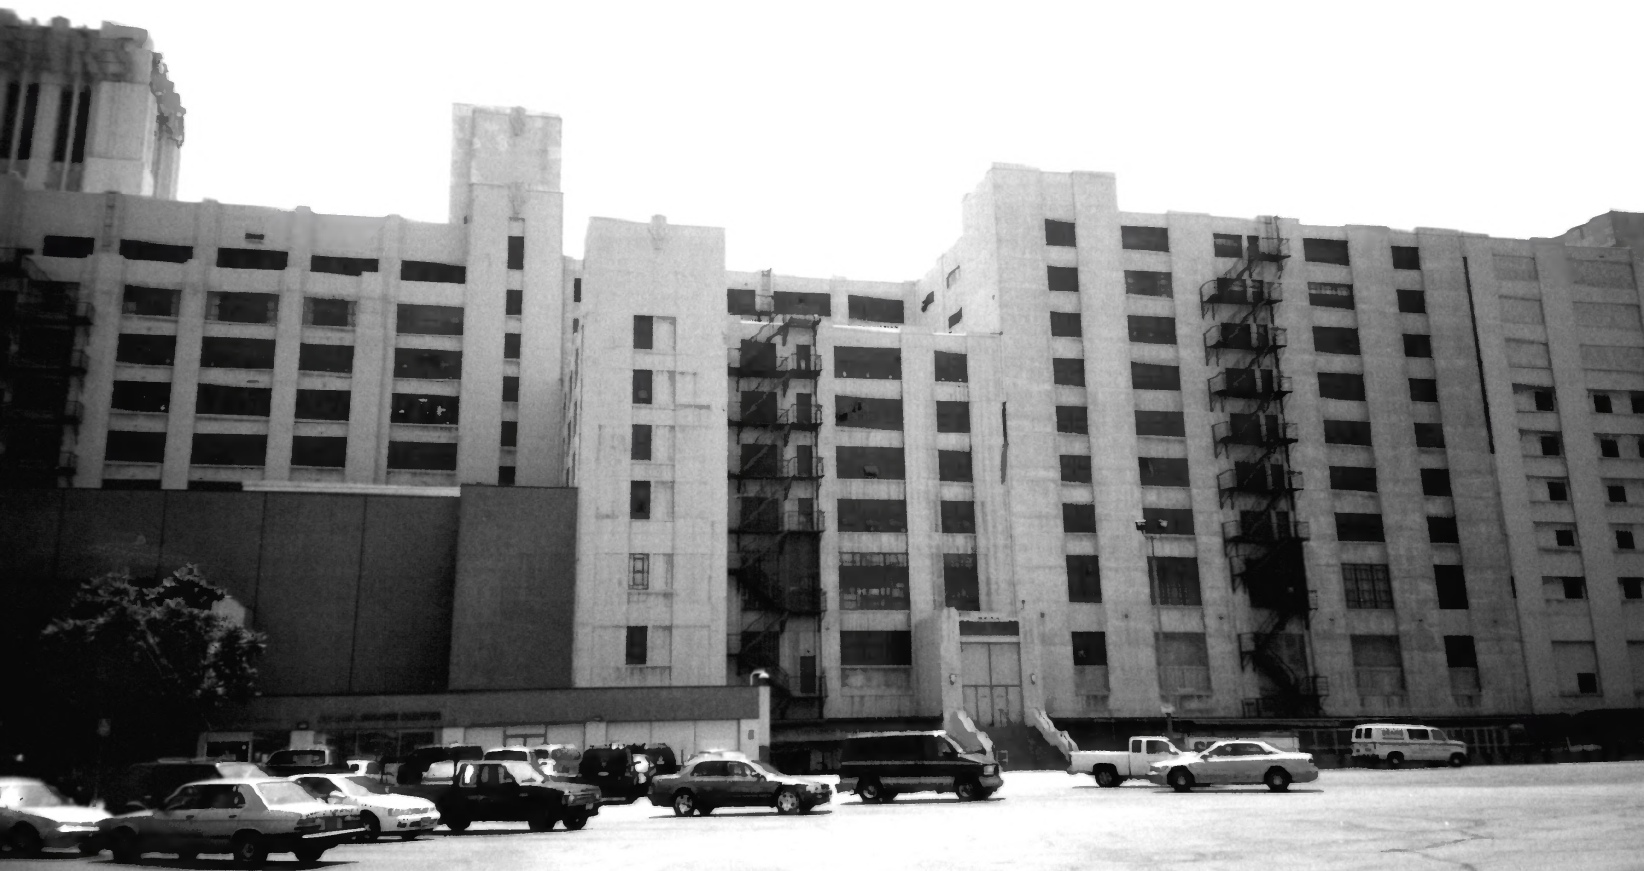
West elevation looking east at 1929

Side entrance
