**RE: National Register of Historic Places for Belmont Square**

Page 1 of 42 \*Resource Name or #: (Assigned by recorder) Belmont Square

Property Name: Belmont Square

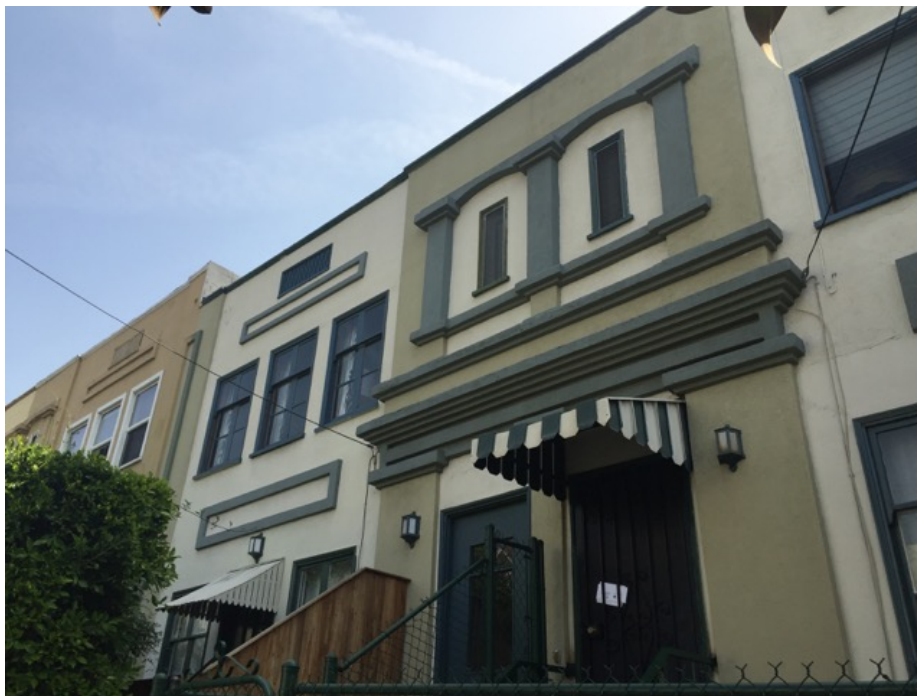
P5a. Photograph or Drawing (Photograph required for buildings, structures, and objects.)

P5b. Description of Photo:  
View facing northeast on  
Columbia Ave; March 20, 2016

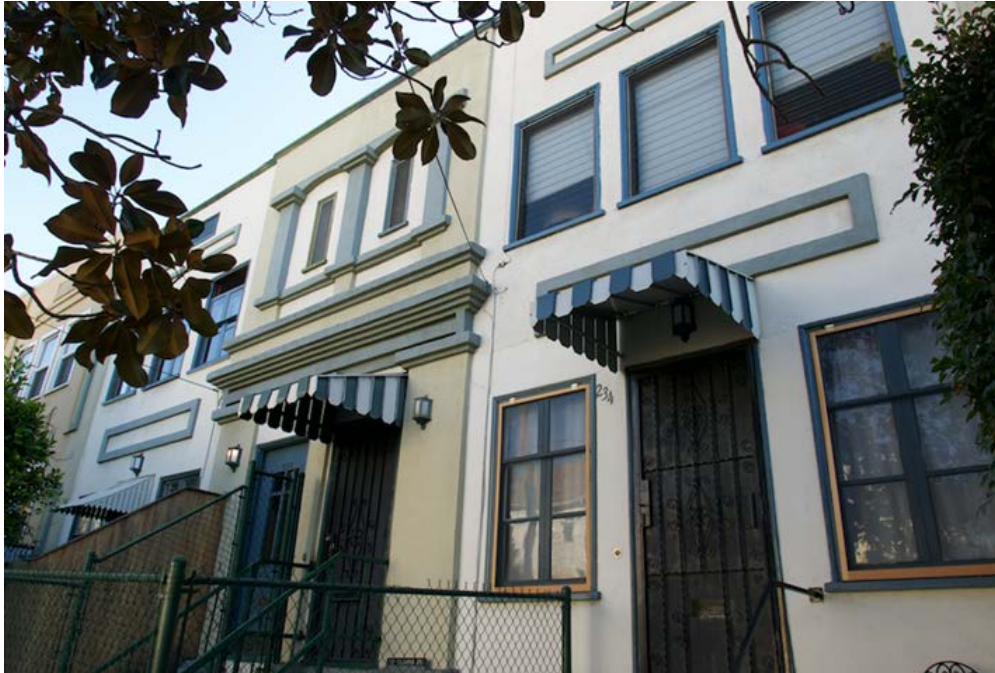
**Photo 5.**

David Witmer's overall façade designs are maintained for the remaining parcels. These include decorative details of the façade and arrangement of fenestrations and doors (**Photo 5**). Although material details of certain resources have been altered by various owners throughout the complex's history, i.e., replacement of doors, windows, and lighting fixtures, and garden spaces have been fenced according to the owner's choice and taste (**Photo 8**), alterations do not detract from the overall integrity of Belmont Square as an early experimentation in garden apartments. Known alterations to individual units are addressed in the resource descriptions. Dates of most alterations are unknown since many owners who made certain changes no longer own the resources, and did not record alterations. The table identifies contributing and noncontributing resources.
