This action is to designate the Bertrand House, located at 2427 Los Amigos Street in the unincorporated community of La Crescenta-Montrose in the Fifth Supervisorial District, as a County of Los Angeles (County) Landmark.

**RESOLUTION  
COUNTY OF LOS ANGELES  
BOARD OF SUPERVISORS  
BERTRAND HOUSE LANDMARK DESIGNATION  
PROJECT NO. PRJ2024-002163  
CASE NO. RPPL2024003269**

**CHARACTER-DEFINING FEATURES  
BERTRAND HOUSE LANDMARK DESIGNATION  
PROJECT NO. PRJ2024-002163  
CASE NO. RPPL2024003269  
2427 LOS AMIGOS STREET**

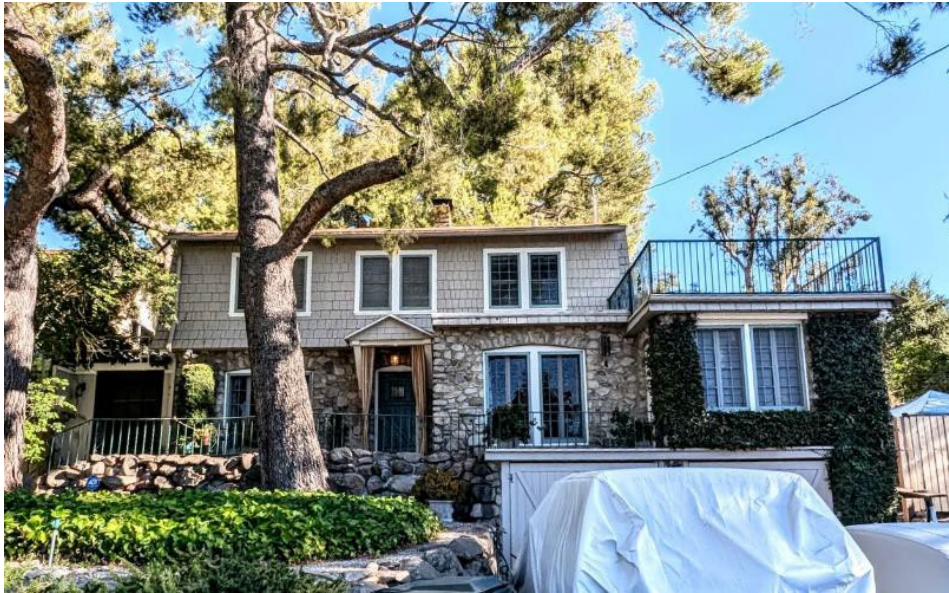
**Figure A-2A. Primary/South Elevation**  
SOURCE: *Sapphos Environmental, Inc., 2023*

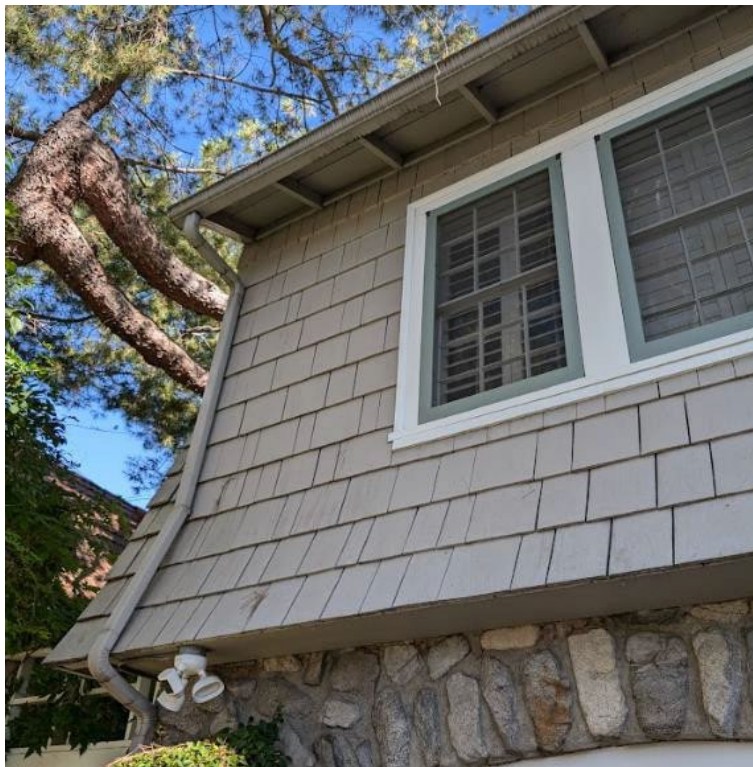
**Figure A-2B. Primary/South Elevation (Detail showing flared wall)**  
Source: *Sapphos Environmental, Inc., 2023*

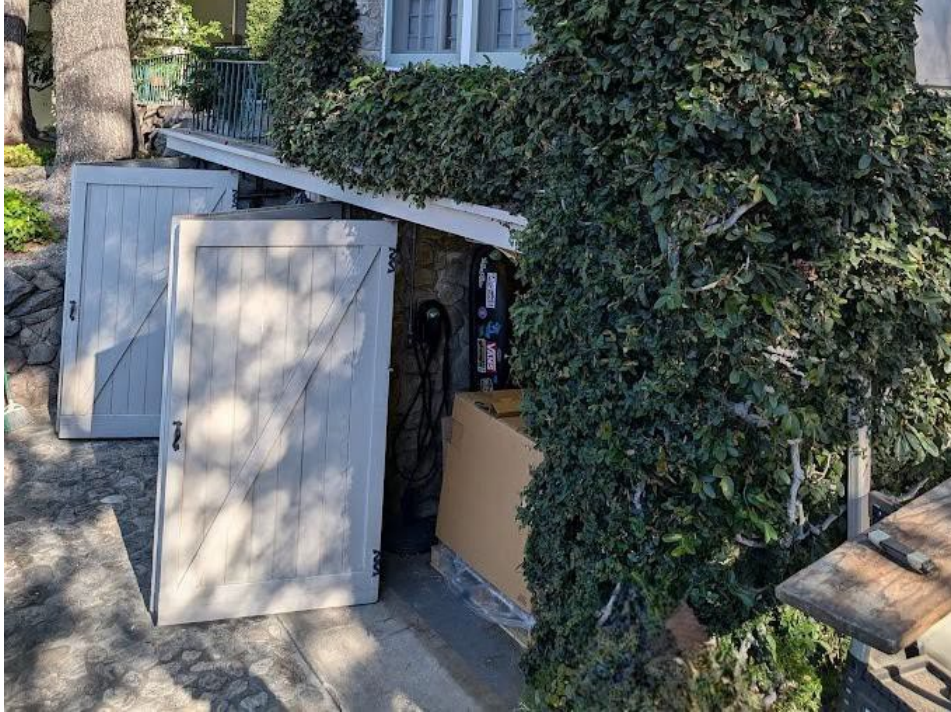
**Figure A-2C. Primary/South Elevation (detail showing bifold garage doors)**  
 SOURCE: Sapphos Environmental, Inc., 2023

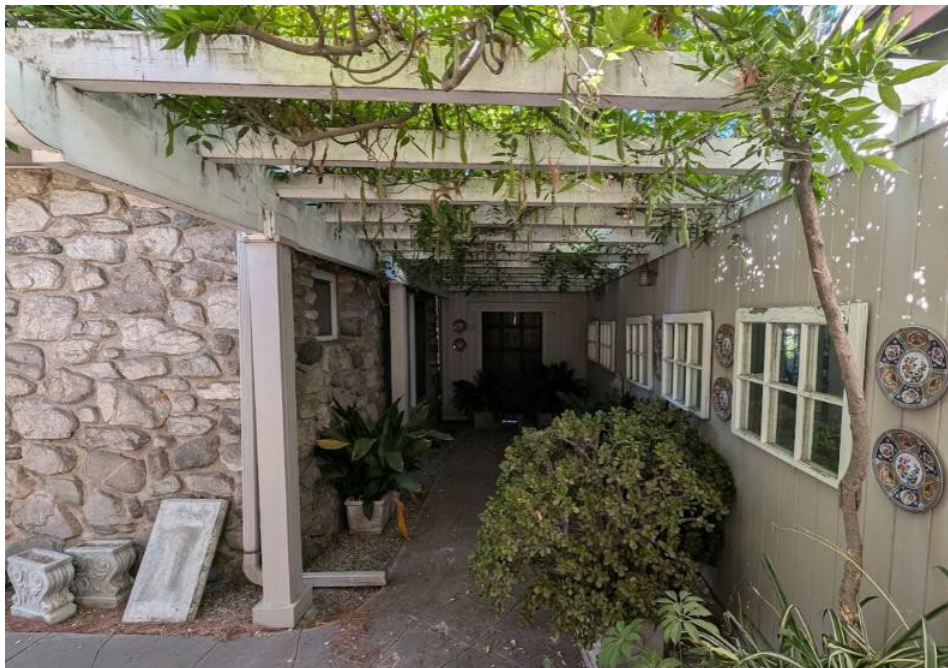
**Figure A-3A. West Elevation (rear portion; wall at left of photo)**  
 SOURCE: Sapphos Environmental, Inc., 2023

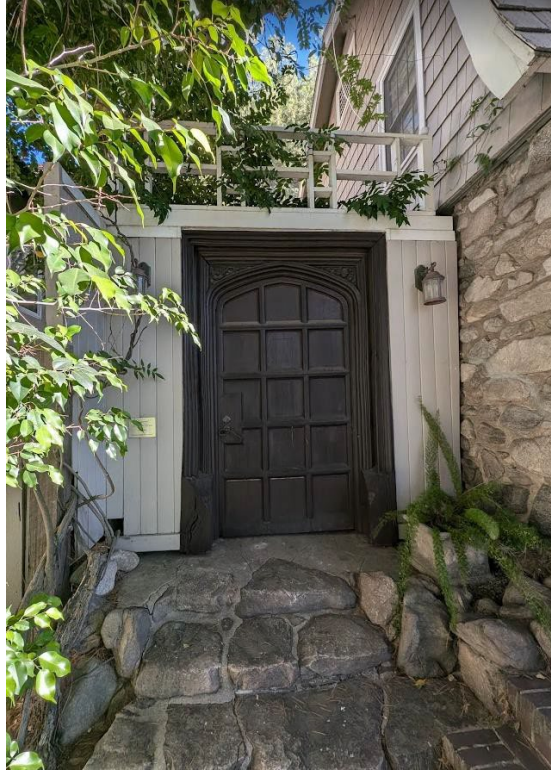
**Figure A-3B. West Elevation (front portion; wall at right of photo)**  
SOURCE: *Sapphos Environmental, Inc., 2023*

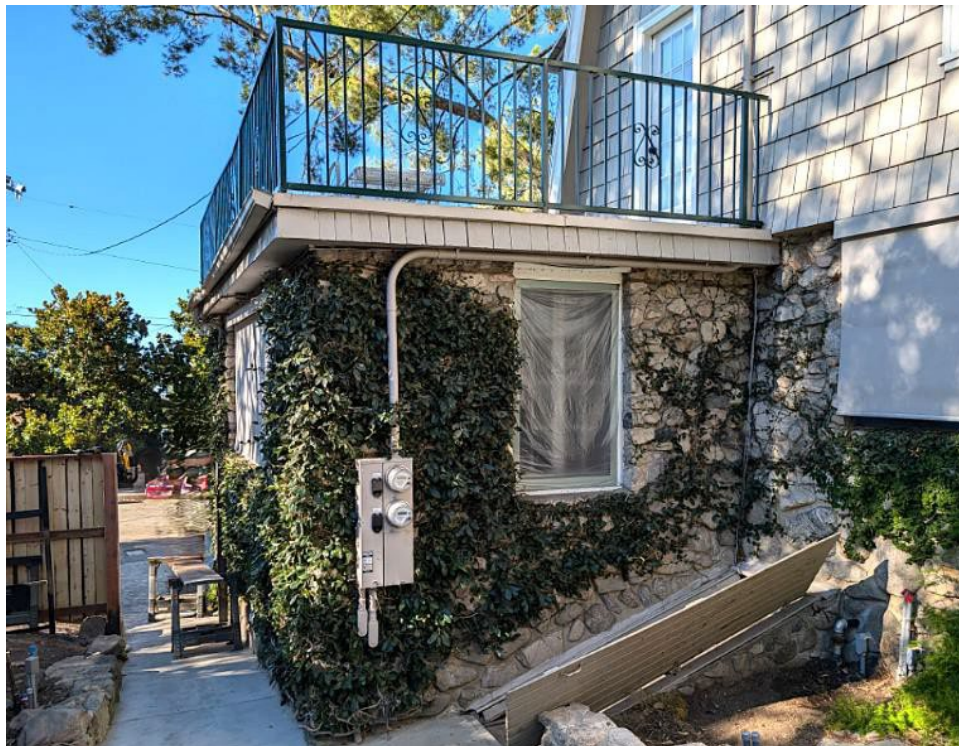
**Figure A-4A. Rear/North Elevation (southeast addition)**  
SOURCE: *Sapphos Environmental Inc., 2024*

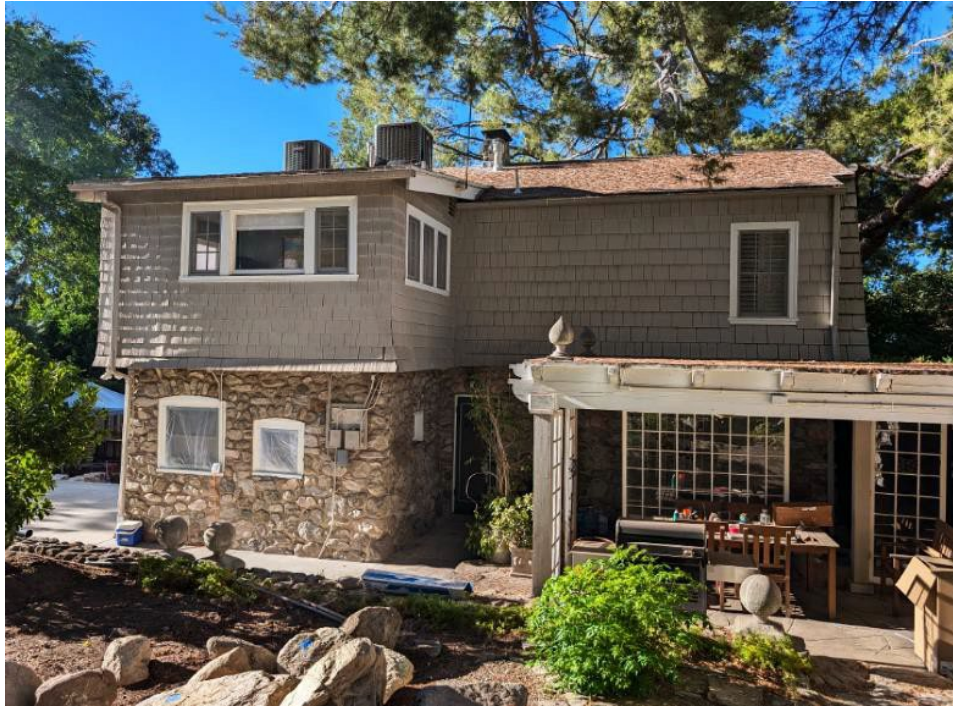
**Figure A-4B. Rear/North Elevation (house)**  
SOURCE: *Sapphos Environmental Inc., 2024*

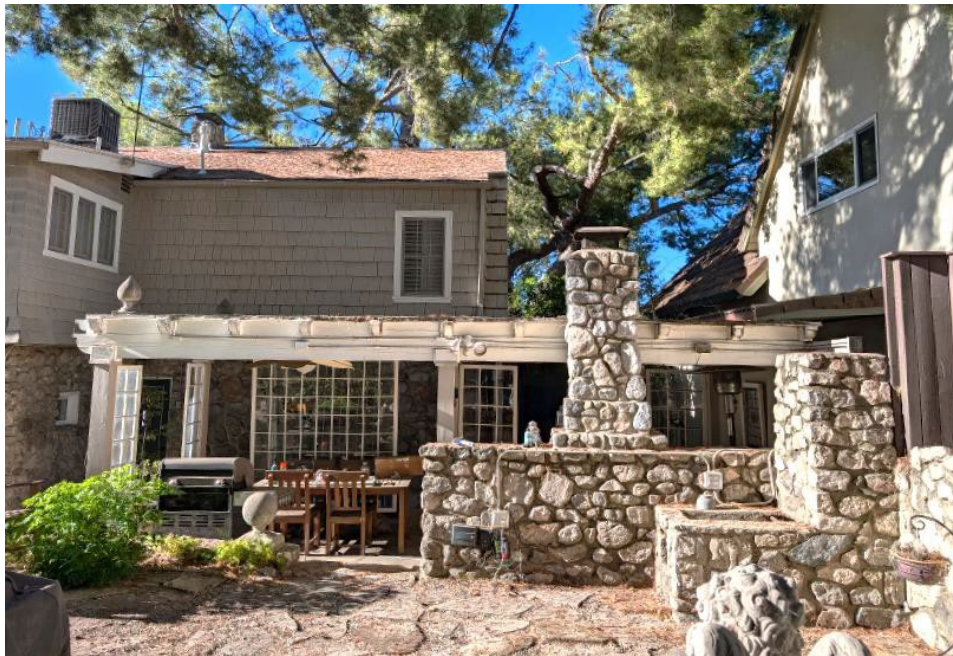
**Figure A-4C. Rear/North Elevation (trellis)**  
SOURCE: *Sapphos Environmental Inc., 2024*

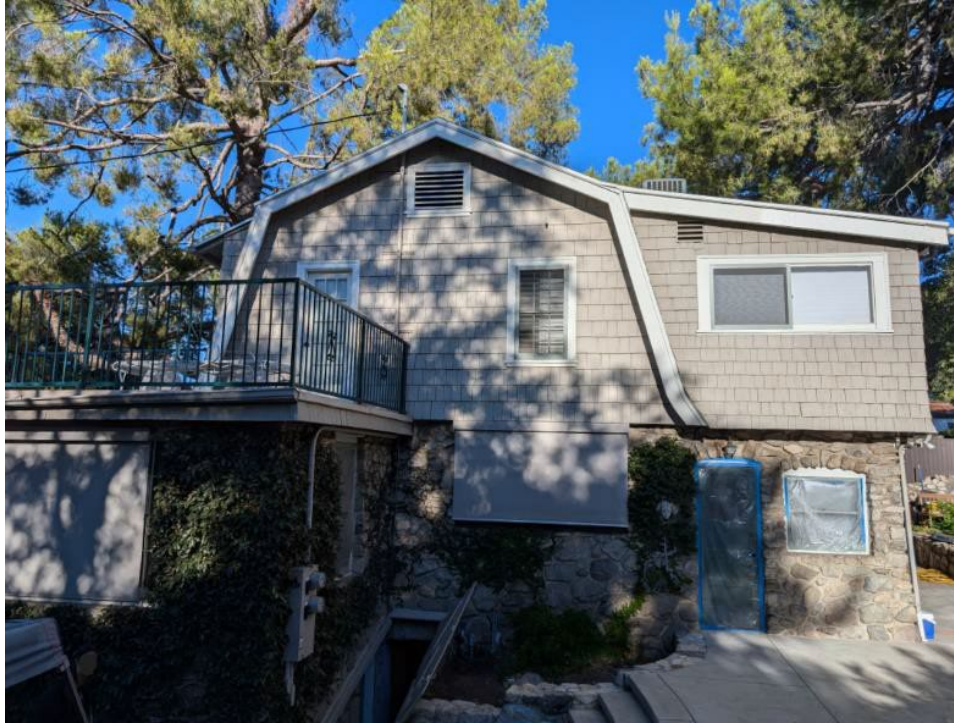
**Figure A-5A. East Elevation**  
SOURCE: *Sapphos Environmental Inc., 2024*

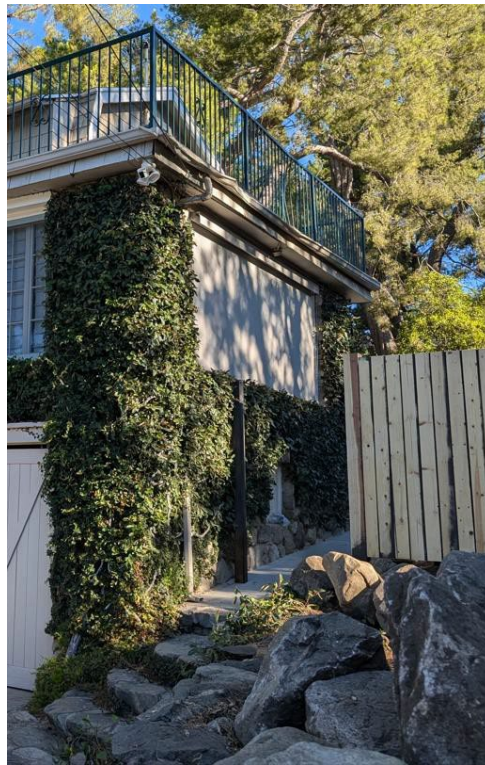
**Figure A-5B. East Elevation (southeast addition)**  
SOURCE: *Sapphos Environmental Inc., 2024*

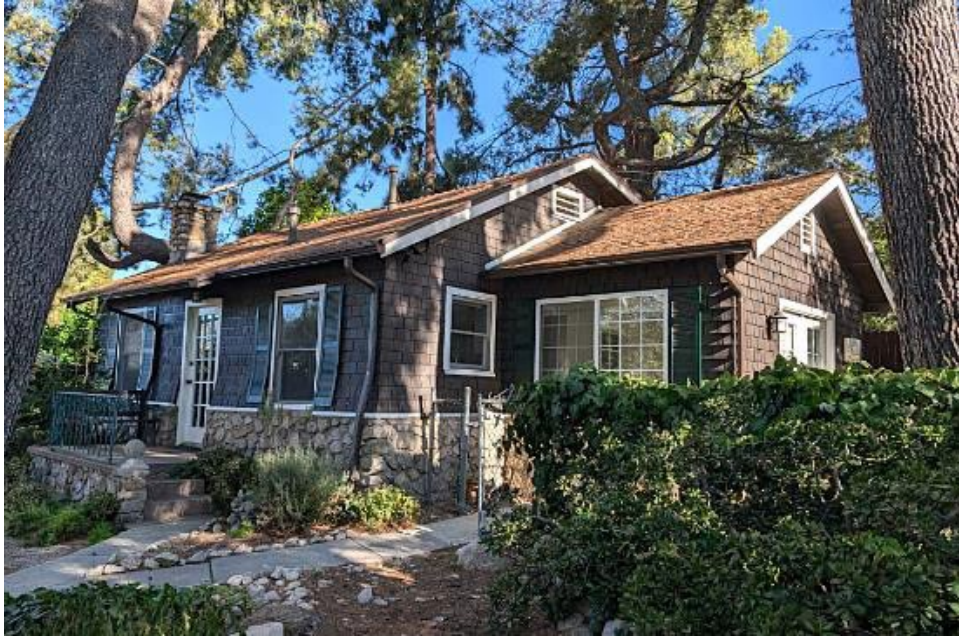
**Figure A-6. South and East Elevations, Guest House (view facing northwest)**  
SOURCE: *Sapphos Environmental Inc., 2024*

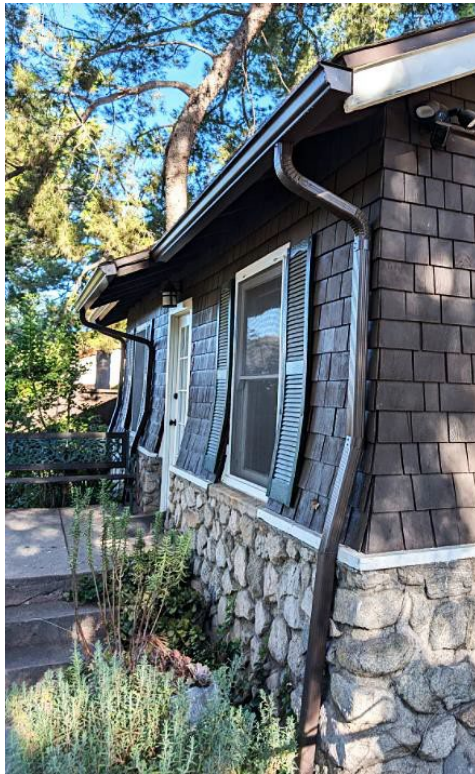
**Figure A-7. South Elevation, Guest House (profile view)**  
SOURCE: *Sapphos Environmental Inc., 2024*

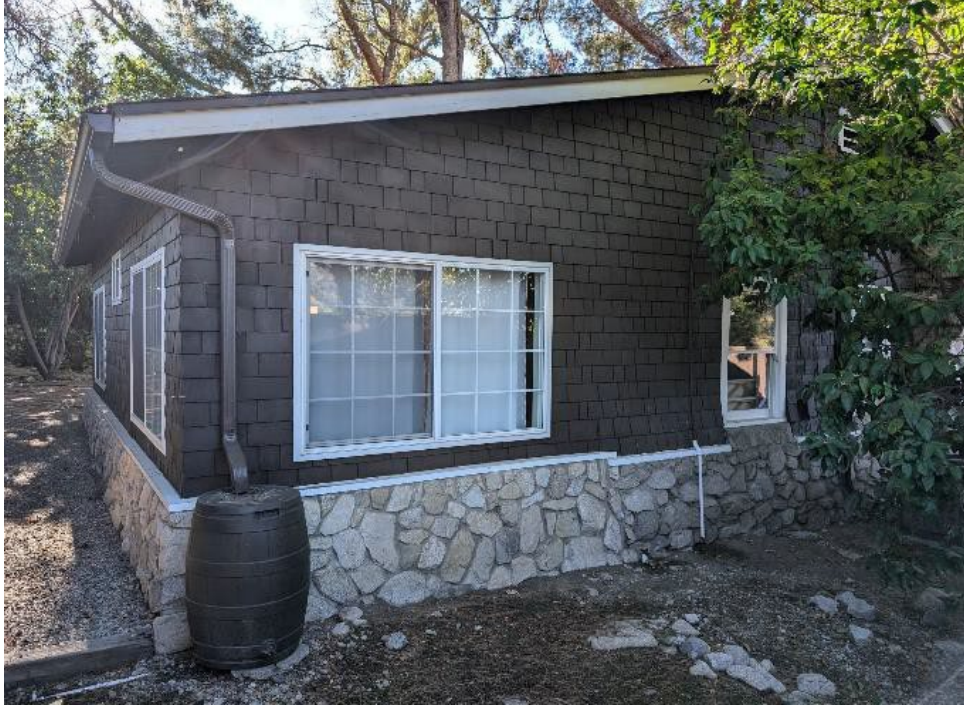
**Figure A-8. West Elevation, Guest House**  
SOURCE: *Sapphos Environmental Inc., 2024*

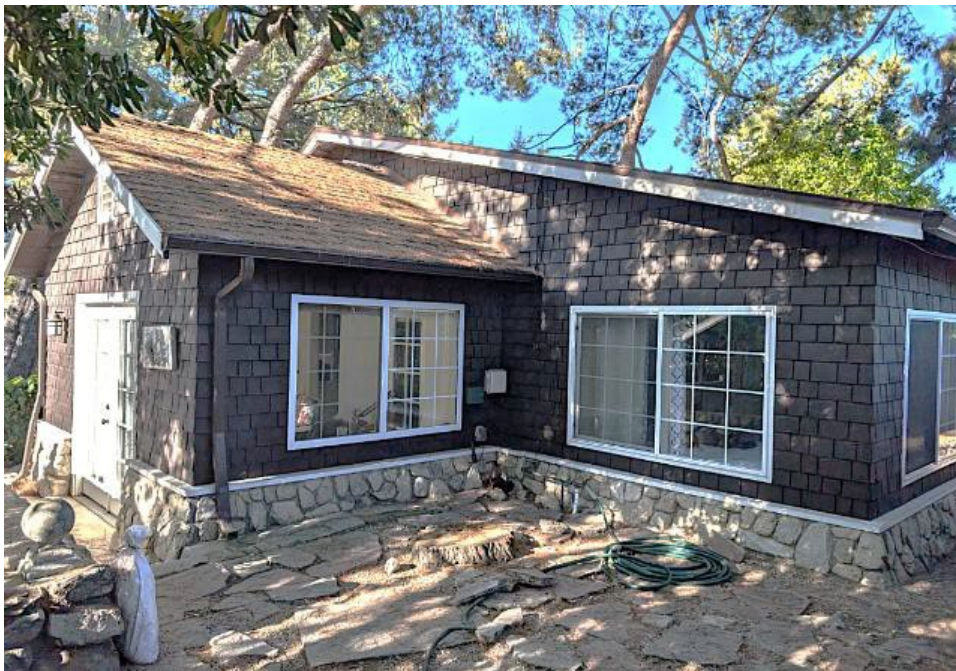
**Figure A-9. North and East Elevations, Guest House (view facing southwest)**  
SOURCE: *Sapphos Environmental Inc., 2024*

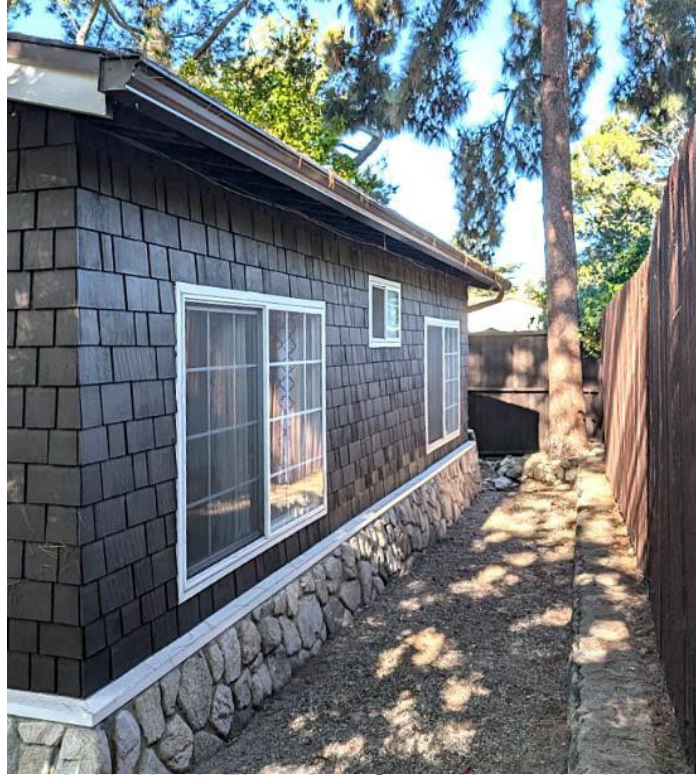
**Figure A-10. North Elevation, Guest House (right portion)**  
 SOURCE: *Sapphos Environmental Inc., 2024*

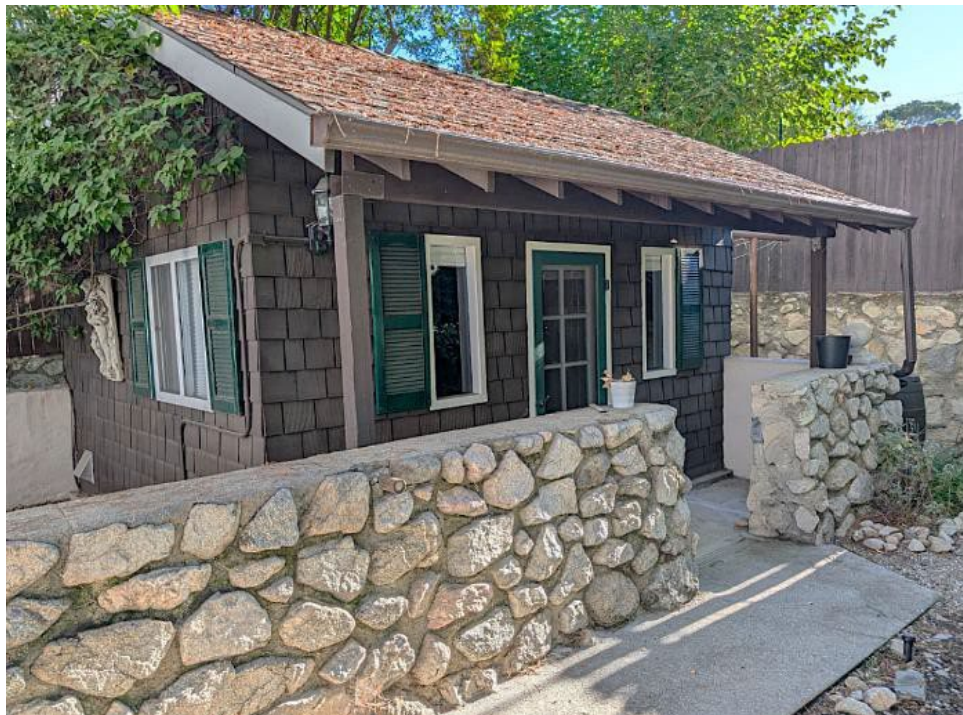
**Figure A-11. South and West Elevations, Home Office (view facing northeast)**  
 SOURCE: *Sapphos Environmental Inc., 2024*

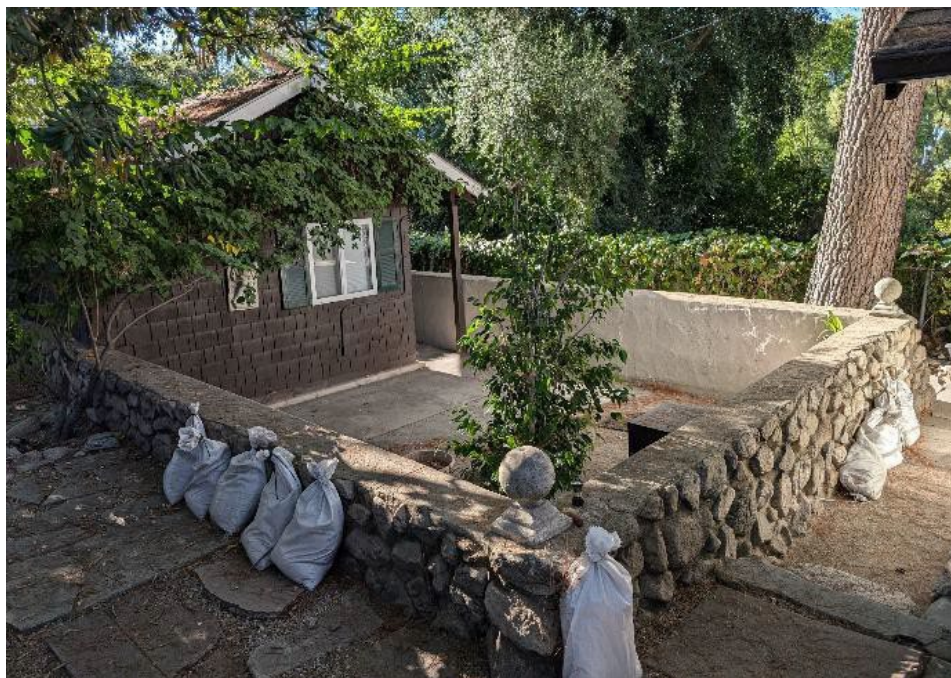
**Figure A-12. Home Office (view facing southeast toward enclosure and west wall)**

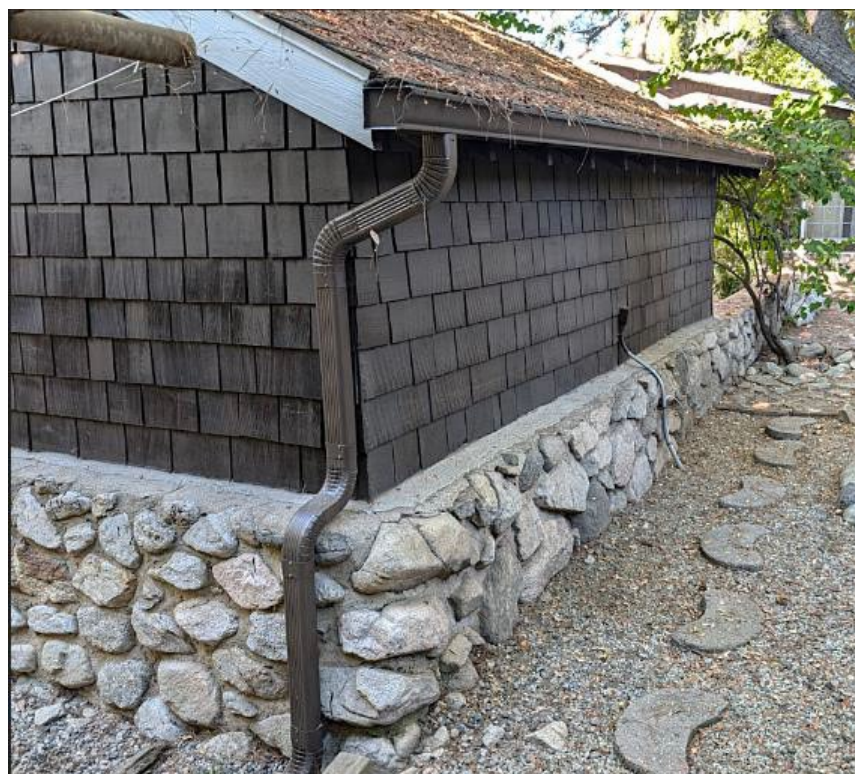
**Figure A-13. East and North Elevations, Home Office (view facing northeast)**

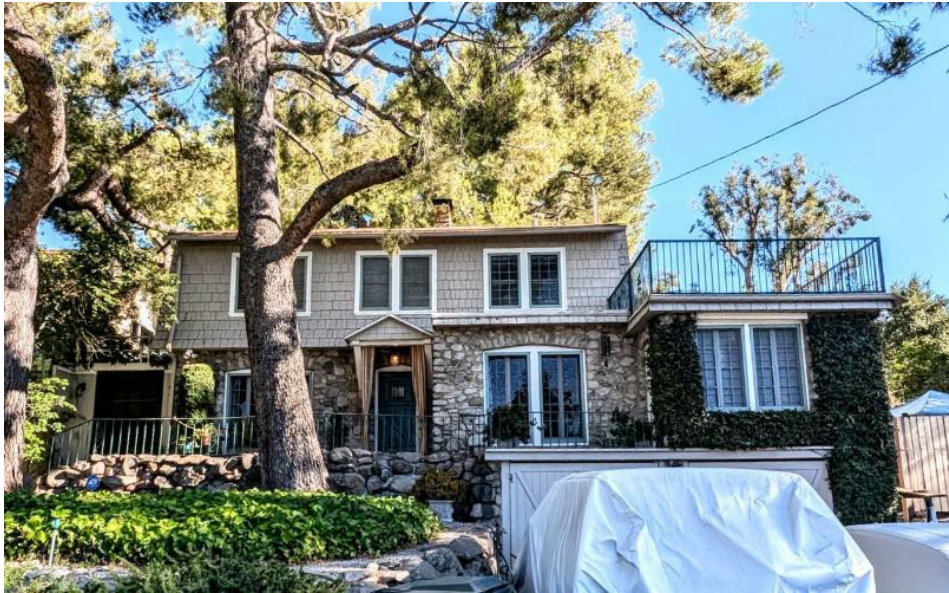
**Figure A-2A. Primary/South Elevation**  
*SOURCE: Sapphos Environmental, Inc., 2023*

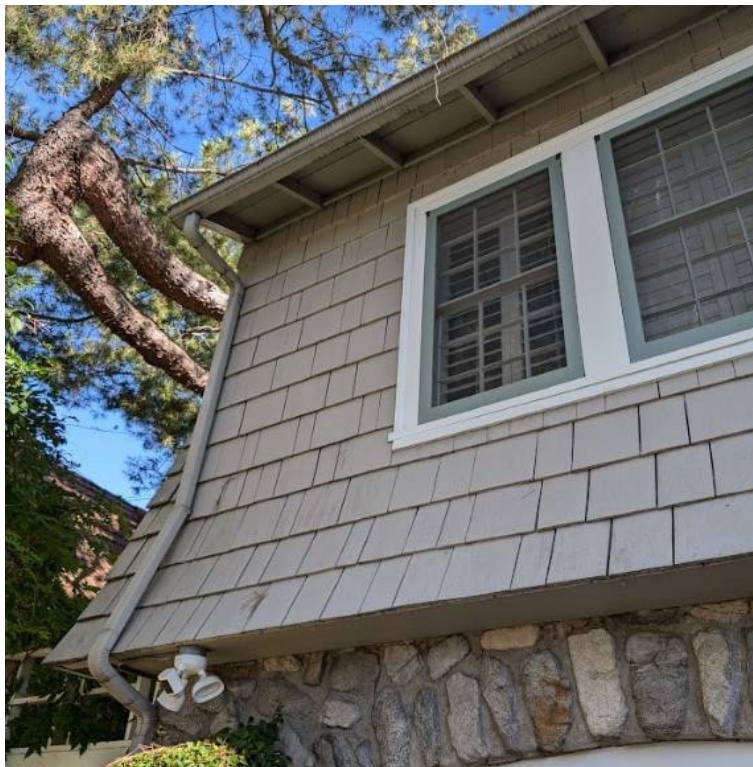
**Figure A-2B. Primary/South Elevation (Detail showing flared wall)**  
*Source: Sapphos Environmental, Inc., 2023*

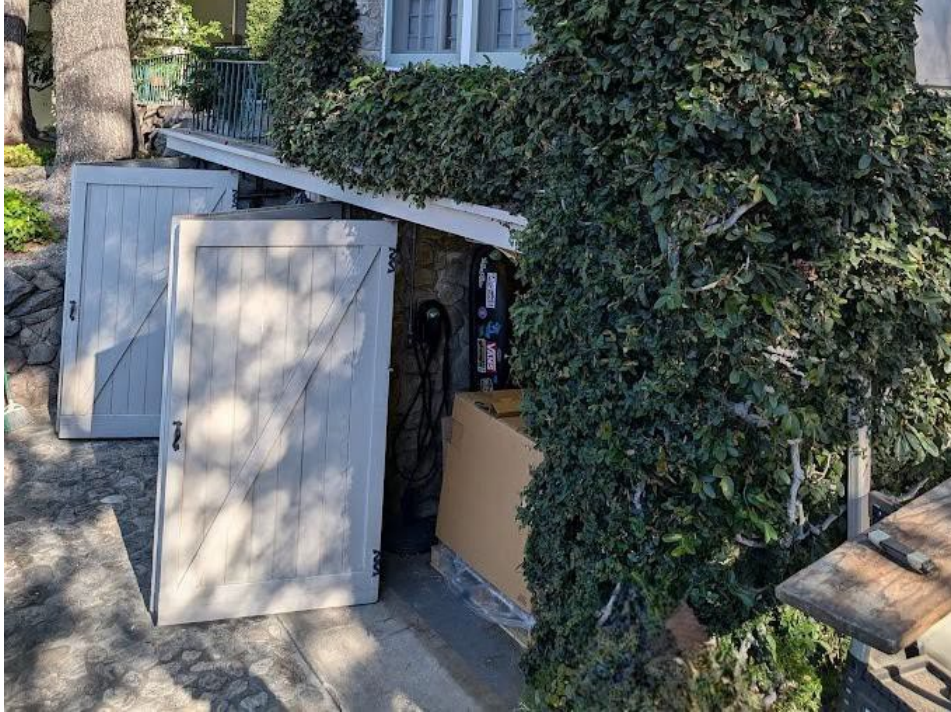
**Figure A-2C. Primary/South Elevation (detail showing bifold garage doors)**  
 SOURCE: Sapphos Environmental, Inc., 2023

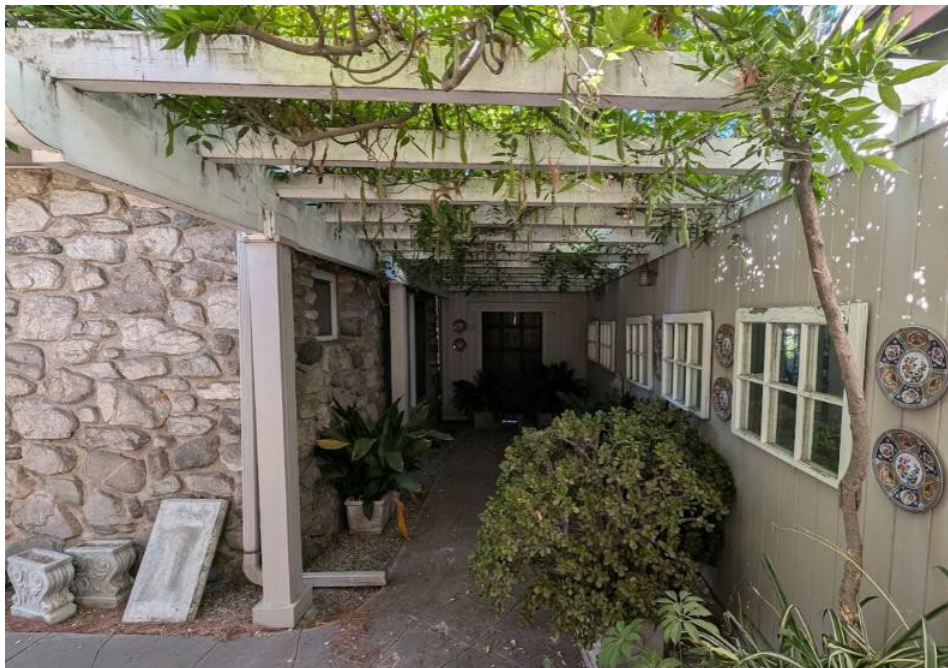
**Figure A-3A. West Elevation (rear portion; wall at left of photo)**  
 SOURCE: Sapphos Environmental, Inc., 2023

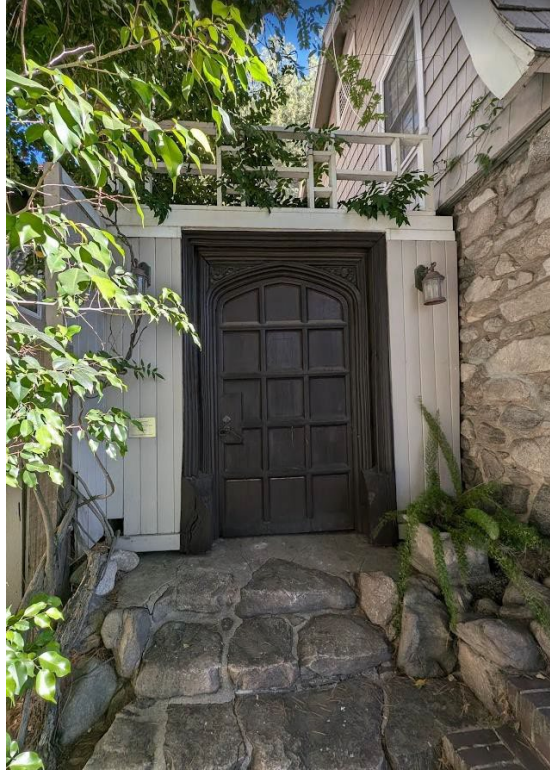
**Figure A-3B. West Elevation (front portion; wall at right of photo)**  
SOURCE: *Sapphos Environmental, Inc., 2023*

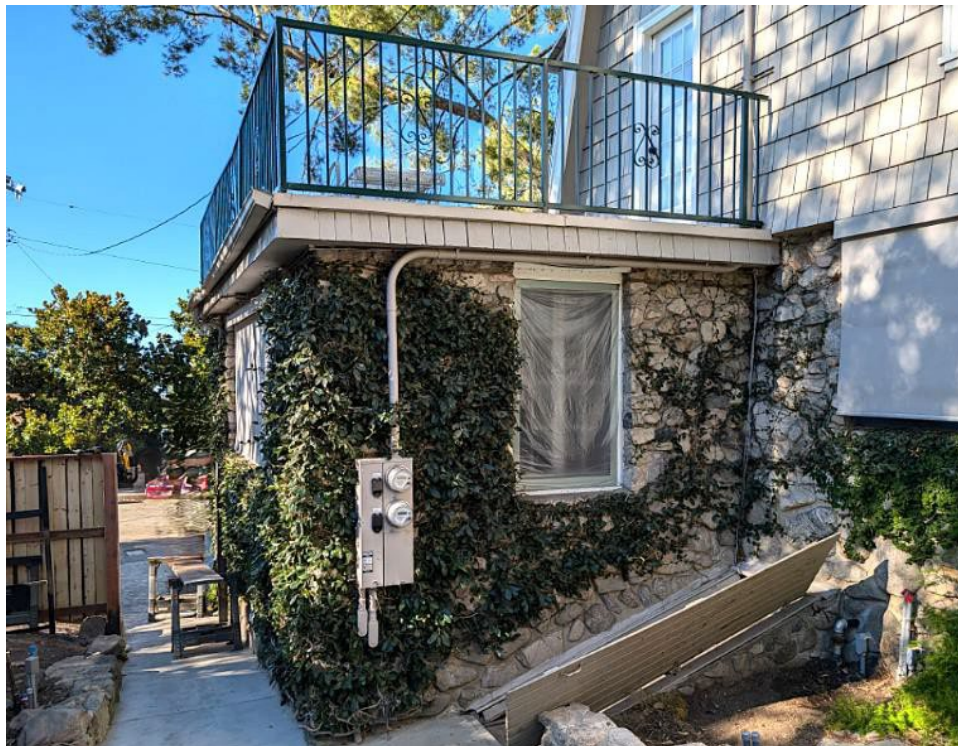
**Figure A-4A. Rear/North Elevation (southeast addition)**  
SOURCE: *Sapphos Environmental Inc., 2024*

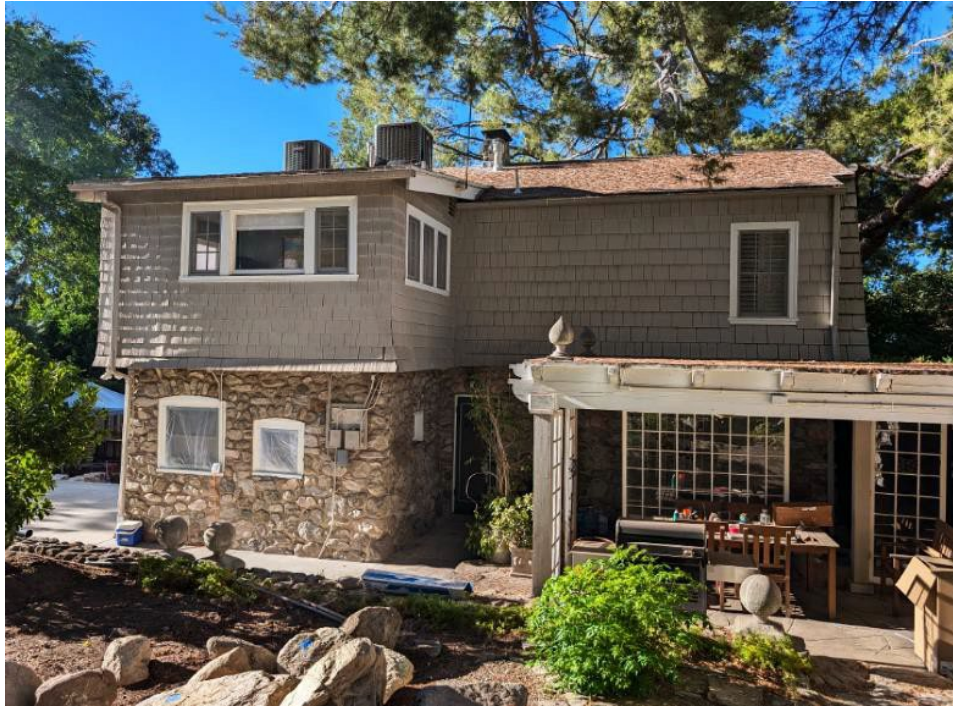
**Figure A-4B. Rear/North Elevation (house)**  
SOURCE: *Sapphos Environmental Inc., 2024*

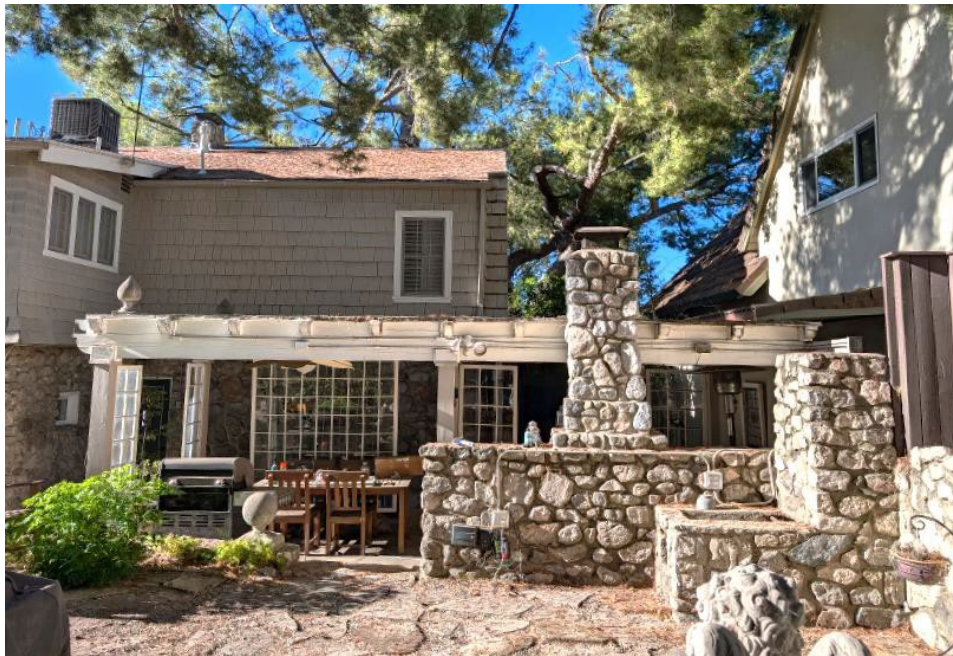
**Figure A-4C. Rear/North Elevation (trellis)**  
SOURCE: *Sapphos Environmental Inc., 2024*

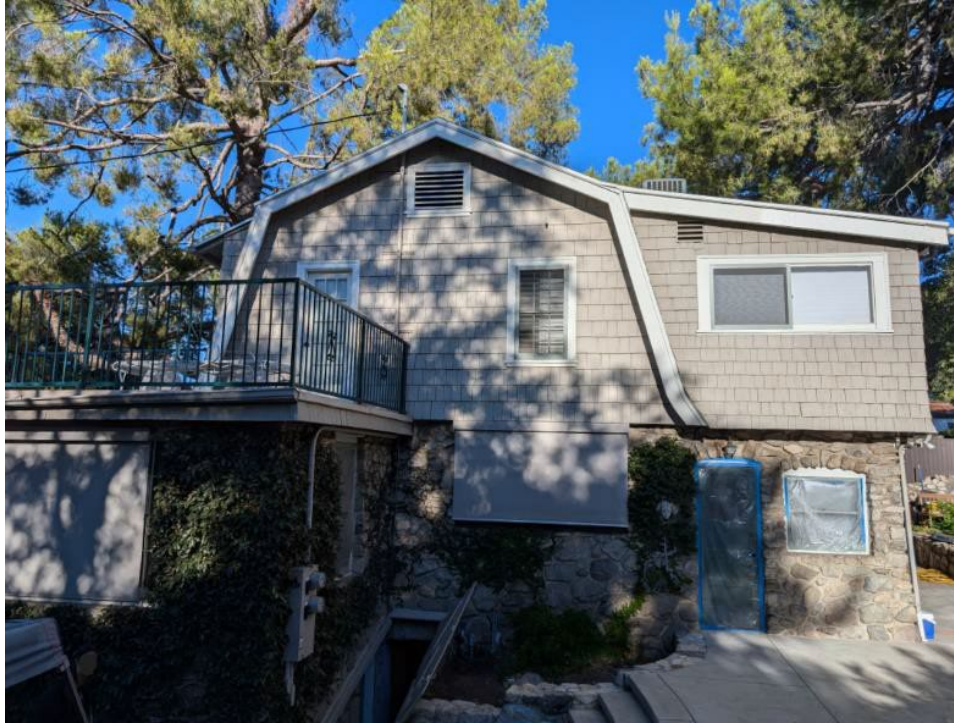
**Figure A-5A. East Elevation**  
SOURCE: *Sapphos Environmental Inc., 2024*

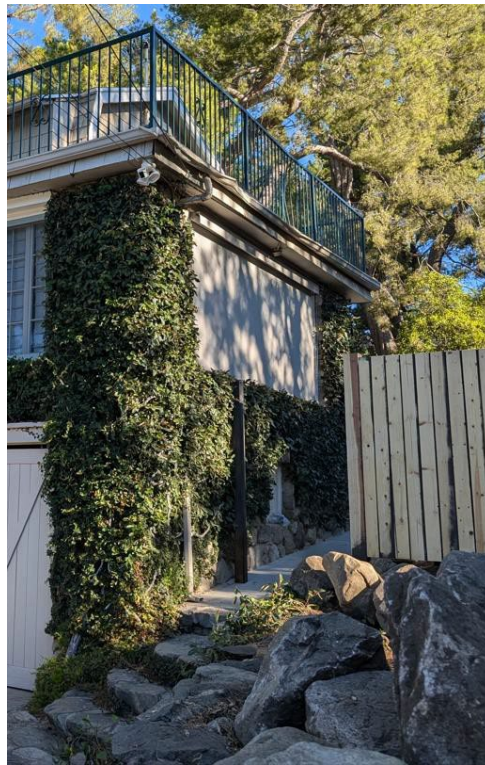
**Figure A-5B. East Elevation (southeast addition)**  
SOURCE: *Sapphos Environmental Inc., 2024*

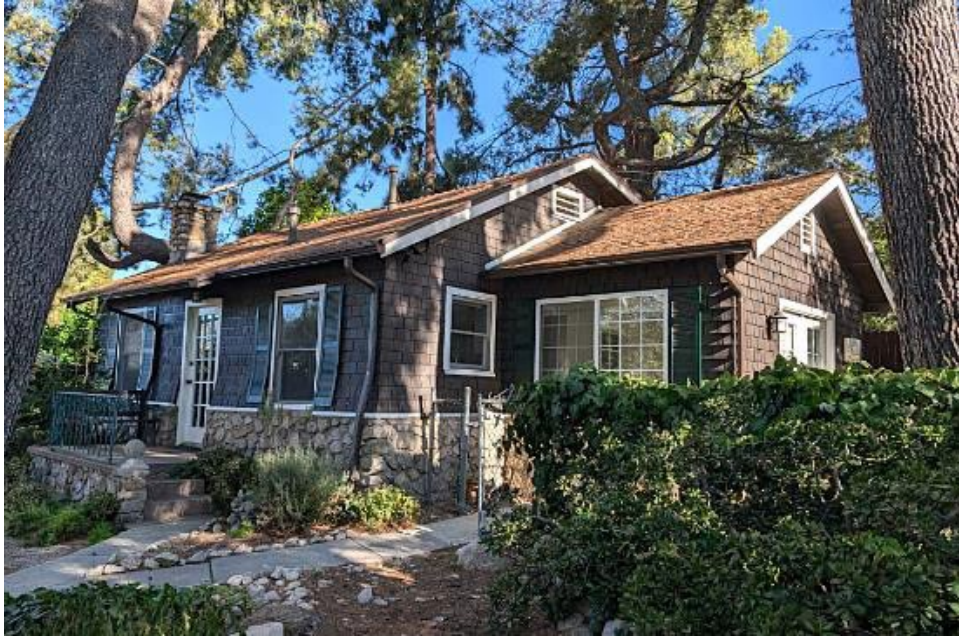
**Figure A-6. South and East Elevations, Guest House (view facing northwest)**  
SOURCE: *Sapphos Environmental Inc., 2024*

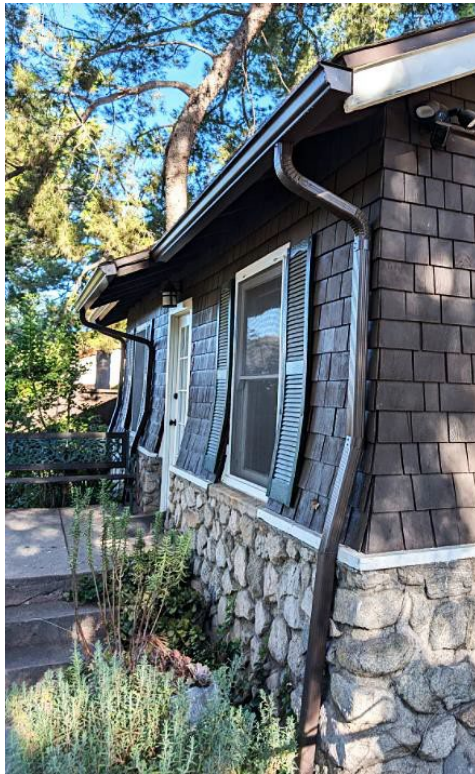
**Figure A-7. South Elevation, Guest House (profile view)**  
SOURCE: *Sapphos Environmental Inc., 2024*

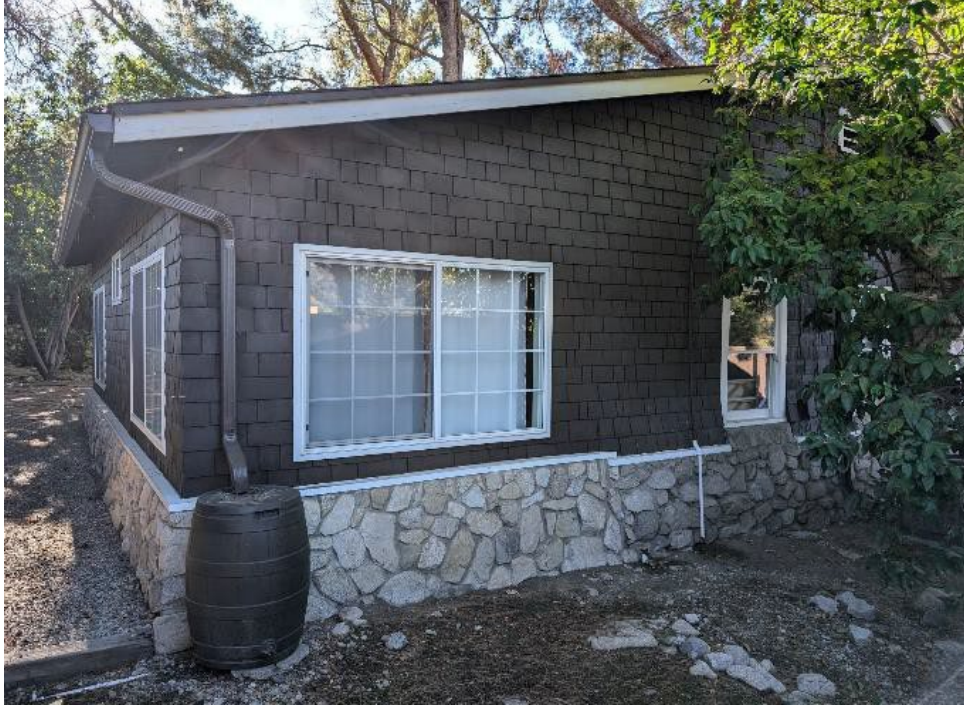
**Figure A-8. West Elevation, Guest House**  
SOURCE: *Sapphos Environmental Inc., 2024*

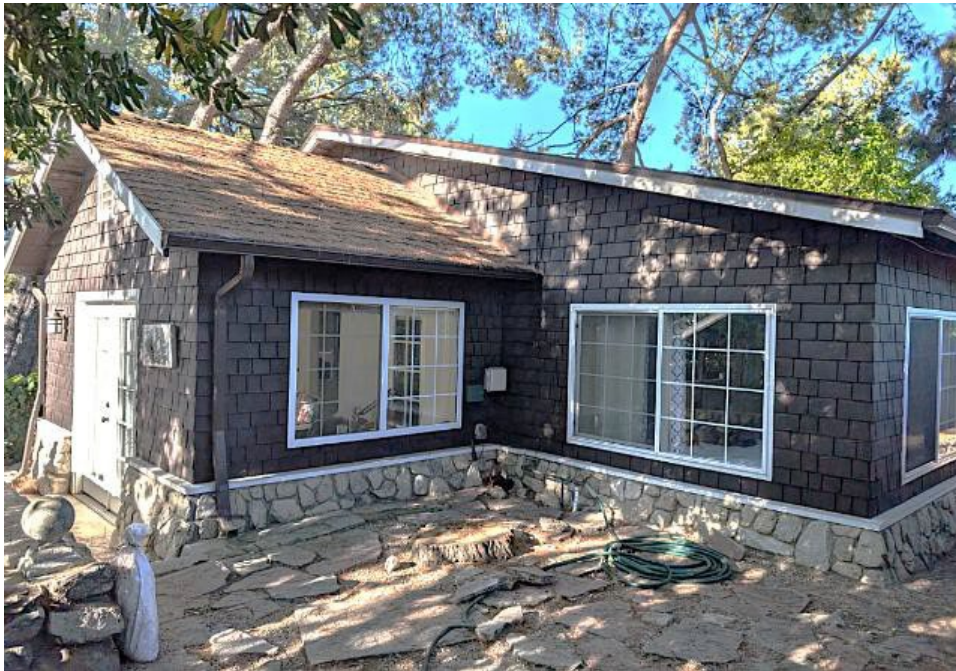
**Figure A-9. North and East Elevations, Guest House (view facing southwest)**  
SOURCE: *Sapphos Environmental Inc., 2024*

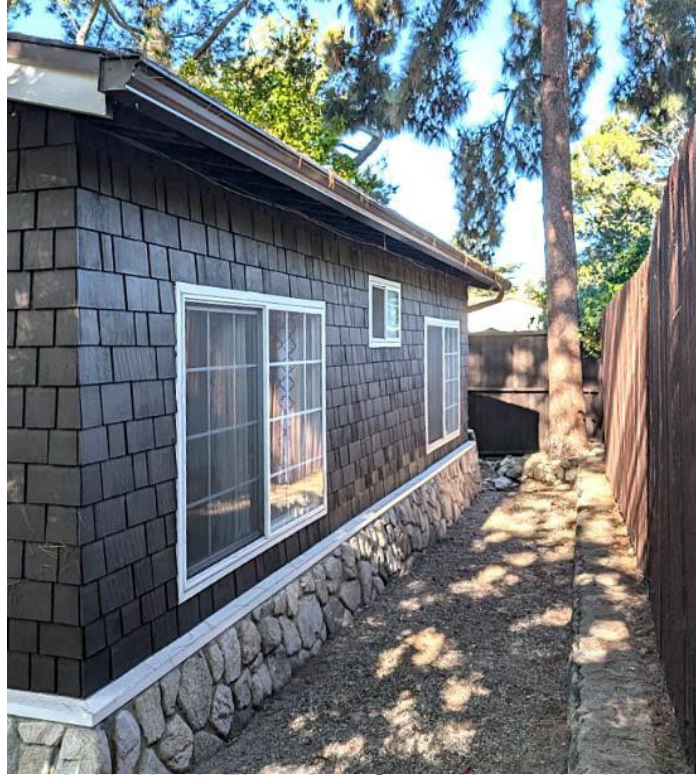
**Figure A-10. North Elevation, Guest House (right portion)**  
 SOURCE: *Sapphos Environmental Inc., 2024*

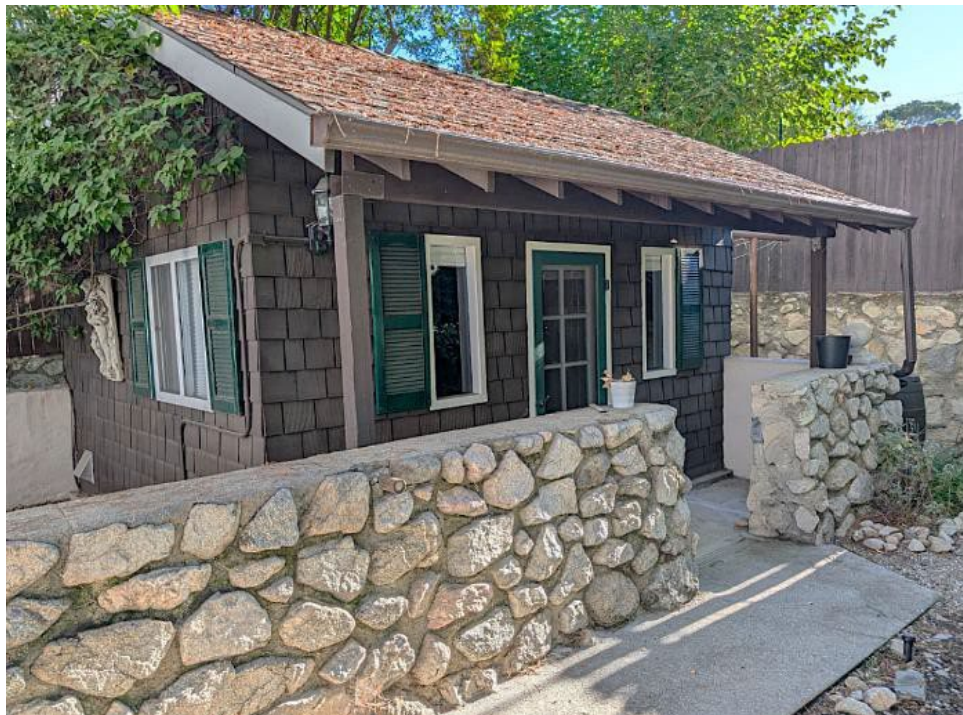
**Figure A-11. South and West Elevations, Home Office (view facing northeast)**  
 SOURCE: *Sapphos Environmental Inc., 2024*

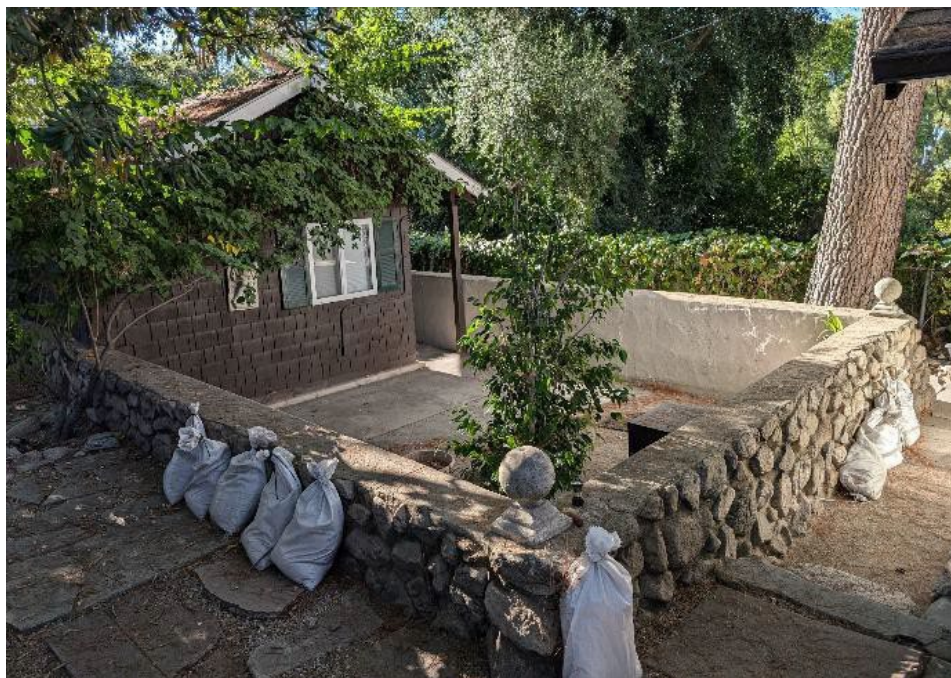
**Figure A-12. Home Office (view facing southeast toward enclosure and west wall)**

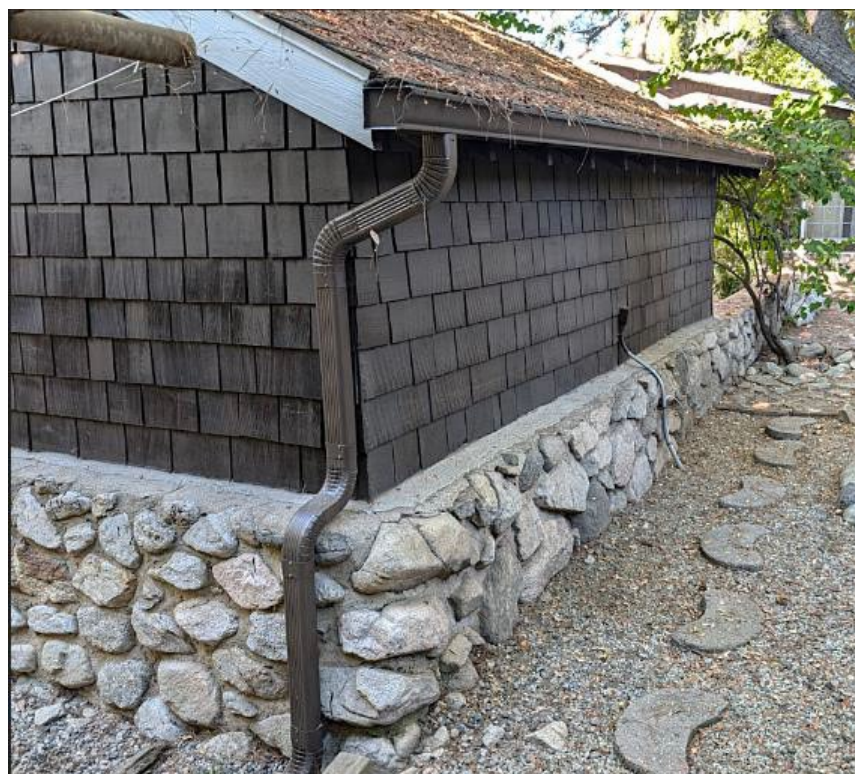
**Figure A-13. East and North Elevations, Home Office (view facing northeast)**
