# PROPERTY CONDITION ASSESSMENT REPORT (PCAR)

MARINA CITY CLUB 4333 ADMIRALTY WAY MARINA DEL REY, CALIFORNIA

**DATE** APRIL 16, 2021

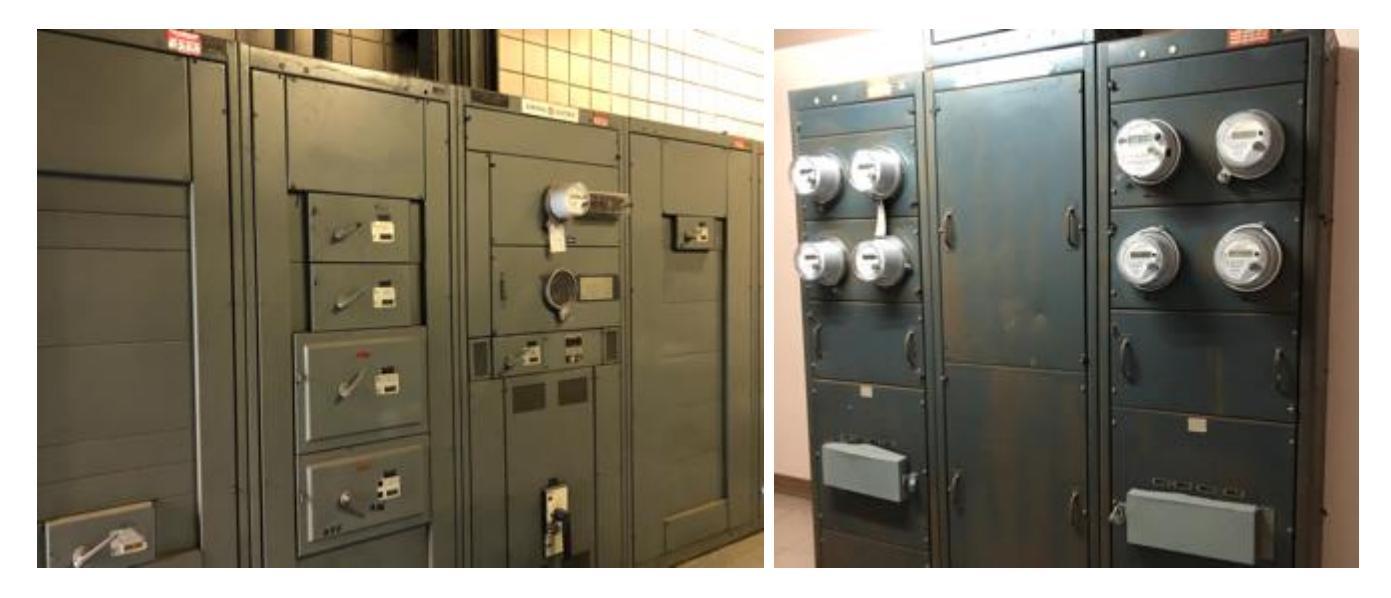
During the walkthrough, all major power service entrances were observed. Mark Baldus was in attendance during the walkthrough and provided information about previous work on the system. Below are two example photos of equipment that REX Engineering observed. The photo on the left of is of the main service entrance in the East Tower. The photo on the right shows typical individual unit meters from the Center Tower. Every unit has its own meter at a central location near the elevators of every floor for each tower building.
