*Project, NP00946501-4:*  
**Safer Alternatives to Copper Antifouling Paints  
for Marine Vessels**  
**FINAL REPORT**

January 2011

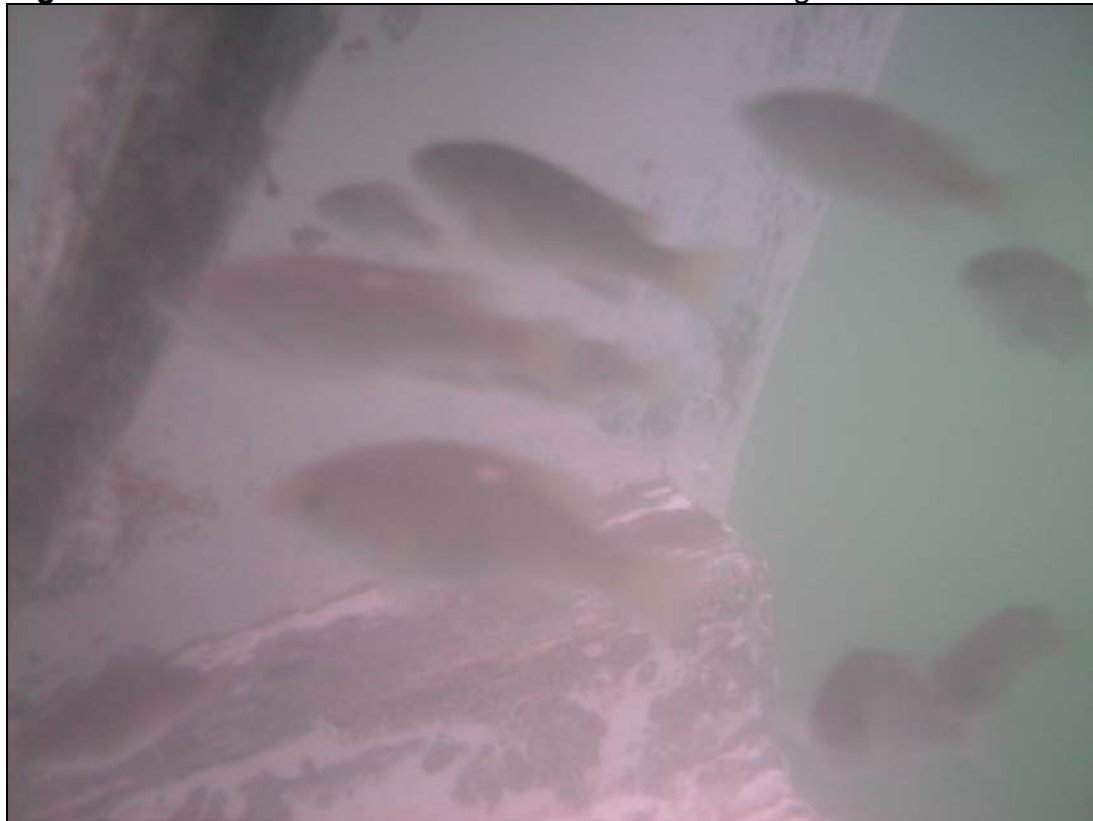
**Figure 6-2.** Surf Perch near Intersleek 900 Test Coating

A unique situation arose with Intersleek 900 during the study. Small imprints were observed on the bottom of both boats (Quadrants I-IV). Upon closer examination the Project Team concluded the imprints were caused by fish, such as surfperch. In fact, during one inspection of the 30'sail boat, the hull cleaner observed surfperch actively nipping at the boat hull (Figure 6-2). At the conclusion of the study, there did not appear to be any structural side effects of the feeding of the surfperch. There is concern that this feeding behavior may potentially lead to coating damage, and the potential effect on long term performance is unknown.
