**GEOTECHNICAL FEASIBILITY EVALUATION
PUENTE HILLS LANDFILL PARK MASTER PLAN PROJECT
PUENTE HILLS LANDFILL
2800 WORKMAN MILL ROAD
WHITTIER, CALIFORNIA**

April 29, 2016
Project No. 209393001

Subject: Geotechnical Feasibility Evaluation
Puente Hills Landfill Park Master Plan Project
Puente Hills Landfill
2800 Workman Mill Road
Whittier, California

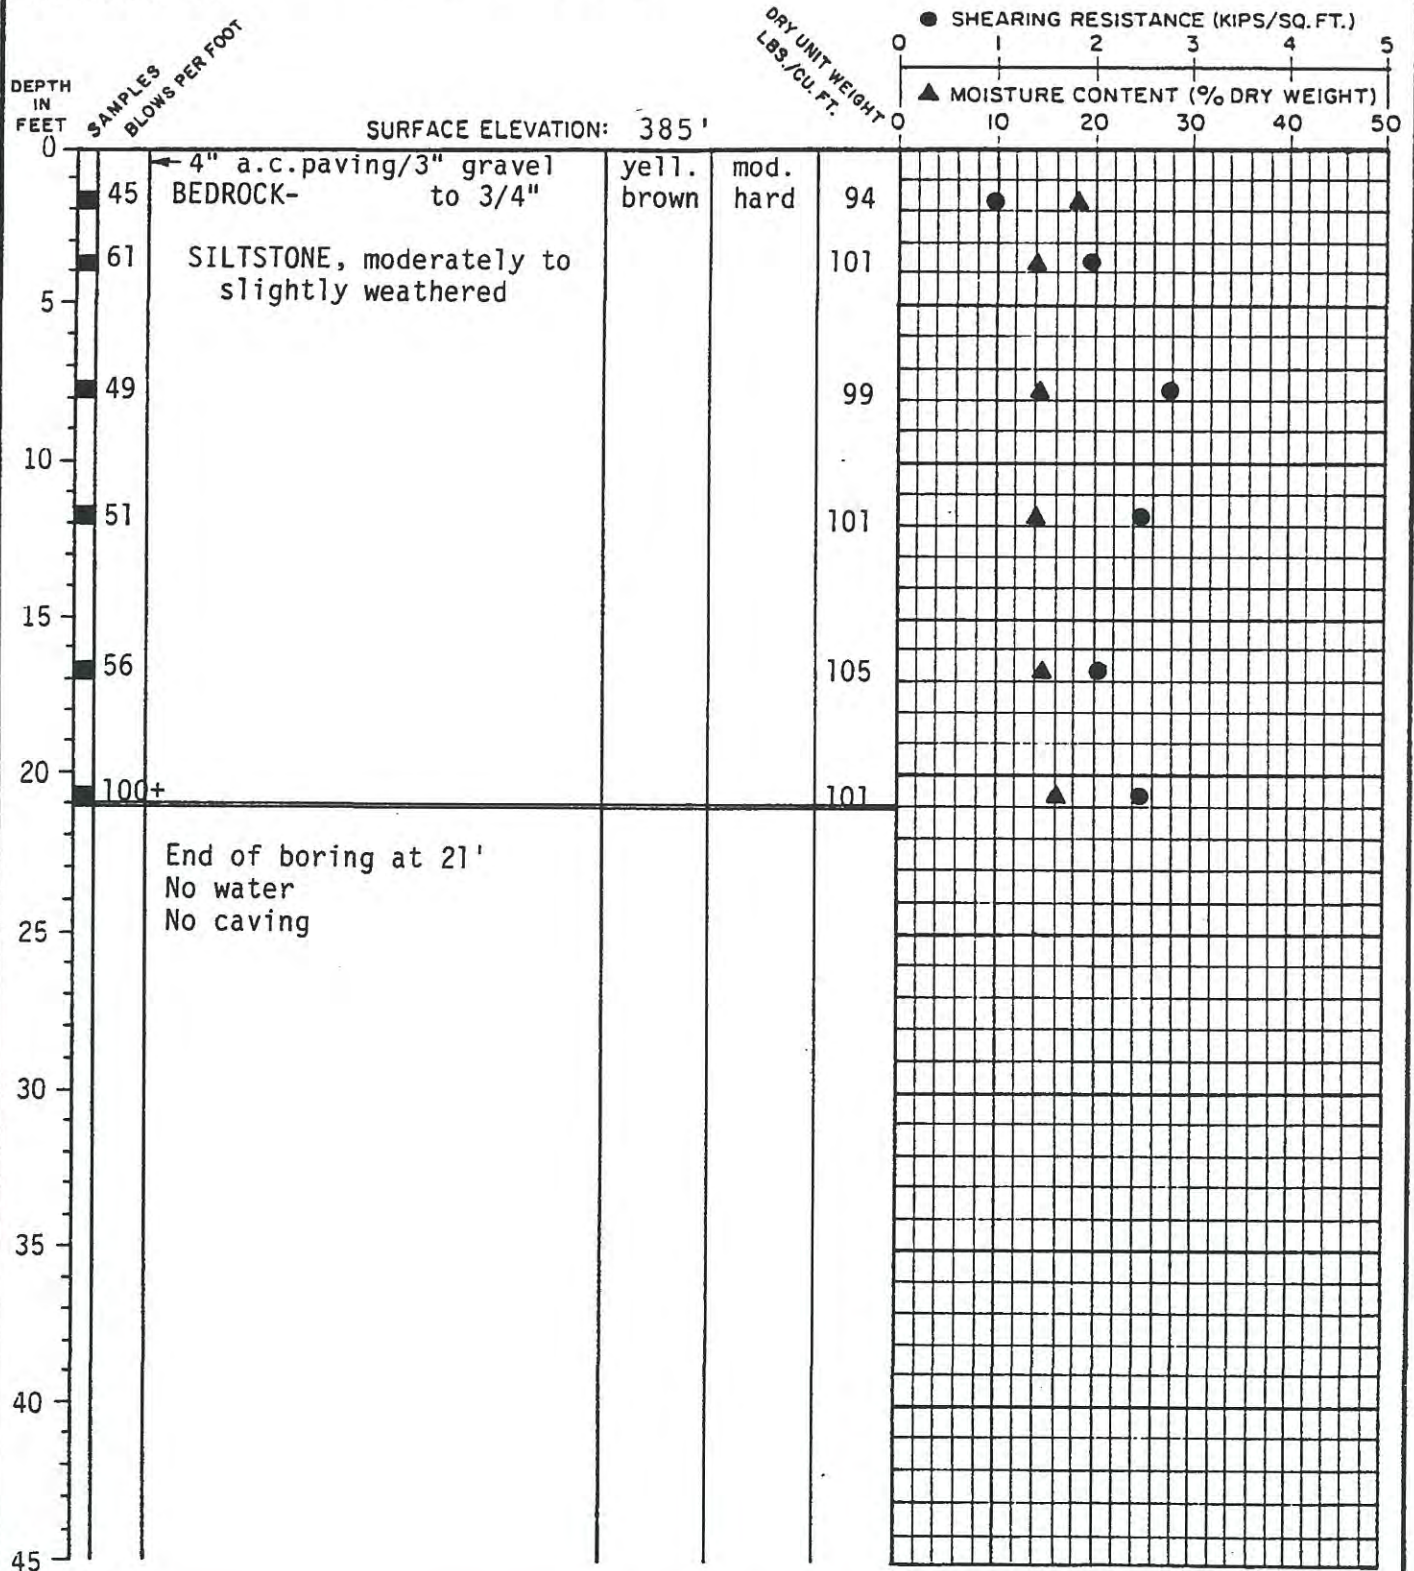
PROJECT NO. 273-101-89

DRILLING EQUIPMENT: 10" hollowstem auger
 DRIVING WEIGHT: 140 lbs., 30" drop

DATE DRILLED: 3/9/89

Puente Hills Landfill Scale House Building
 Los Angeles County,
 California

Soils International (1989a) performed two hollow-stem-auger exploratory borings for a geotechnical study for the scale house building. The borings were drilled to depths of approximately 21 feet. Based on the boring logs, bedrock materials of the Puente Formation were encountered that consisted of massive siltstone. A thin, hard, cemented layer was encountered at approximately 16 feet. The approximate locations of the borings are shown on Figure 2 and copies of the logs are included in Appendix A. The geotechnical report concluded that the northerly descending slope was considered stable based on the approximate 21-degree angle of the slope and the strength of the underlying siltstone bedrock; however, a slope stability analysis was not performed.

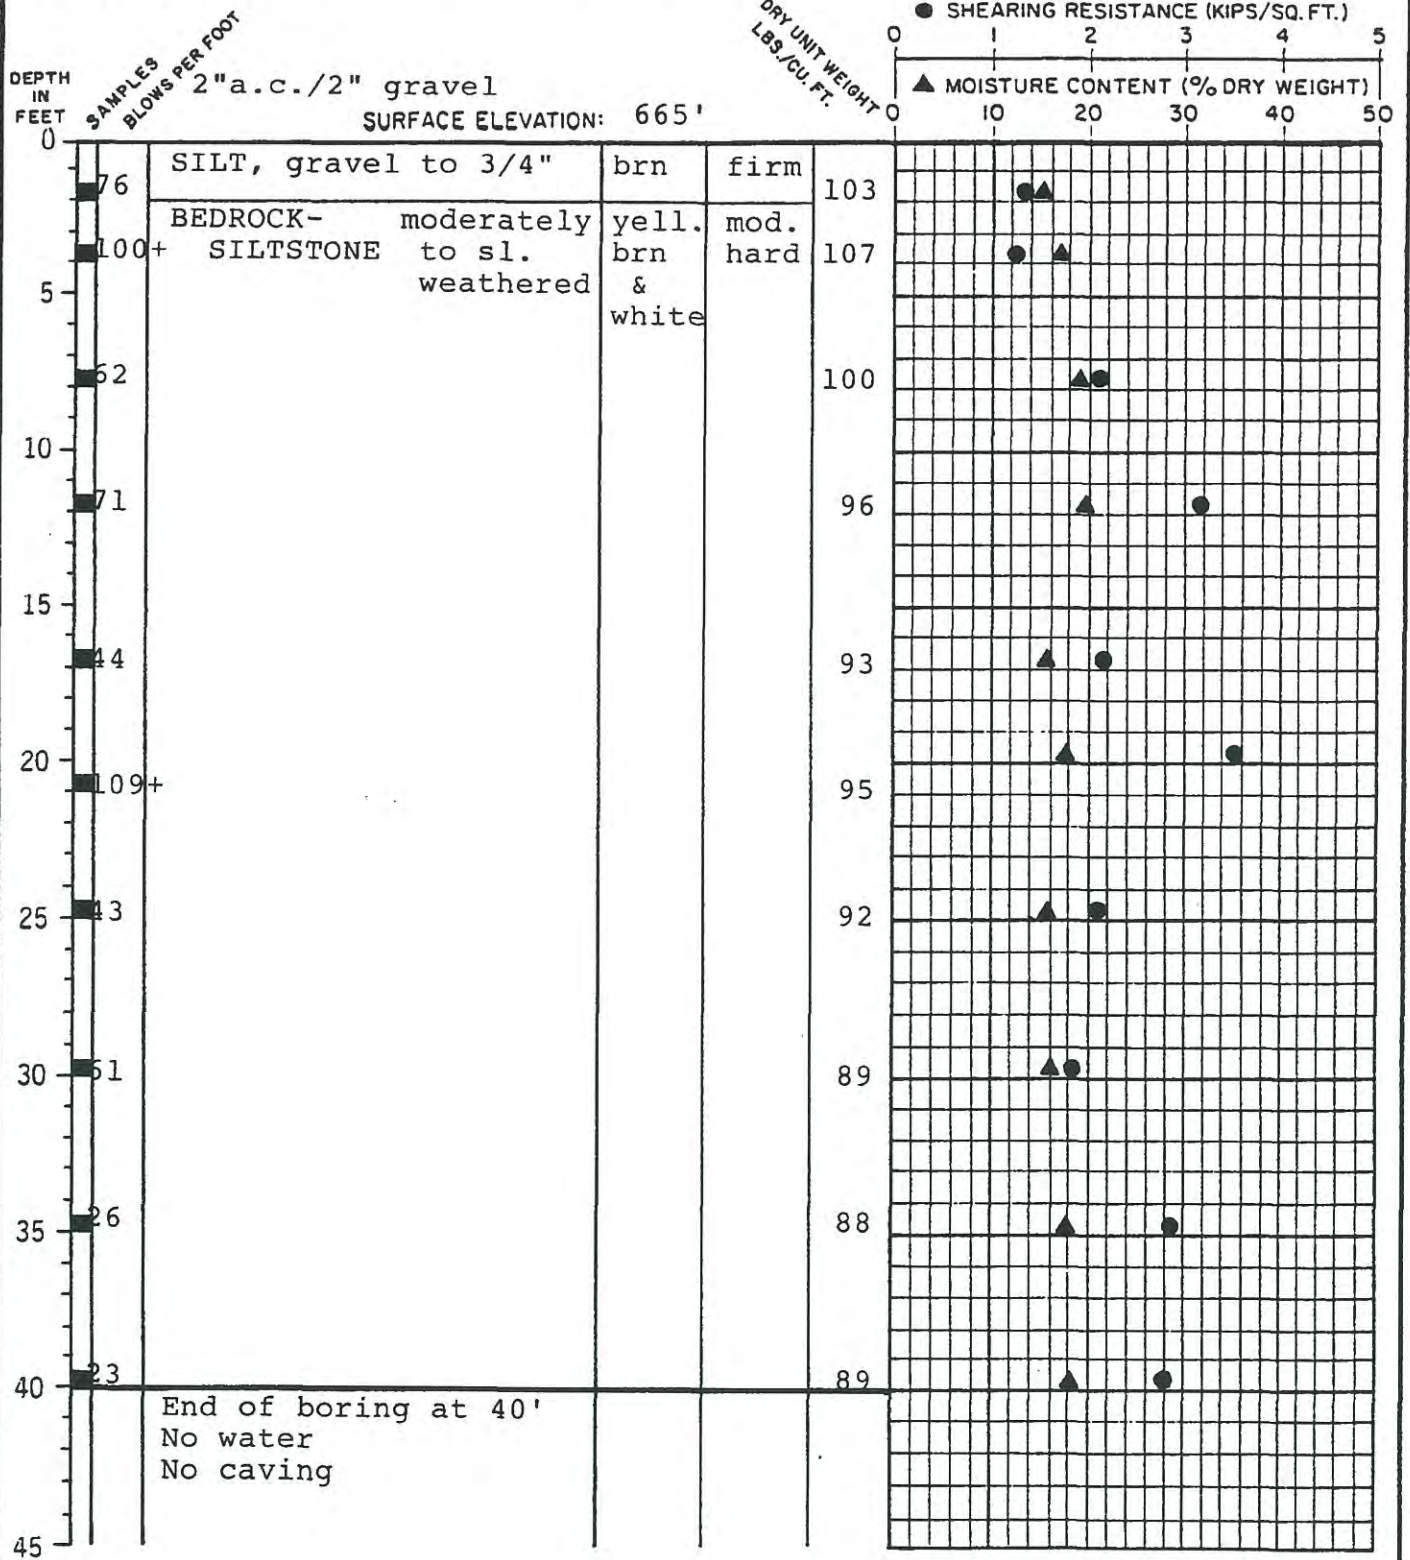
PROJECT NO. 273-101-89
 PLATE D-1

DRILLING EQUIPMENT: 10" hollowstem auger
 DRIVING WEIGHT: 140 lbs., 30" drop

DATE DRILLED: 3/6/89

Puente Hills Landfill PERG Maintenance Building
 Los Angeles County,
 California

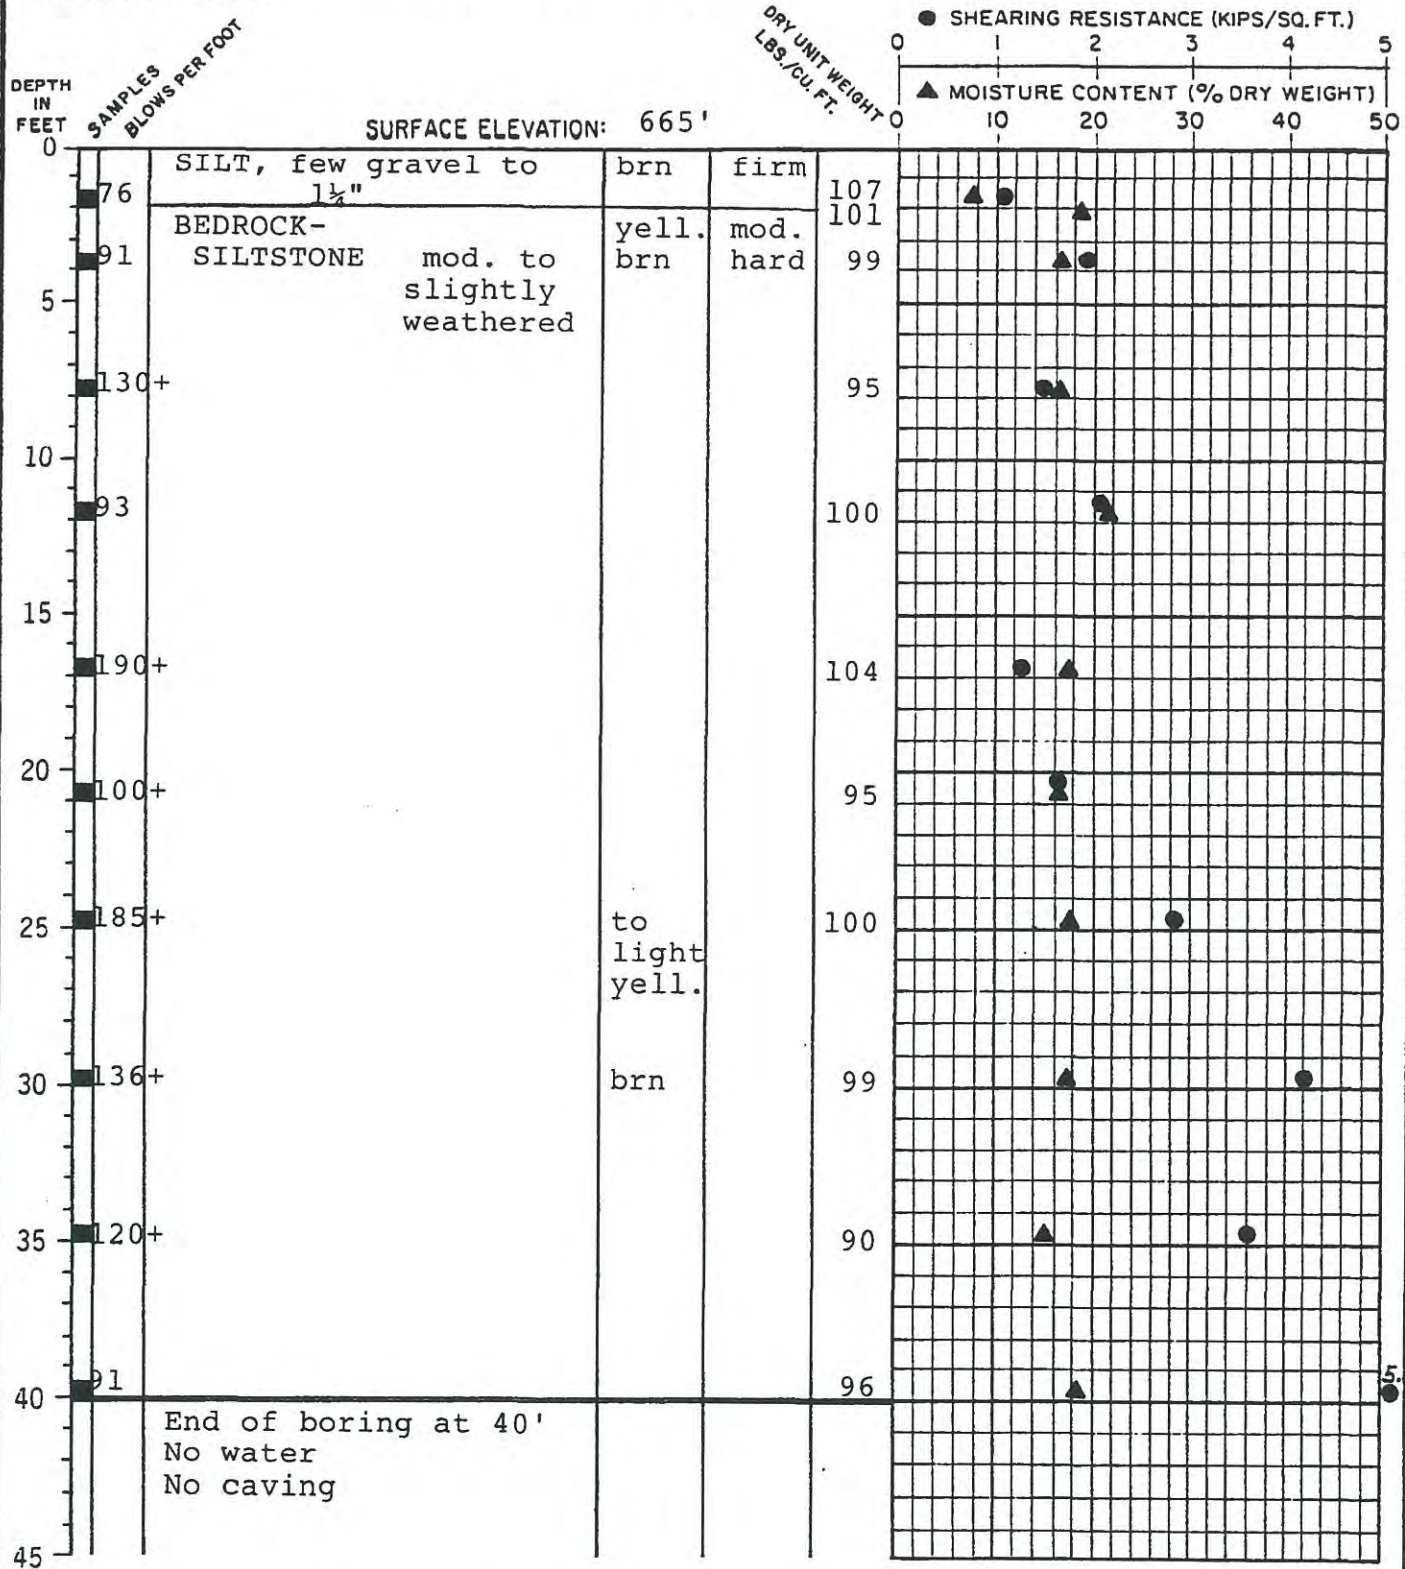
Puente Hills Landfill PERG Maintenance Building Los Angeles County, California	PROJECT NO.	273-101-89
	PLATE	E-1

DRILLING EQUIPMENT: 10" hollowstem auger
 DRIVING WEIGHT: 140 lbs., 30" drop

DATE DRILLED: 3/9/89

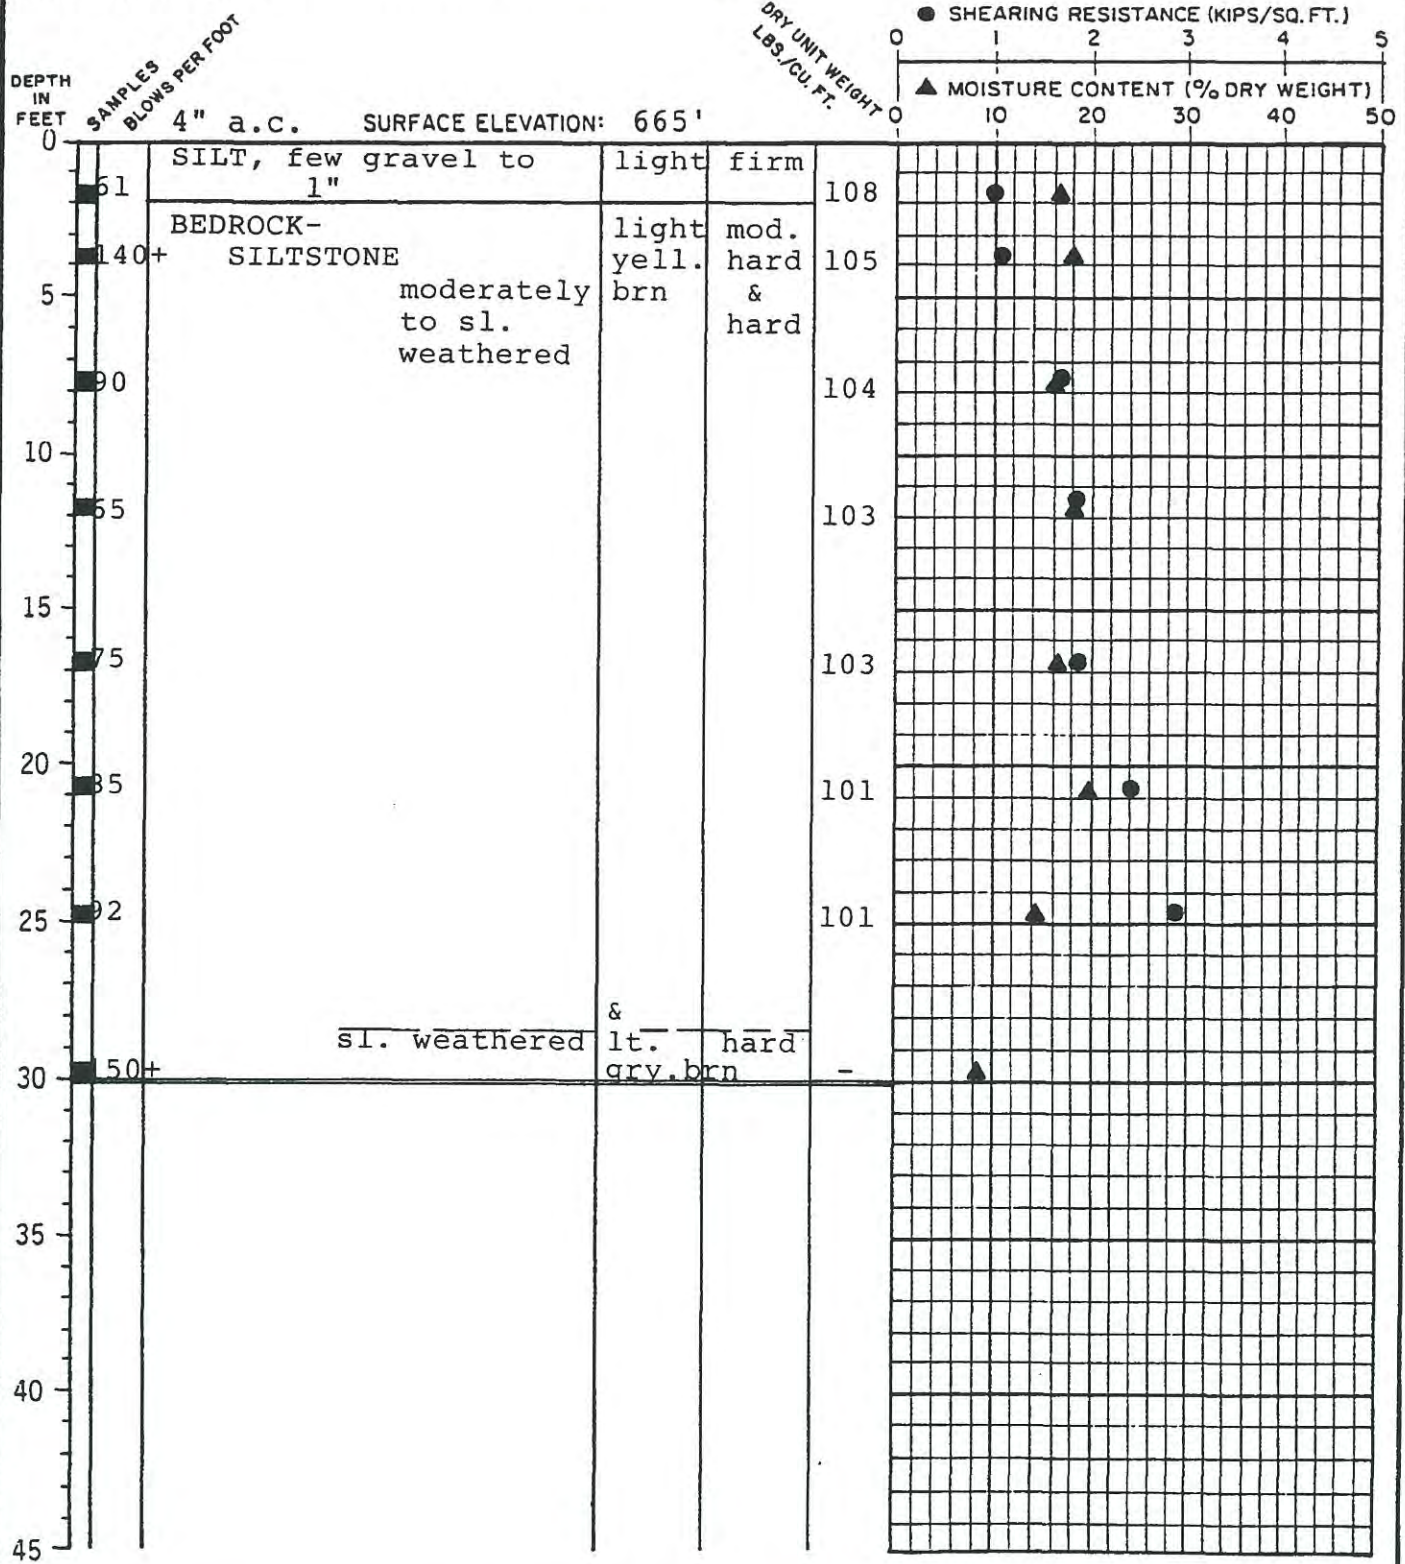
PROJECT NO. 273-101-89
 PLATE F-1

LOG OF BORING NO. 5

DRILLING EQUIPMENT: 10" hollowstem auger
 DRIVING WEIGHT: 140 lbs., 30" drop

DATE DRILLED: 3/9/89

Puente Hills Landfill PERG Maintenance Building
 Los Angeles County,
 California

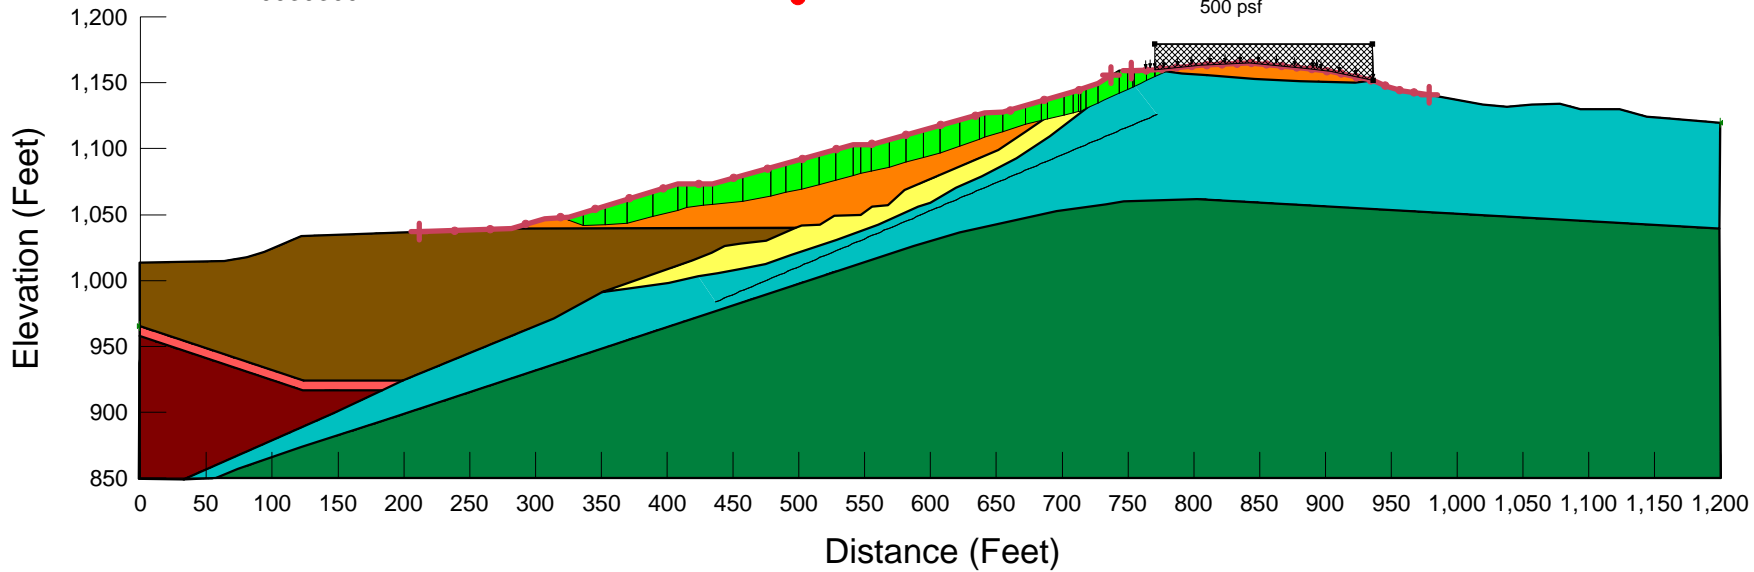
Section C-C' Slope Stability - Static
 Puente Hills Landfill
 209393001

2.25

- Name: Fill
 Model: Mohr-Coulomb
 Unit Weight: 110 pcf
 Cohesion: 50 psf
 Phi: 28 °
 Phi-B: 0 °
- Name: Soil Stockpile
 Model: Mohr-Coulomb
 Unit Weight: 120 pcf
 Cohesion: 100 psf
 Phi: 27 °
 Phi-B: 0 °
- Name: Cover
 Model: Mohr-Coulomb
 Unit Weight: 115 pcf
 Cohesion: 150 psf
 Phi: 28 °
 Phi-B: 0 °
- Name: MSW
 Model: Mohr-Coulomb
 Unit Weight: 85 pcf
 Cohesion: 0 psf
 Phi: 33 °
 Phi-B: 0 °
- Name: Ols
 Model: Mohr-Coulomb
 Unit Weight: 120 pcf
 Cohesion: 1,430 psf
 Phi: 16 °
 Phi-B: 0 °
- Name: Siltstone
 Model: Mohr-Coulomb
 Unit Weight: 120 pcf
 Cohesion: 1,400 psf
 Phi: 35 °
 Phi-B: 0 °
- Name: Weathered Siltstone Clay
 Model: Anisotropic Fn.
 Unit Weight: 120 pcf
 Cohesion: 530 psf
 Phi: 35 °
 Phi-Anisotropic Strength Fn.: phi
 C-Anisotropic Strength Fn.: c
 Phi-B: 0 °

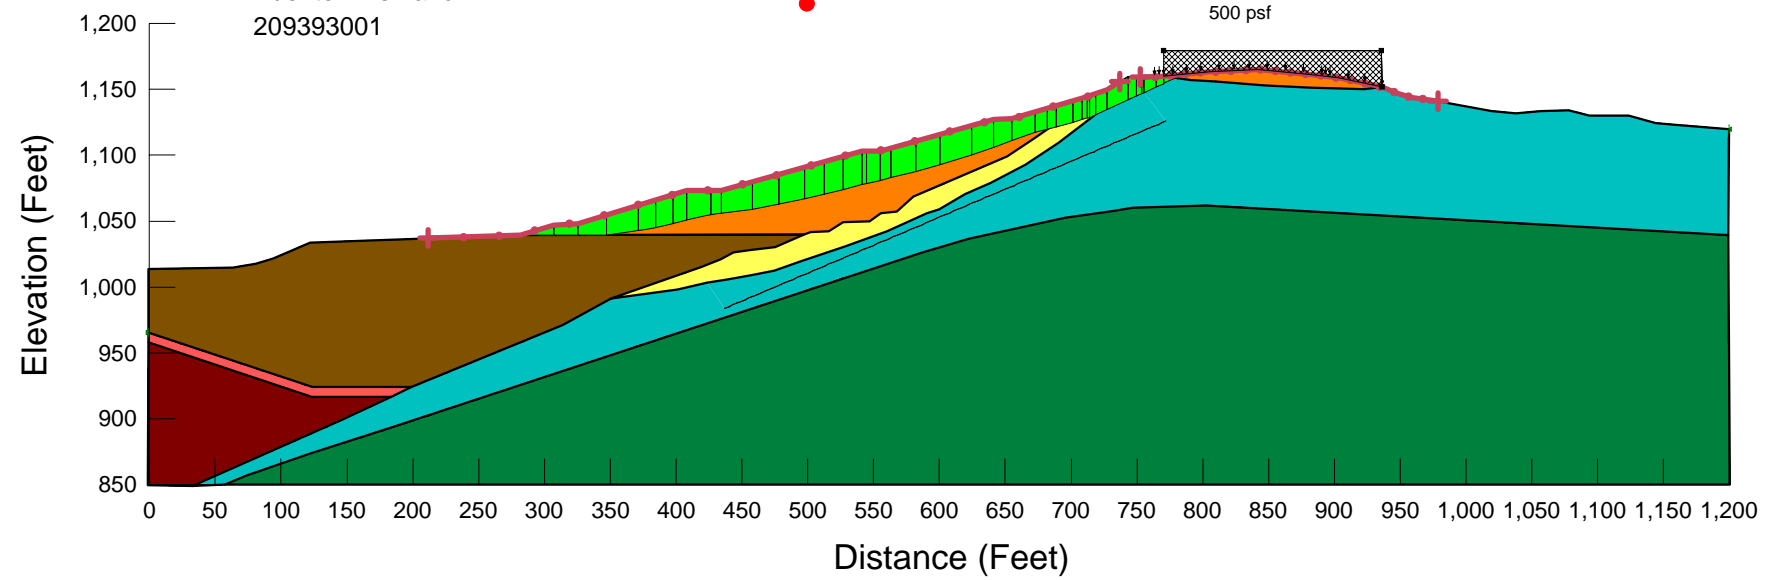
Section C-C' Slope Stability - Pseudostatic

1.40

500 psf

- Name: Fill
Model: Mohr-Coulomb
Unit Weight: 110 pcf
Cohesion: 50 psf
Phi: 28 °
Phi-B: 0 °
- Name: Soil Stockpile
Model: Mohr-Coulomb
Unit Weight: 120 pcf
Cohesion: 100 psf
Phi: 27 °
Phi-B: 0 °
- Name: Cover
Model: Mohr-Coulomb
Unit Weight: 115 pcf
Cohesion: 150 psf
Phi: 28 °
Phi-B: 0 °
- Name: MSW
Model: Mohr-Coulomb
Unit Weight: 85 pcf
Cohesion: 0 psf
Phi: 33 °
Phi-B: 0 °
- Name: Qls
Model: Mohr-Coulomb
Unit Weight: 120 pcf
Cohesion: 1,430 psf
Phi: 16 °
Phi-B: 0 °
- Name: Siltstone
Model: Mohr-Coulomb
Unit Weight: 120 pcf
Cohesion: 1,400 psf
Phi: 35 °
Phi-B: 0 °
- Name: Weathered Siltstone Clay
Model: Anisotropic Fn.
Unit Weight: 120 pcf
Cohesion: 530 psf
Phi: 35 °
Phi-Anisotropic Strength Fn.: phi
C-Anisotropic Strength Fn.: c
Phi-B: 0 °

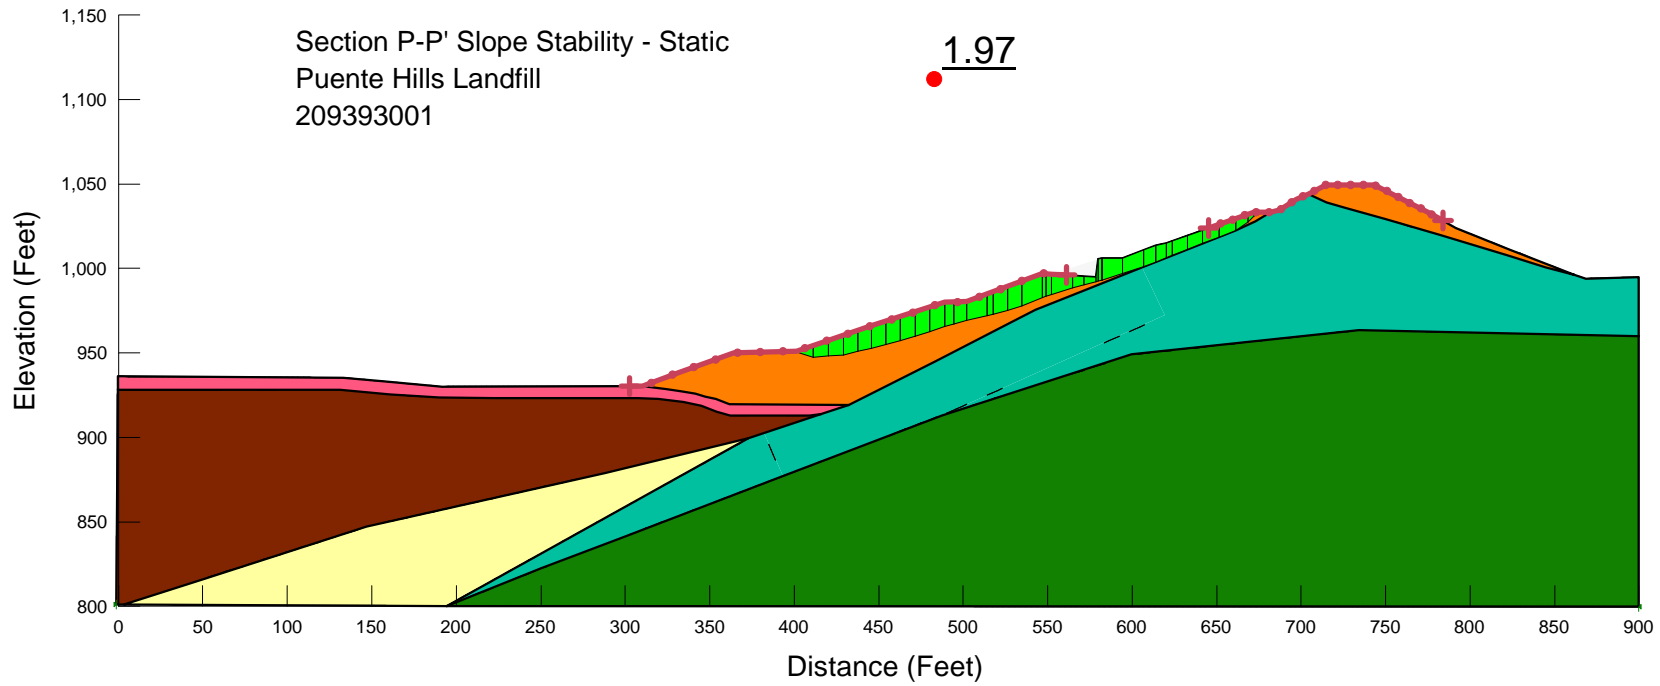
Section P-P' Slope Stability - Static
 Puente Hills Landfill
 209393001

1.97

- Name: Fill
 Model: Mohr-Coulomb
 Unit Weight: 110 pcf
 Cohesion: 50 psf
 Phi: 28 °
 Phi-B: 0 °
- Name: Cover
 Model: Mohr-Coulomb
 Unit Weight: 115 pcf
 Cohesion: 150 psf
 Phi: 28 °
 Phi-B: 0 °
- Name: MSW
 Model: Mohr-Coulomb
 Unit Weight: 85 pcf
 Cohesion: 0 psf
 Phi: 33 °
 Phi-B: 0 °
- Name: Ols
 Model: Mohr-Coulomb
 Unit Weight: 120 pcf
 Cohesion: 1,430 psf
 Phi: 16 °
 Phi-B: 0 °
- Name: Siltstone
 Model: Mohr-Coulomb
 Unit Weight: 120 pcf
 Cohesion: 1,400 psf
 Phi: 35 °
 Phi-B: 0 °
- Name: Weathered Siltstone Clay
 Model: Anisotropic Fr.
 Unit Weight: 120 pcf
 Cohesion: 530 psf
 Phi: 35 °
 Phi-Anisotropic Strength Fr.: phi
 C-Anisotropic Strength Fr.: c
 Phi-B: 0 °

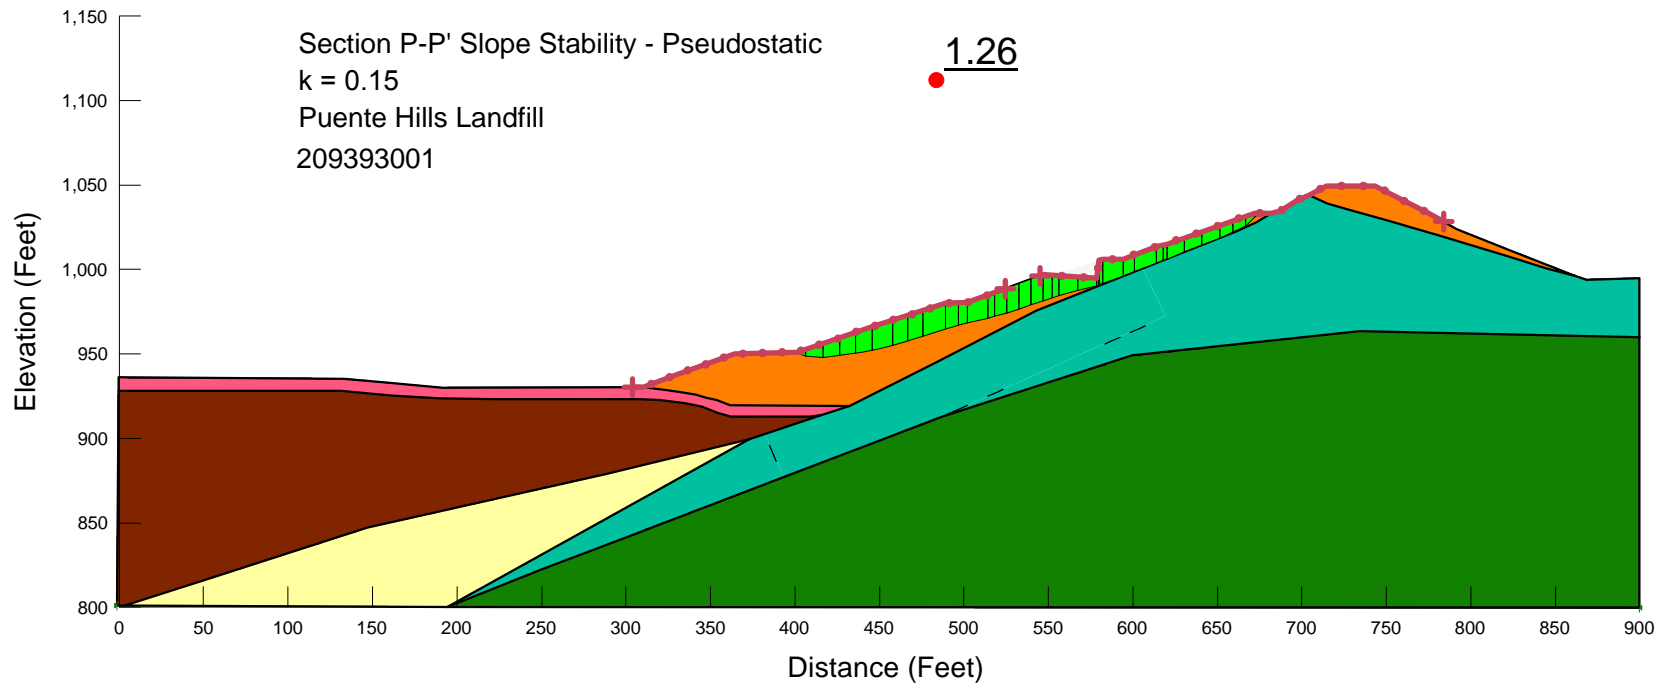
- Name: Fill
 Model: Mohr-Coulomb
 Unit Weight: 110 pcf
 Cohesion: 50 psf
 Phi: 28 °
 Phi-B: 0 °
- Name: Cover
 Model: Mohr-Coulomb
 Unit Weight: 115 pcf
 Cohesion: 150 psf
 Phi: 28 °
 Phi-B: 0 °
- Name: MSW
 Model: Mohr-Coulomb
 Unit Weight: 85 pcf
 Cohesion: 0 psf
 Phi: 33 °
 Phi-B: 0 °
- Name: Qls
 Model: Mohr-Coulomb
 Unit Weight: 120 pcf
 Cohesion: 1,430 psf
 Phi: 16 °
 Phi-B: 0 °
- Name: Siltstone
 Model: Mohr-Coulomb
 Unit Weight: 120 pcf
 Cohesion: 1,400 psf
 Phi: 35 °
 Phi-B: 0 °
- Name: Weathered Siltstone Clay
 Model: Anisotropic Fn.
 Unit Weight: 120 pcf
 Cohesion: 530 psf
 Phi: 35 °
 Phi-Anisotropic Strength Fn.: phi
 C-Anisotropic Strength Fn.: c
 Phi-B: 0 °
