BOARD MOTION OF OCTOBER 17, 2023, AGENDA ITEM 4 ROADWAY SAFETY ALONG SAN FRANCISQUITO CANYON ROAD

ROADWAY SAFETY ALONG SAN FRANCISQUITO CANYON ROAD

San Francisquito Canyon Road Corridor Traffic Safety Study

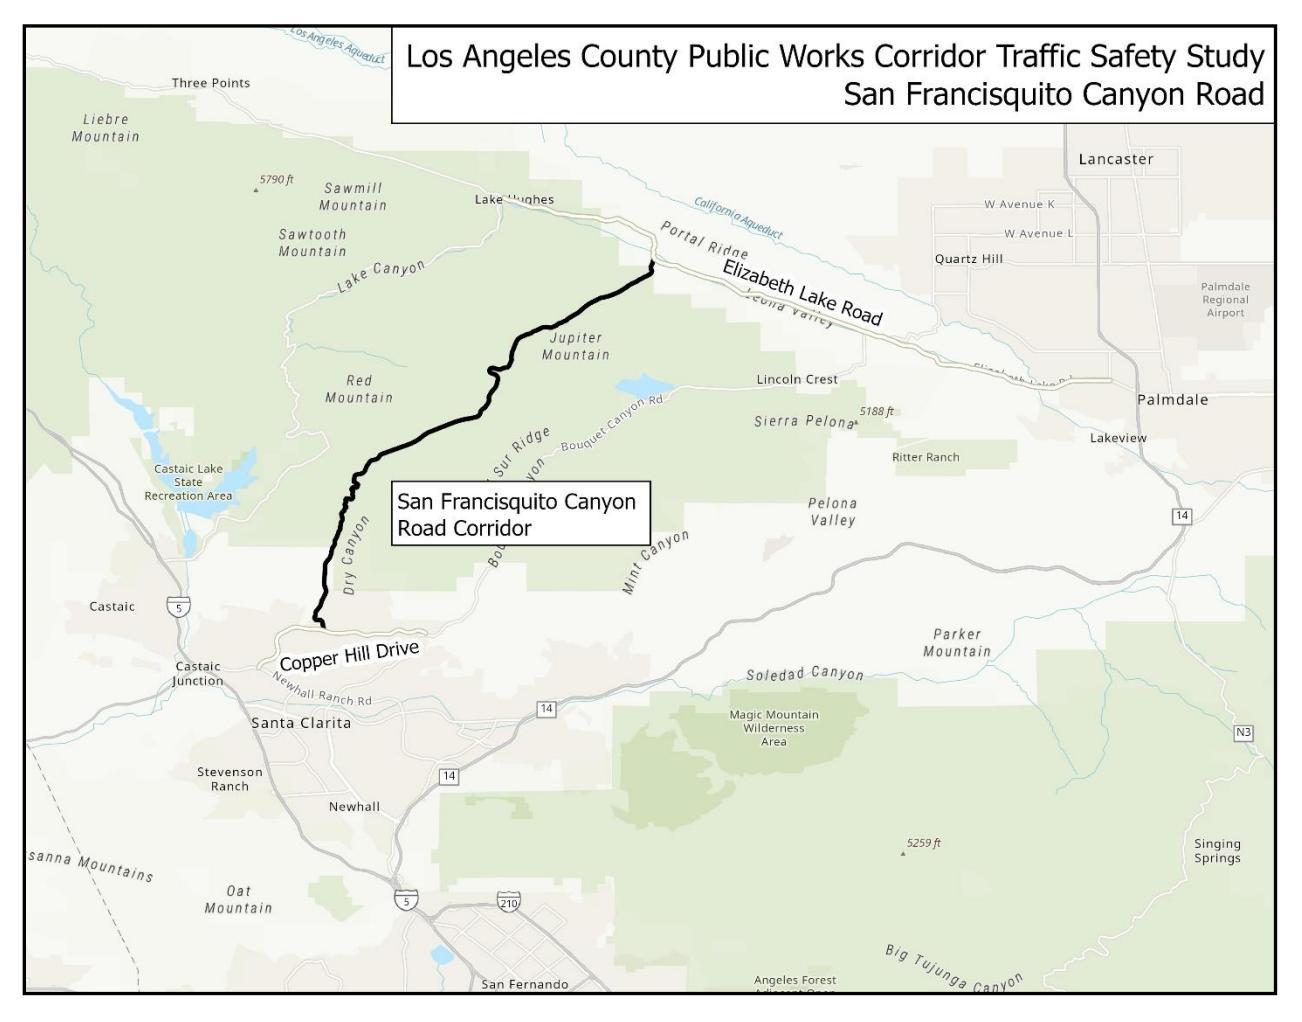
Figure 1 – Overview of San Francisquito Canyon Road from the City of Santa Clarita boundary to Elizabeth Lake Road

San Francisquito Canyon Road is 19-mile corridor bounded by Copper Hill Drive in Santa Clarita to the south and Elizabeth Lake Road in unincorporated Los Angeles County to the north. The corridor provides important connectivity to the local neighborhoods of Green Valley and for travelers between Santa Clarita and the southwestern region of the Antelope Valley. Due to a series of collisions and community concerns in recent years, a Corridor Traffic Safety Study was initiated to identify potential road safety challenges and suggest countermeasures to mitigate those safety issues. **Figure 1** illustrates the study corridor and adjacent major roads.

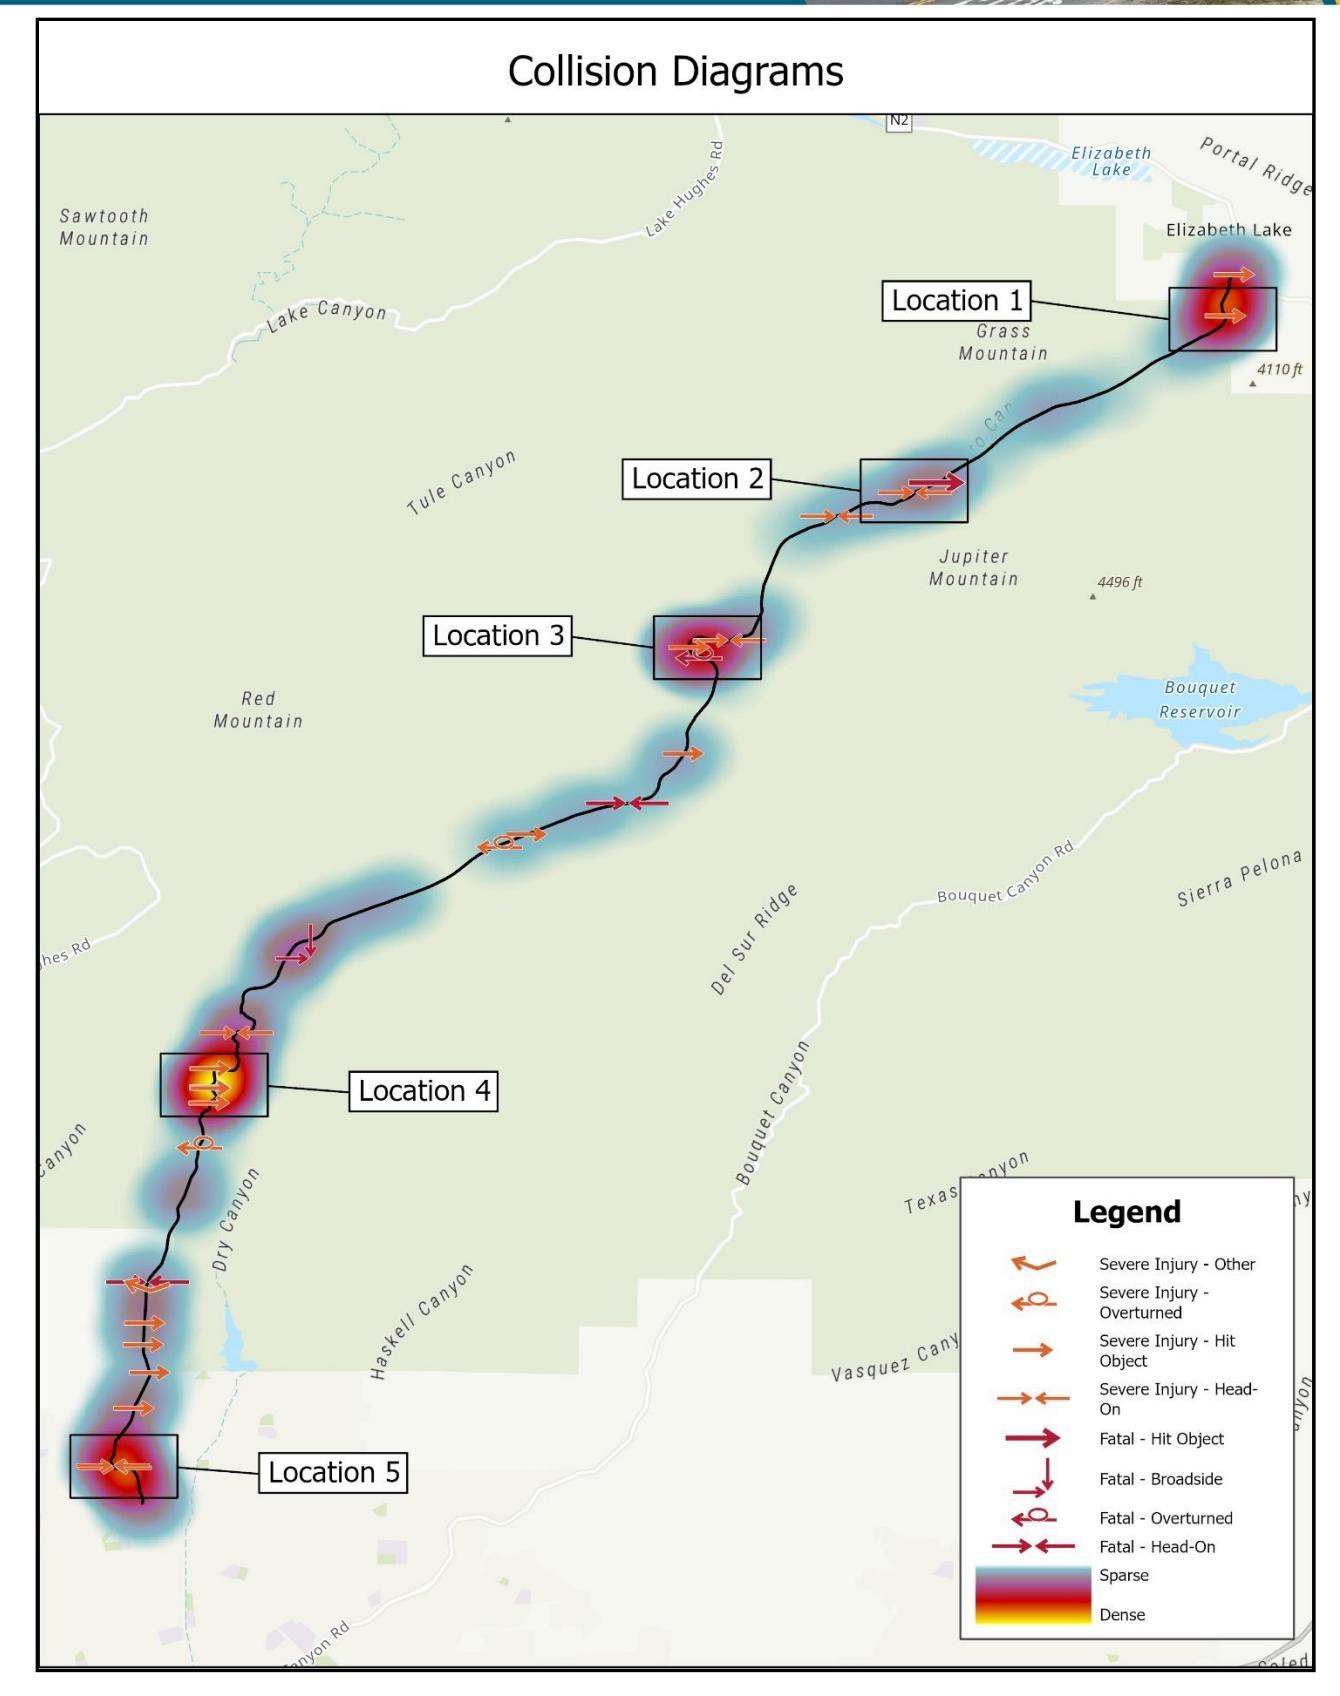
Figure 2 – Collision Diagram along Study Corridor

From 2018 to 2022, there were a total of 128 collisions, five of which resulted in fatalities and 24 resulted in severe injuries. The TIMS database does not include property damage only (PDO) collisions, so this was not included in the analysis. **Figure 2** shows an analysis of all collisions along San Francisquito Canyon Road and identifies locations with more collisions and a larger proportion of fatal/severe injuries. The figure also breaks down the collision type of all the high-severity collisions.

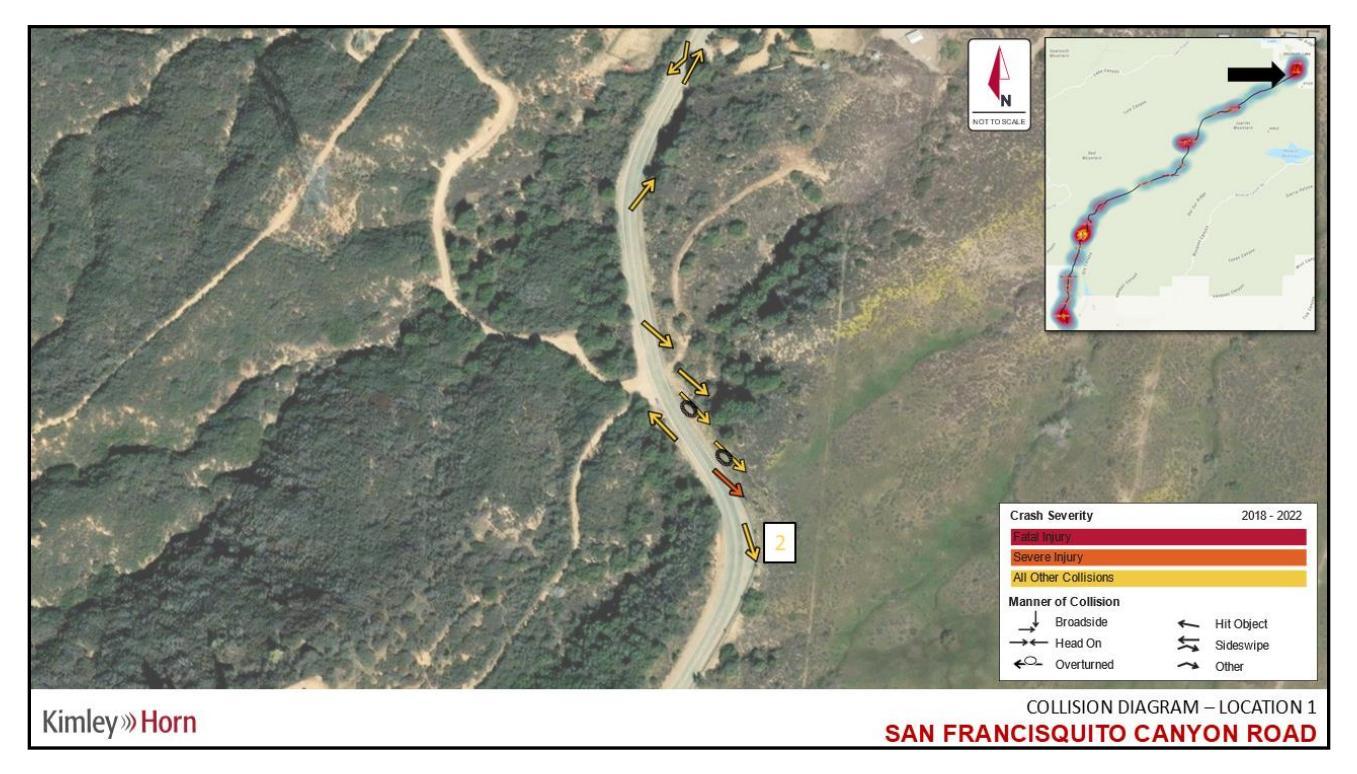
Figure 3 – Collision Diagram Location 1

Location 1 had a significant number of collisions showing drivers crossing the centerline onto the other side of the roadway and colliding with fixed objects.

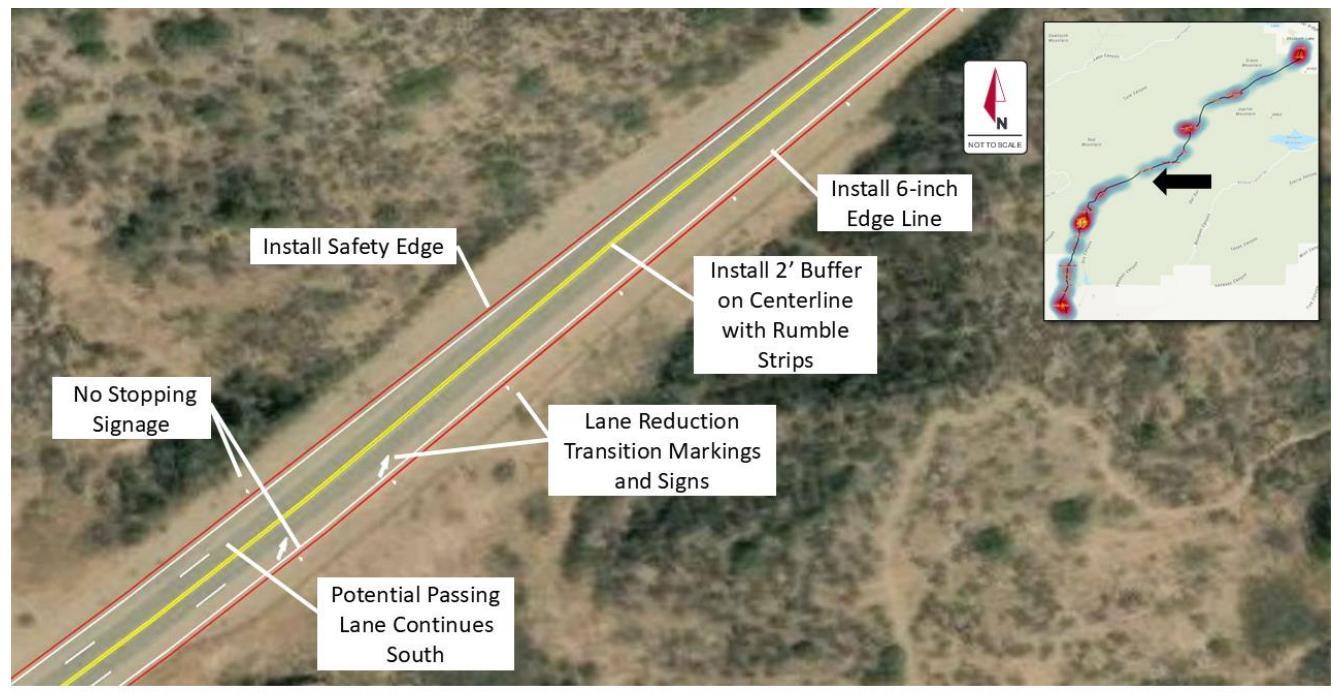
LOCATION E – Beginning MM 10.55 SAN FRANCISQUITO CANYON ROAD

Section 3 analyzed one example location in its analysis. Location E is a proposed passing lane from MM 10.55 to 11.80 in an effort in reduce unsafe passing along the corridor.

Passing Lanes are most suitable at this location due to the lack of curves in this section which has led many drivers to pass illegally and unsafely in its existing condition. The implementation of this countermeasure will allow for a safe and legal manner of passing.

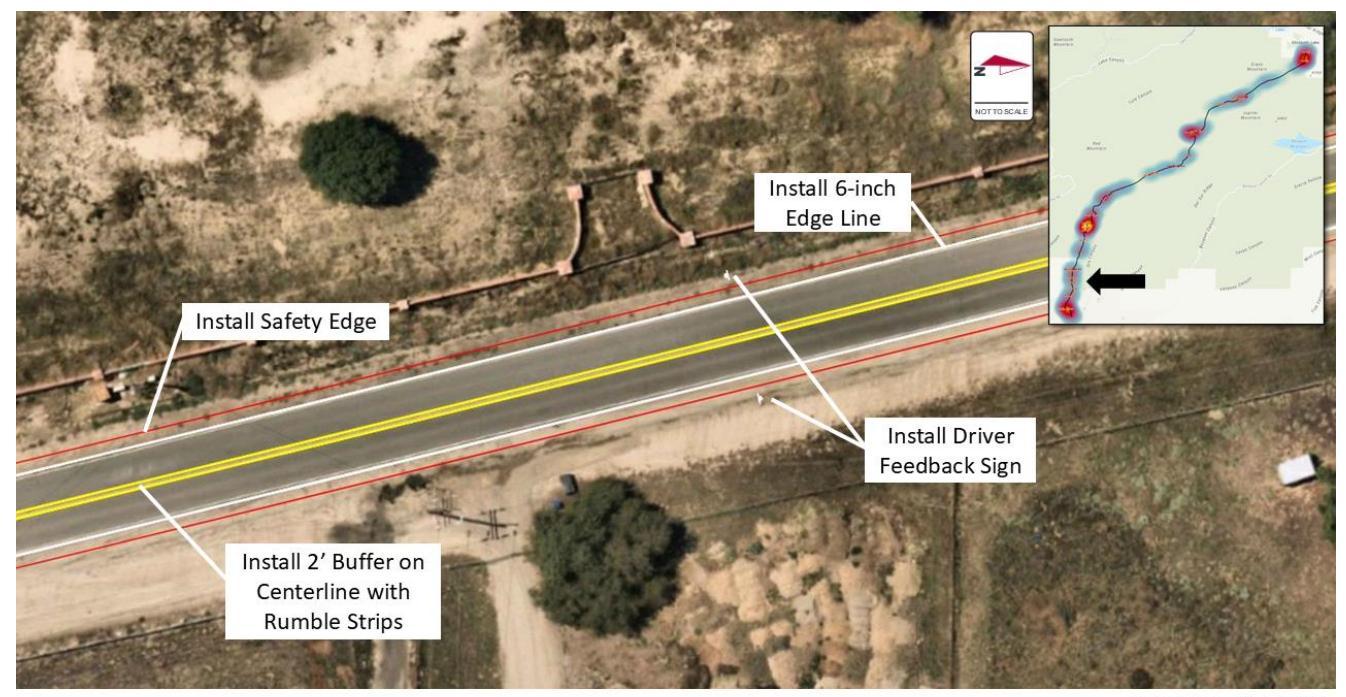
LOCATION L – MM 17.73 SAN FRANCISQUITO CANYON ROAD Location L proposes a driver speed feedback sign to remind drivers of their speed and to reduce unsafe speeding.

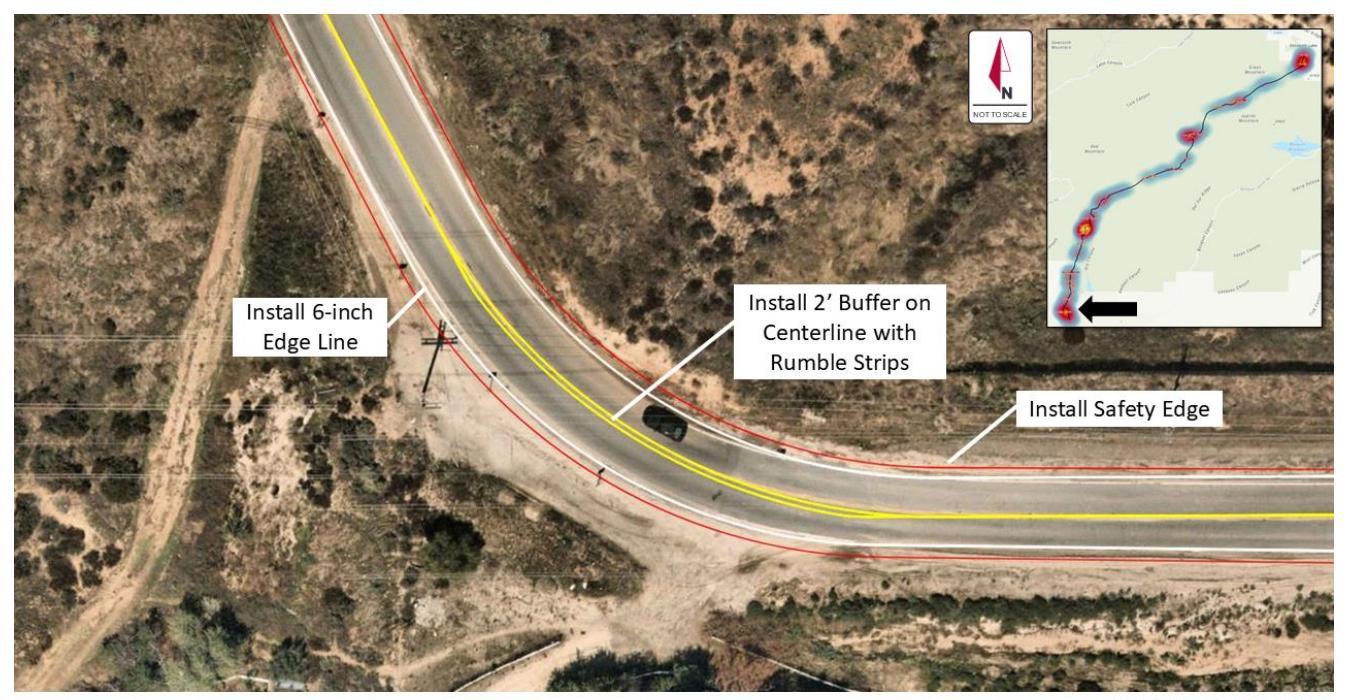
LOCATION M - MM 19.22 SAN FRANCISQUITO CANYON ROAD

Location M has two severe injury "head-on" collisions and the corridor-wide implementation of a 2foot buffer with rumble strips along curves is recommended to enhance safety at this location. In addition, transverse rumble strips are recommended to alert drivers of equestrian crossings utilized by the local community.

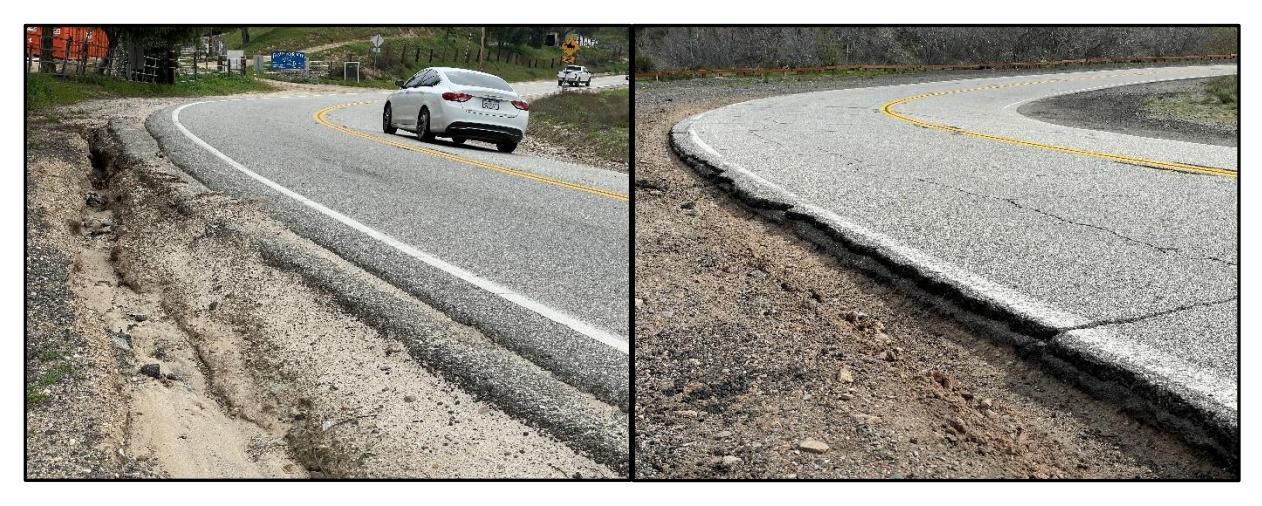
Figure 13 – Steep Erosion along Roadway

Observation #1 – Rainfall has led to erosion along the edge of the roadway.

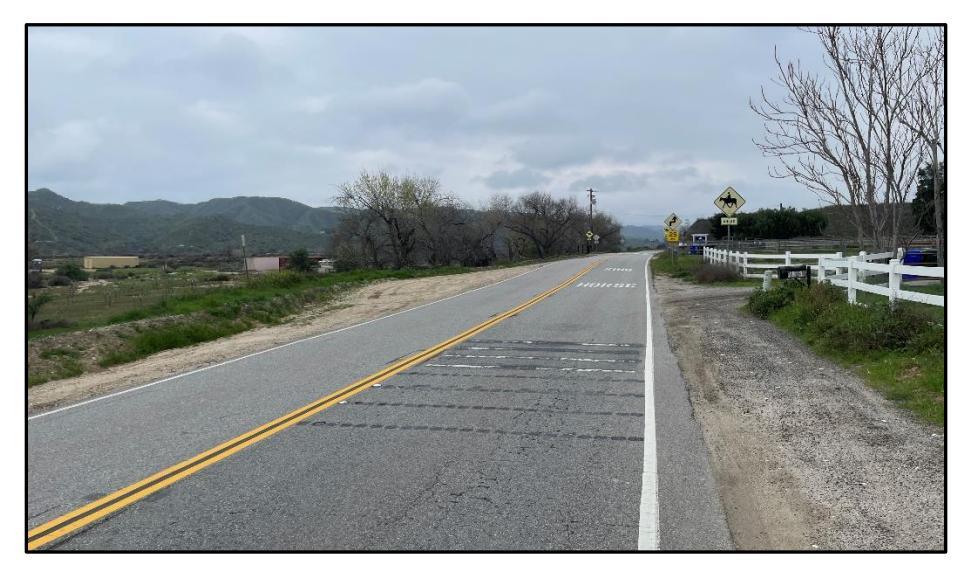
Figure 14 – Equestrian Crossings with Deteriorated Transverse Rumble Strips

Observation #2 – There are multiple equestrian crossings along the study corridor marked with signs and crosswalks. A few locations have transverse rumble strips that show signs of wear.

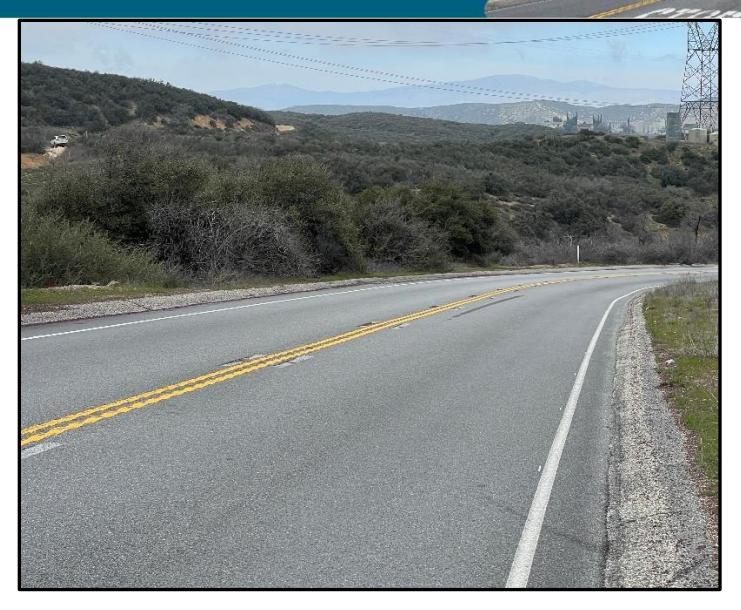
Figure 15 – Existing Centerline Rumble Strips

Observation #3 – Centerline rumble strips exist on the northern 6-mile portion of the study corridor, including through Green Valley.

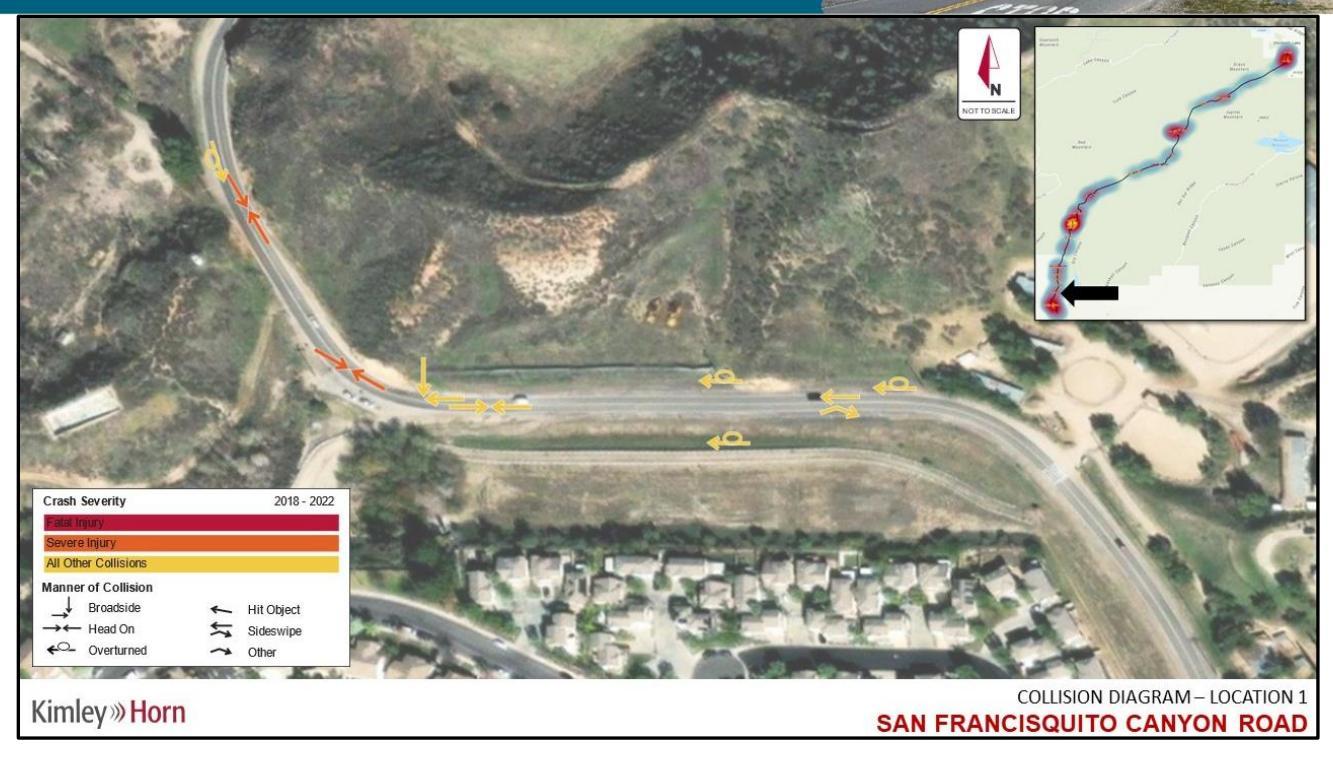
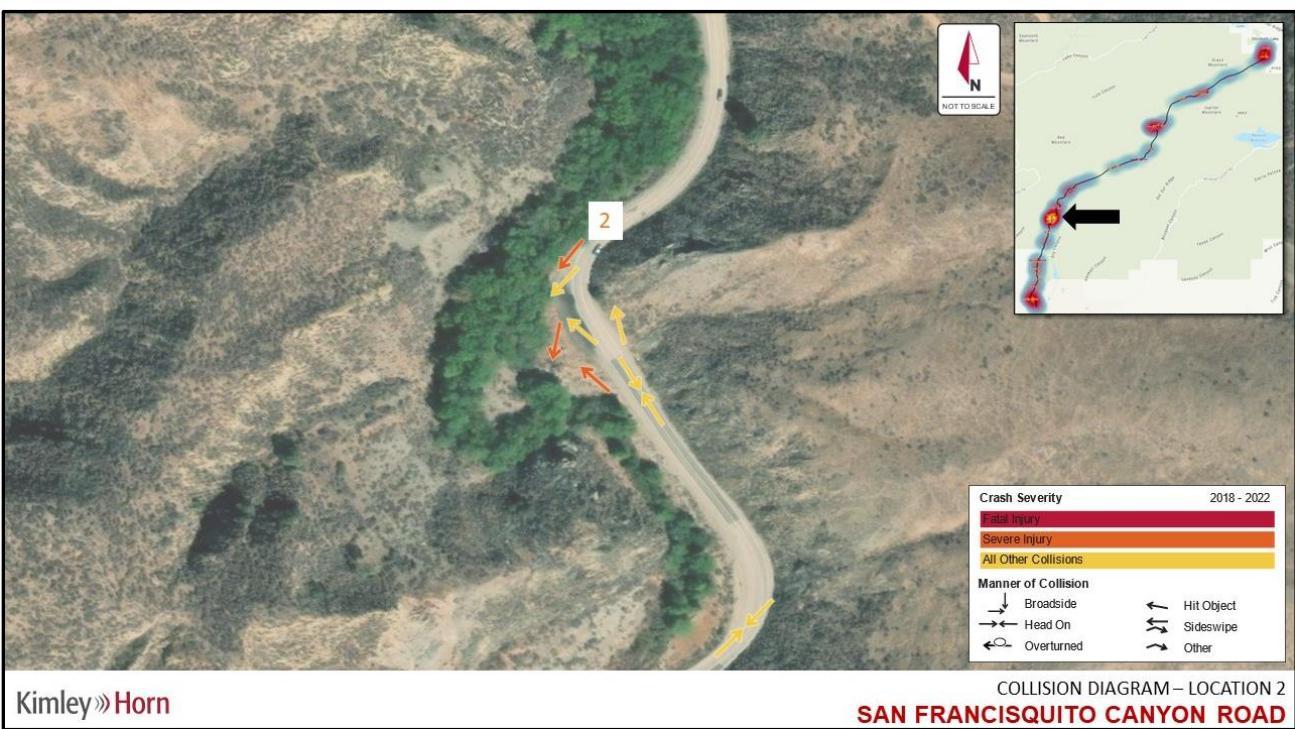
The observed data from the collision data, constituent feedback, and field visit led to several spot locations of which greater focus would result in the largest impact. **Figure 17** shows the initial five locations overlayed with collision data provided from TIMS.

Location 1 had a four "overturned" and three "head-on" collisions, two of which resulted in severe injuries. Location 2 had seven "hit object" collisions near MM 14.52. Location 3 had seven "hit object" collisions in the northbound direction. This location also had an "overturned" collision resulting in a fatality. Location 4 had a fatal "hit object" collision from a vehicle heading southbound near MM 3.53. Location 5 had a significant number of collisions showing drivers crossing the centerline onto the other side of the roadway and colliding with fixed objects. These five locations will serve as focus locations for further analysis.
