Draft VICTORIA PARK GOLF COURSE REDEVELOPMENT PROJECT

Jurisdictional Delineation Report

Prepared for Shopoff Group February 2018

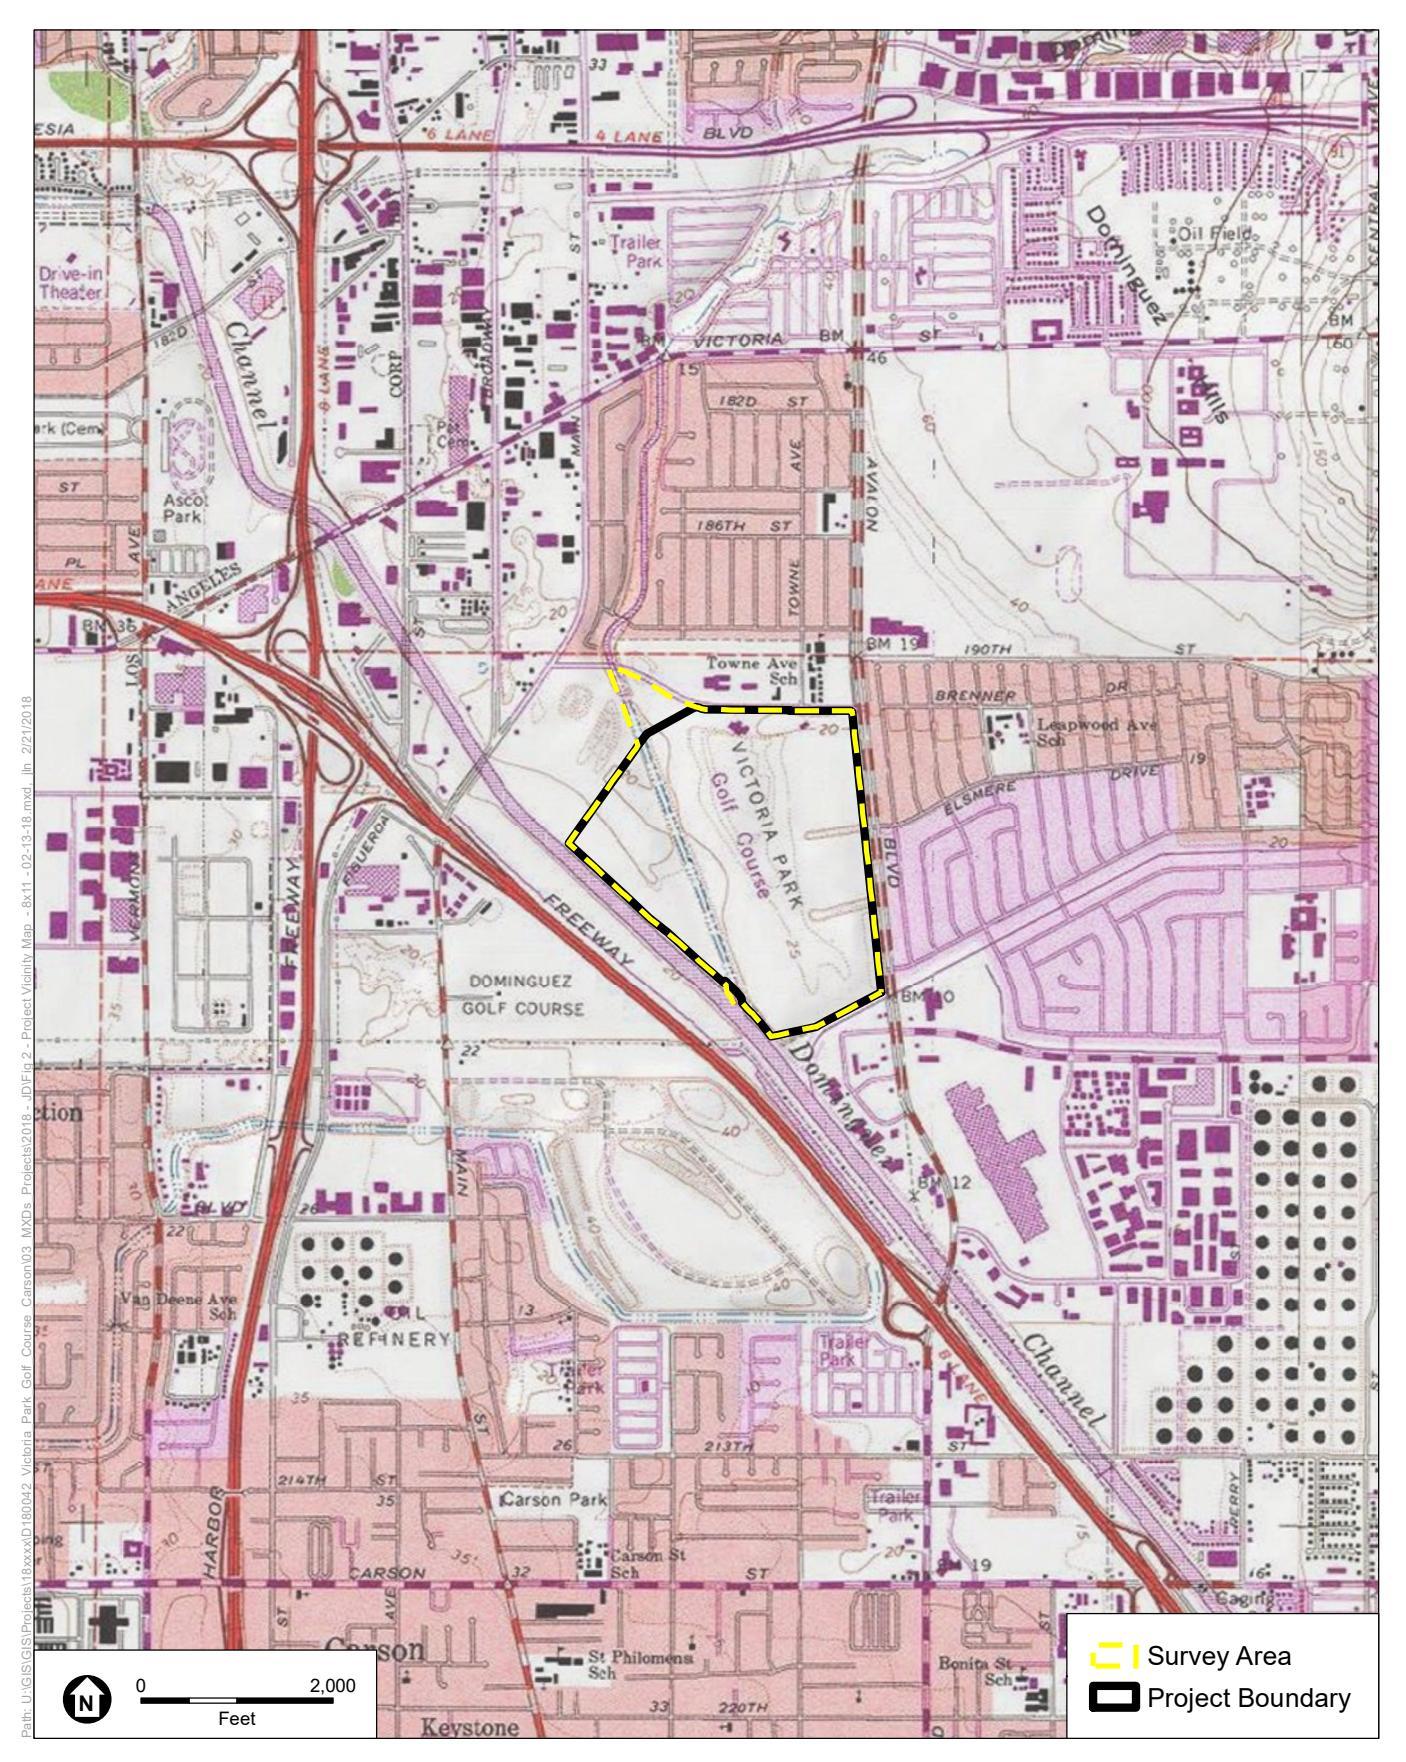
The drainage channel on the project site is mapped as an intermittent blue-line stream on the *Torrance, California* USGS 7.5-minute topographic quadrangle map (**Figure 2**). This blue-line stream historically and currently connects to the Dominguez Channel. The drainage channel that runs along the western portion of the project site contains a disturbed marsh habitat with non-native trees along the slopes. The elevation on the project site is relatively flat, ranging from approximately 25 feet above mean sea level (AMSL) in the northern portion of the site to approximately 30 feet AMSL in the southern portion of the site.

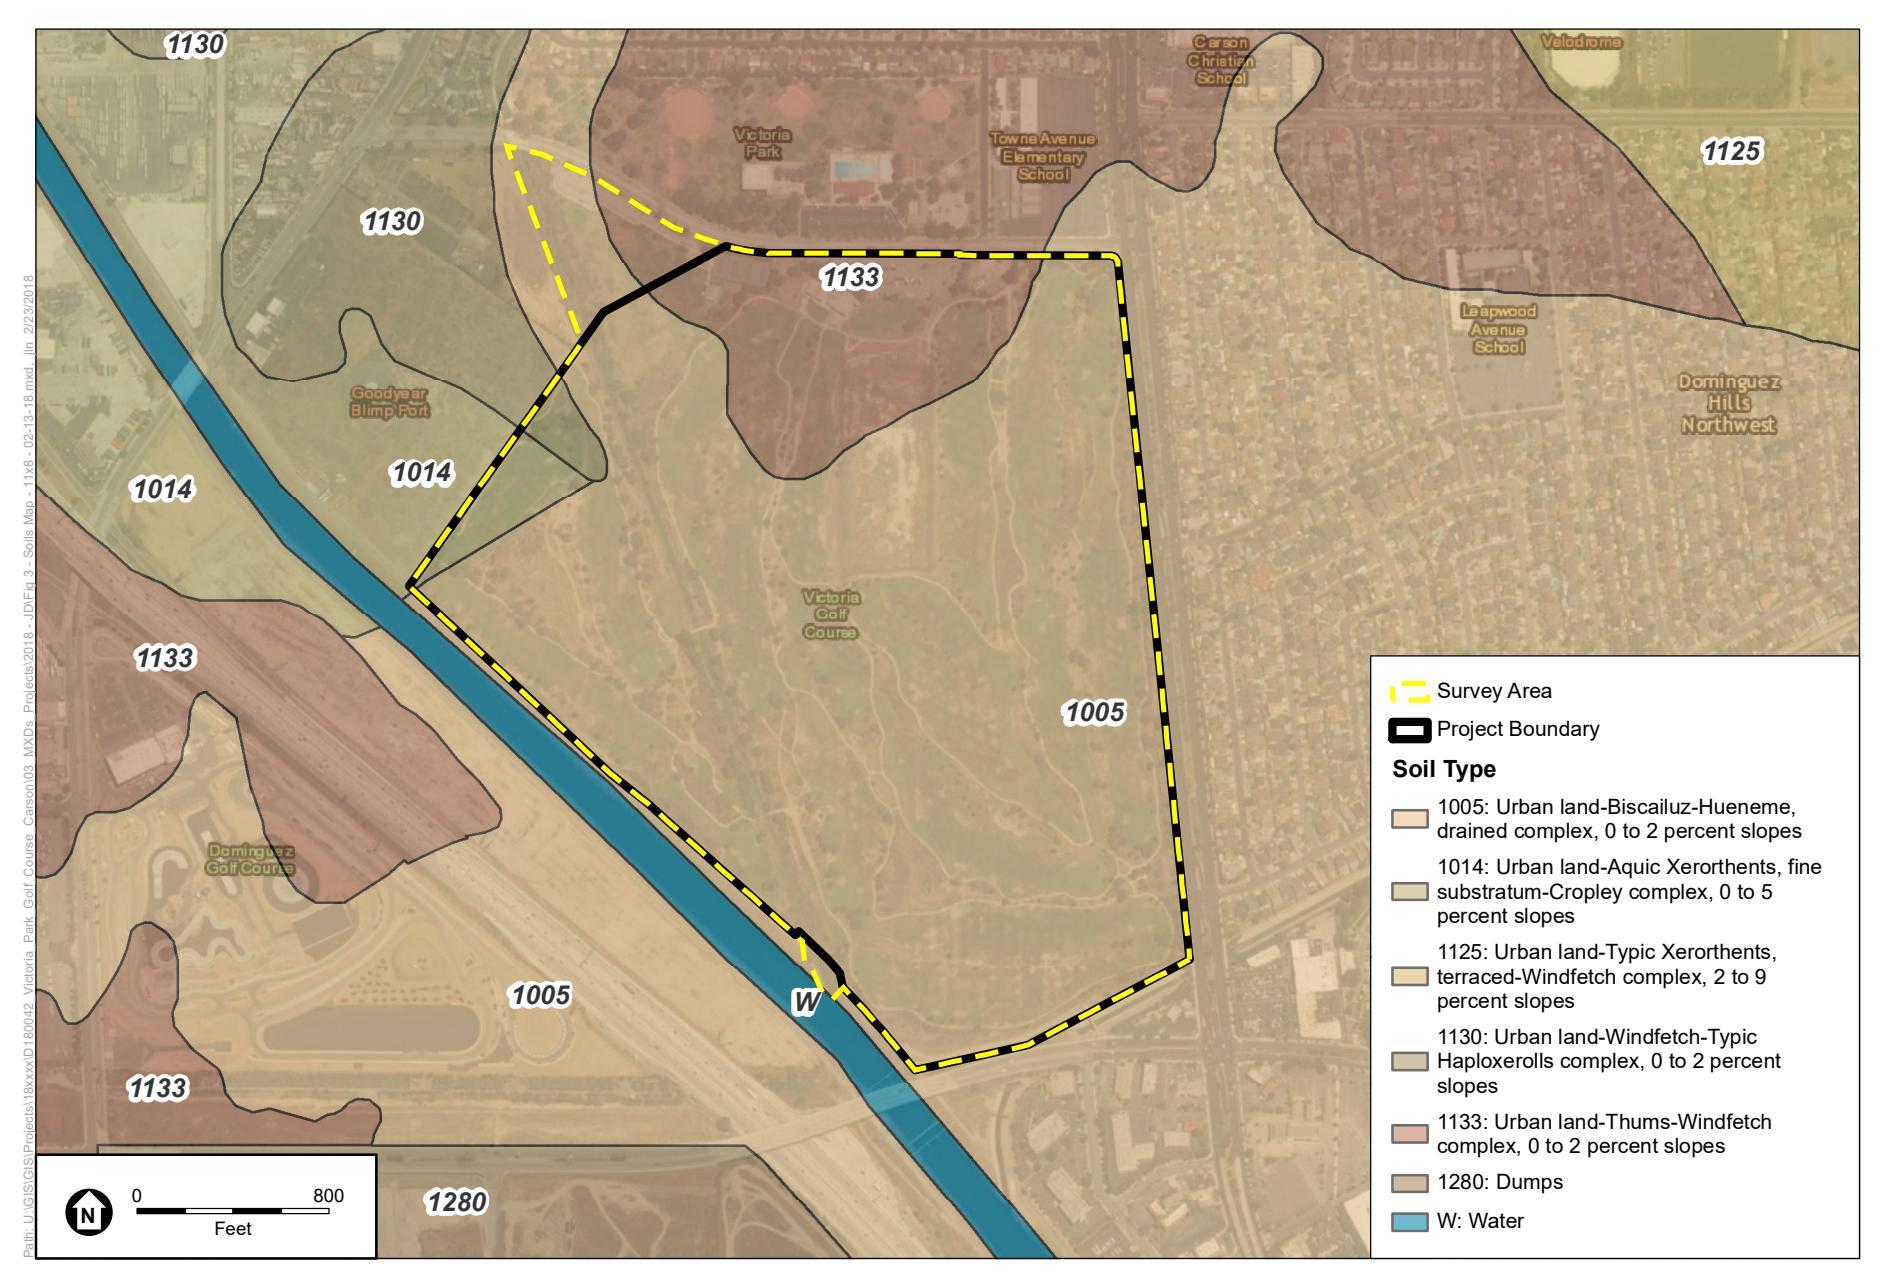
Figure 3 Soils Map

The U.S Department of Agriculture Natural Resources Conservation Service (NRCS) maps the majority of the project site as complexes of several soil types including the following: Urban land-Biscailuz-Hueneme, drained complex, Urban land-Thums-Windfetch complex, Urban land-Aquic Xerorthents, fine substratum-Cropley complex, and Urban land-Windfetch-Typic Haploxerolls complex (**Figure 3**). According to the NRCS, none of these soils are considered hydric. The observed surface soils show evidence of previous and continued disturbance due to golf course operations and maintenance activities. The previous grading and degradation to the natural soil horizons has created complexes of mixed native soil and urban land that has either been constructed upon, compacted, and/or consists of fill material.

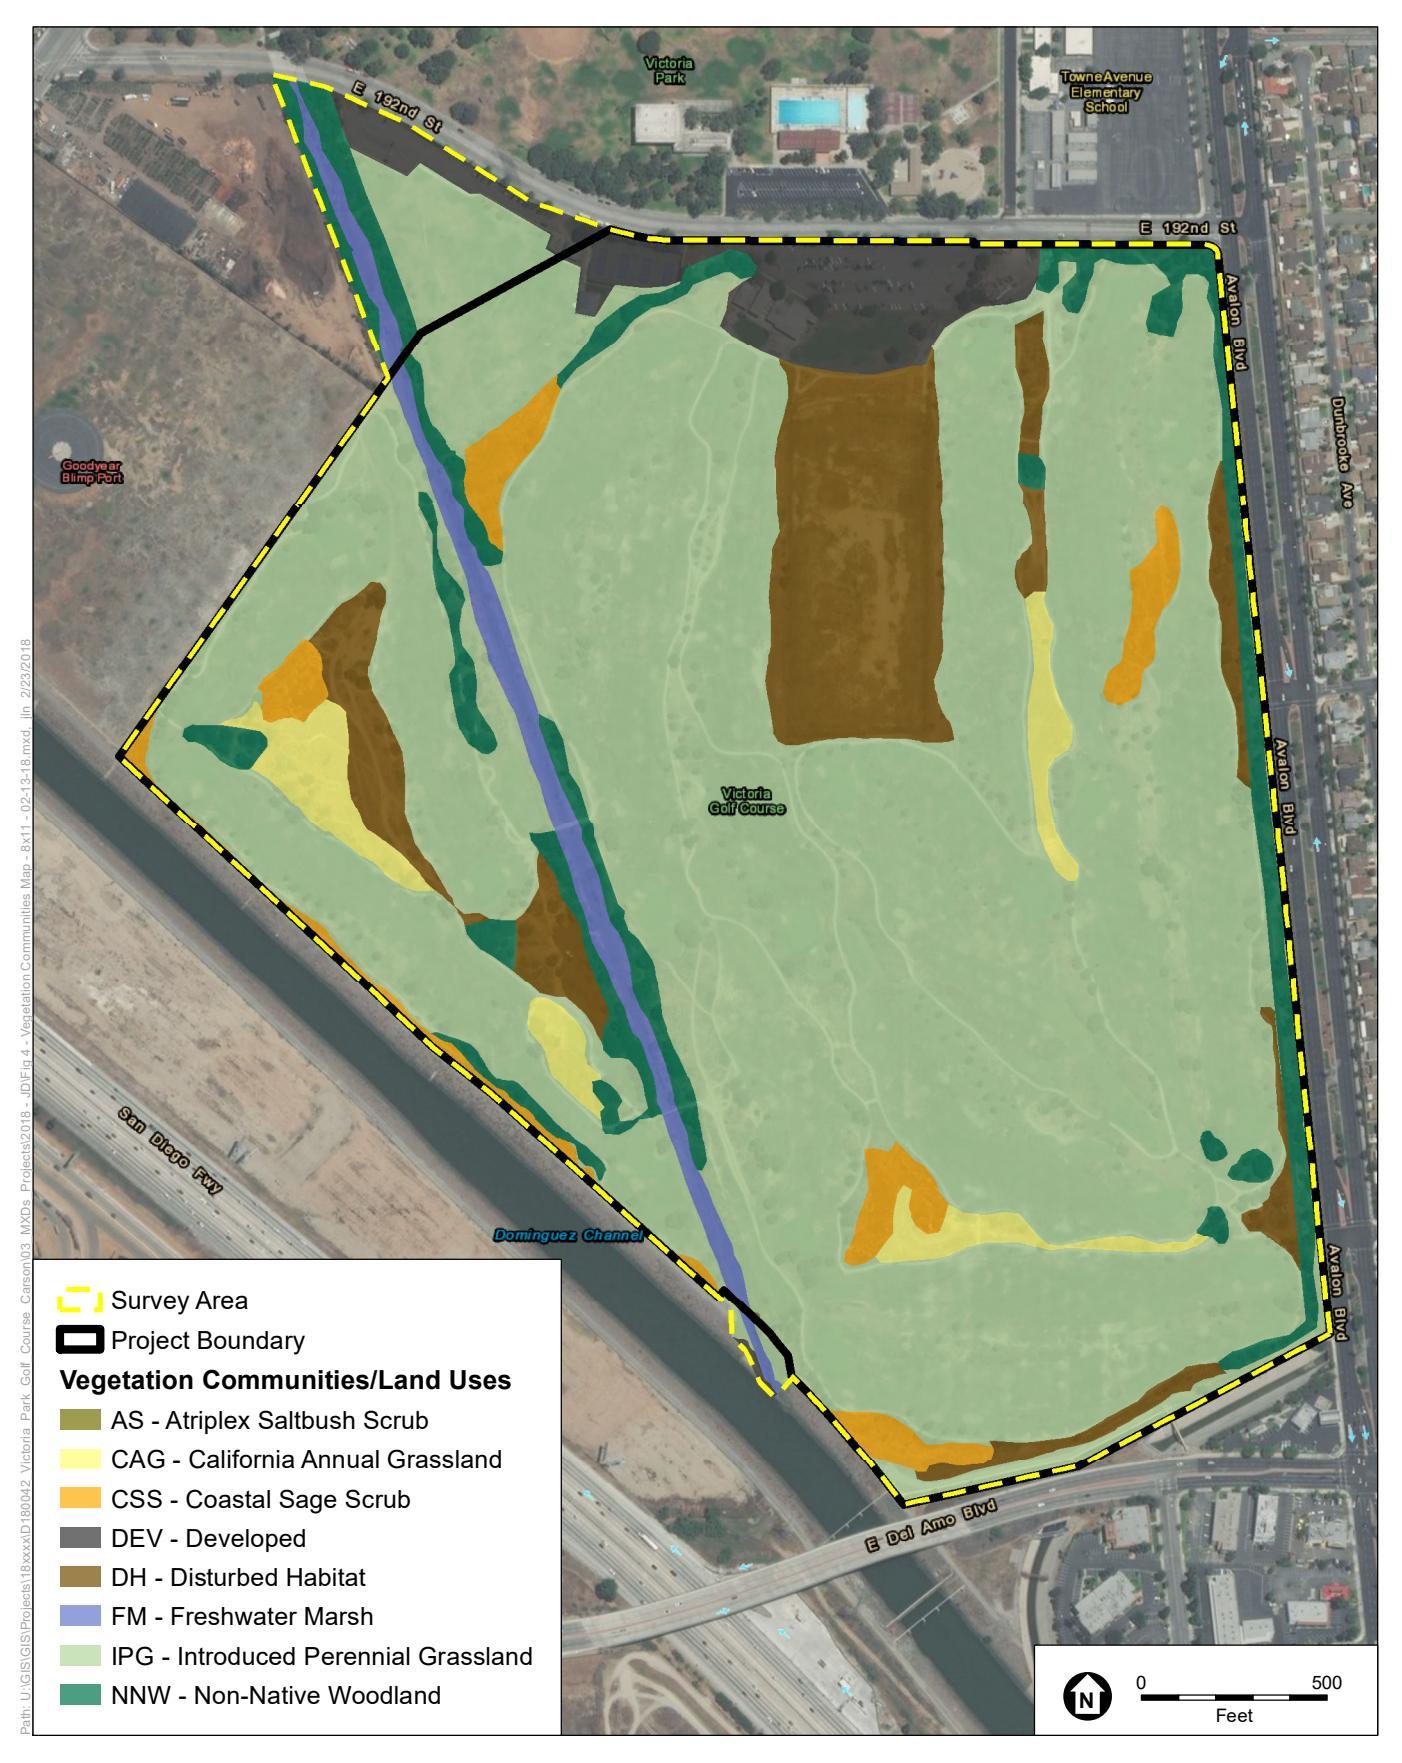
The project is characterized and dominated by non-native and disturbed habitat with scattered native vegetation communities and a disturbed drainage (**Figure 4**). Within the project site, the most dominant cover type is introduced perennial grassland which mainly consists of landscaped sod grass installed for use on the golf course. Other vegetation communities within the project site that were observed less frequently include California annual grassland, atriplex scrub, coastal sage scrub, freshwater marsh, and non-native woodland. Land use types on the project site include disturbed habitat, and developed land. Disturbed habitat is the second most abundant land use type on the project site. **Table 1** displays the mapped vegetation communities and calculated acres on the project site and in adjacent offsite areas within the survey area. A complete list of the botanical species observed/detected in the survey area during surveys of the site is provided in **Appendix C**. The discussion of each vegetation community is included further below.

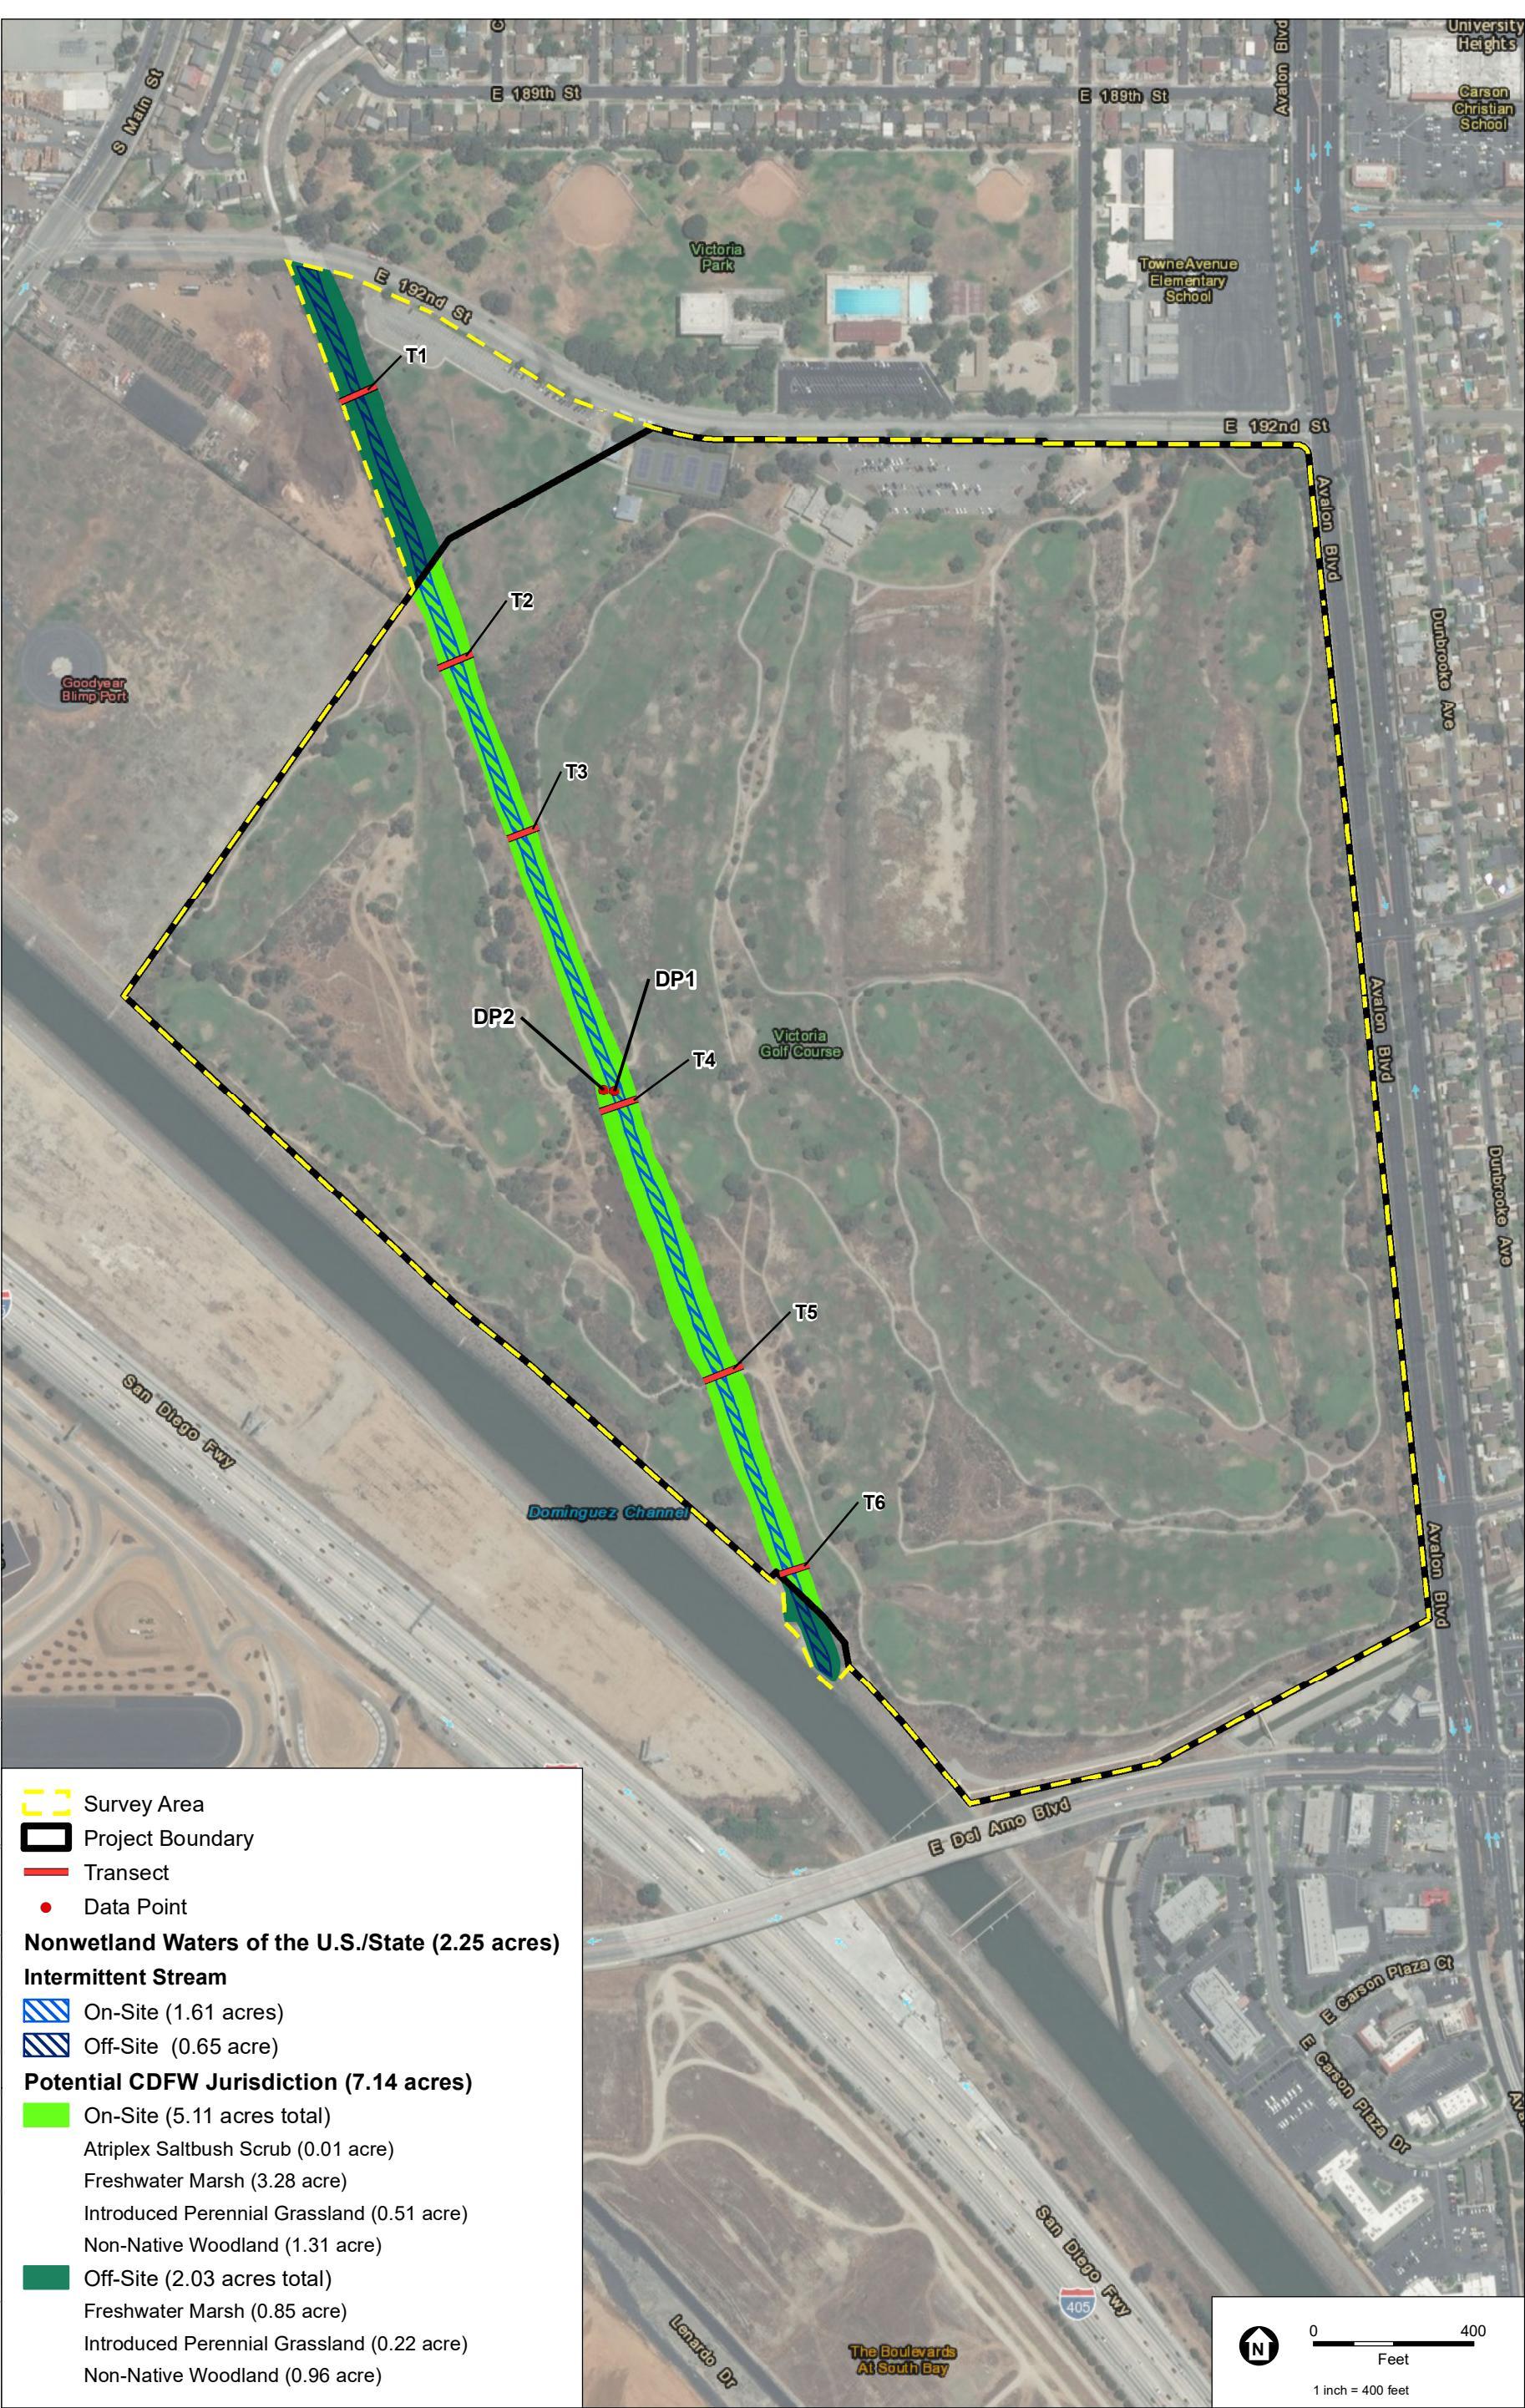
Figure 5 Jurisdictional Delineation Map

The potential jurisdictional feature delineated within the survey area boundary, including the project site, is shown on **Figure 5**, and further described on the following pages. The mapped potential jurisdictional feature is based on the database and literature review and field delineation survey, and is summarized in **Table 2** below.

The site has been used for recreational golf consistently since 1966 and mainly has been operated by the Los Angeles County Department of Parks and Recreation. The Drainage Channel on the western portion of the project site was installed during conversion of the former landfill into a golf course, which now drains local runoff from upstream areas to the south towards the Dominguez Channel. Historically, the topography on the project site and to the immediate north of the site, did not support a natural drainage feature; however, an intermittent blue-line stream is mapped on 1959 USGS topo maps further to the north that was connected to the Drainage Channel on the project site during development of the area in the 1960's (NETR 2018). The Drainage Channel contains a concrete-lined low-flow channel bottom, with freshwater marsh vegetation growing on sediment deposited on the channel floodplain, and earthen manufactured slopes that contain non-native woodland species. The Drainage Channel currently conveys runoff and stormwater flows from upstream sources north of the project site, downstream (south) towards the Dominguez Channel.

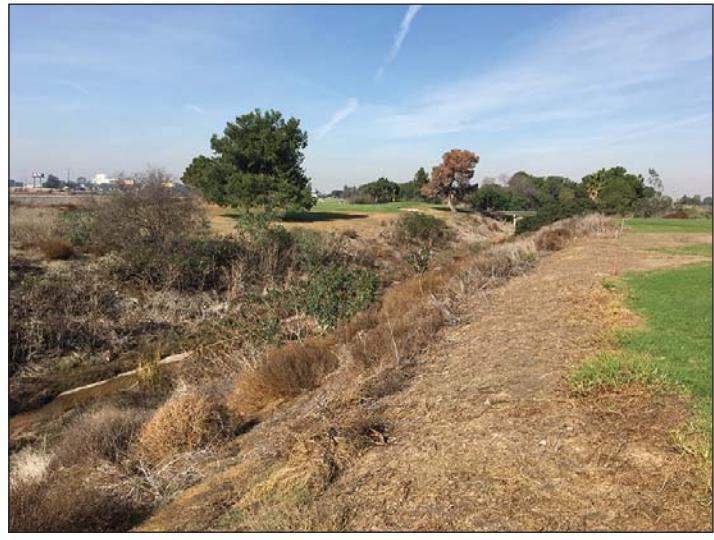
PHOTOGRAPH 1: Taken from the southern survey area boundary, facing northwest towards the Drainage Channel.

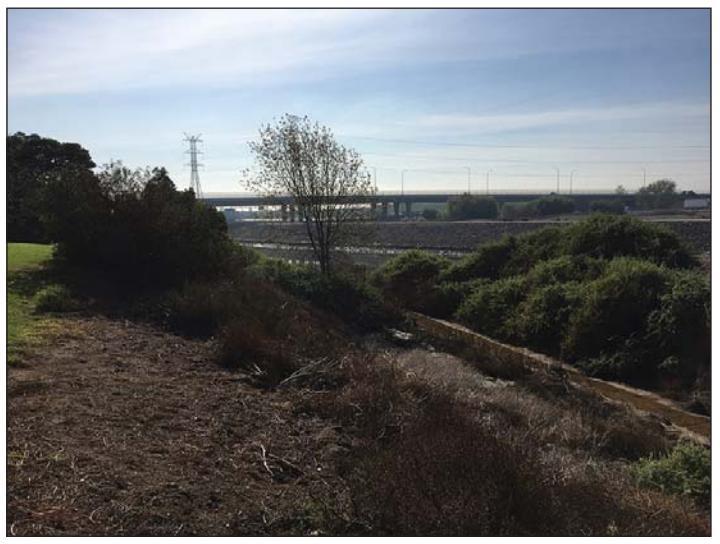
PHOTOGRAPH 2: Taken from the southern survey area boundary, facing southeast towards the Drainage Channel.

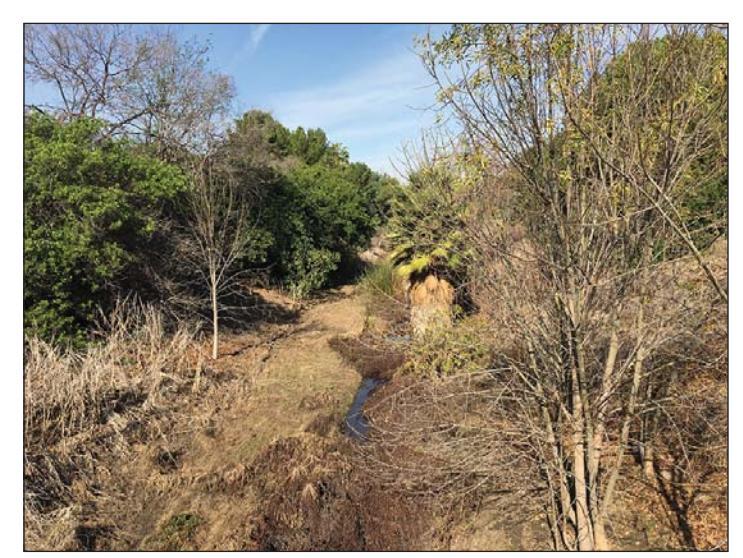
PHOTOGRAPH 3: Taken from the southern portion of the Drainage Channel, facing northwest. Note non-native trees within the limits of the Drainage Channel.

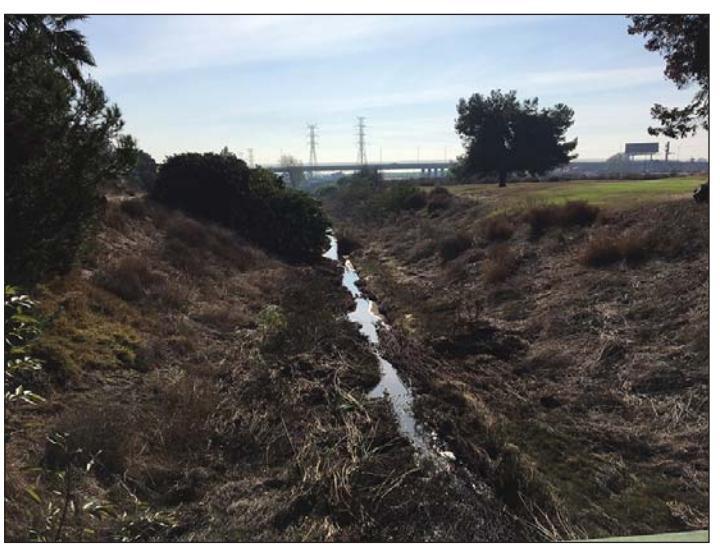
PHOTOGRAPH 4: Taken from the southern portion of the Drainage Channel, facing southeast. Note disturbed upland banks.

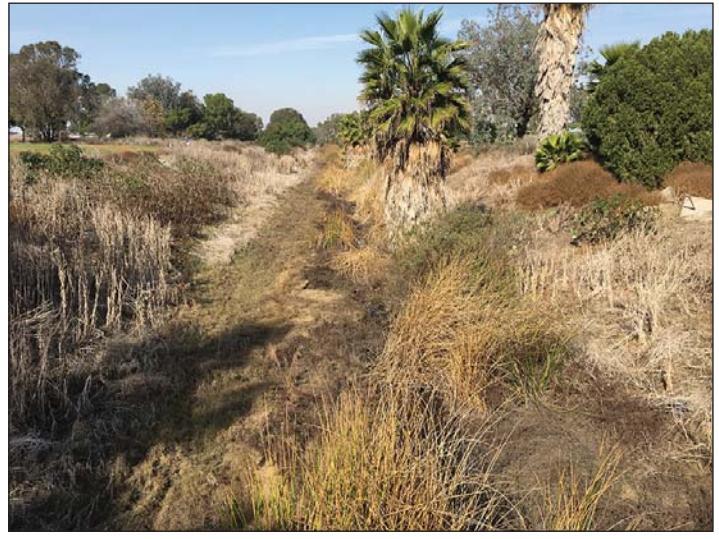
PHOTOGRAPH 5: Taken near the center of the Drainage Channel, facing northwest.

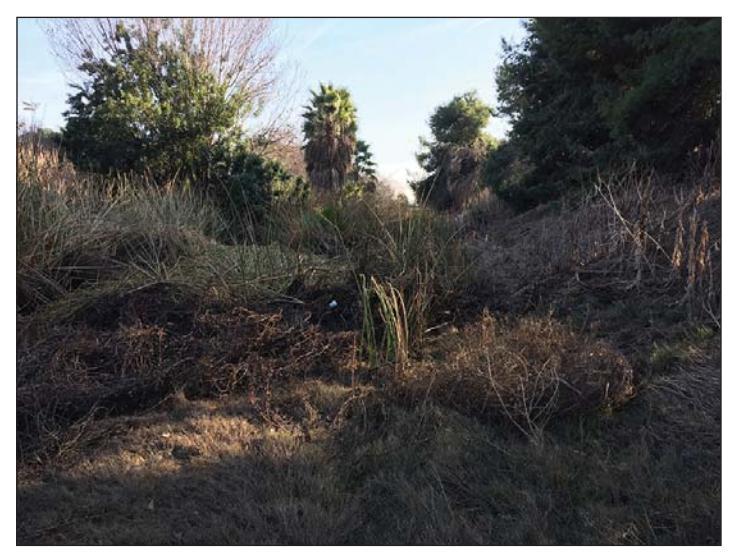
PHOTOGRAPH 7: Taken at DP1, facing northwest. Note freshwater marsh habitat in the active floodplain.

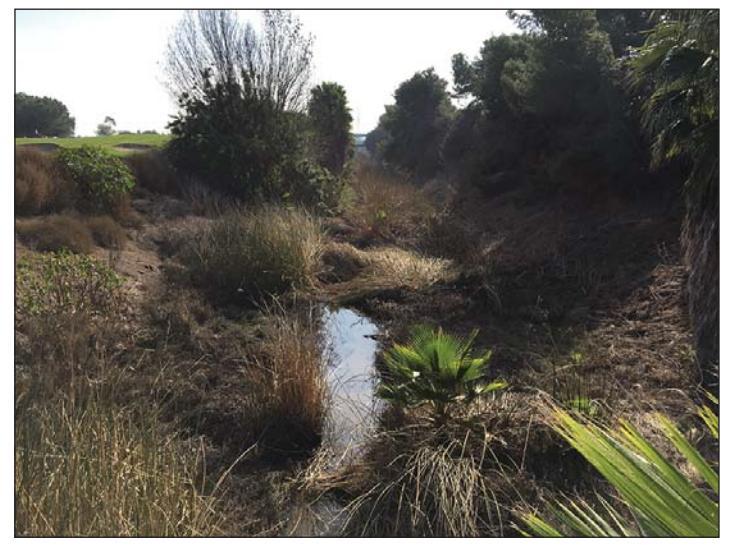
PHOTOGRAPH 6: Taken near the center of the Drainage Channel, facing southeast. Note surface water in the low-flow channel, and a mix of native and non-native vegetation.

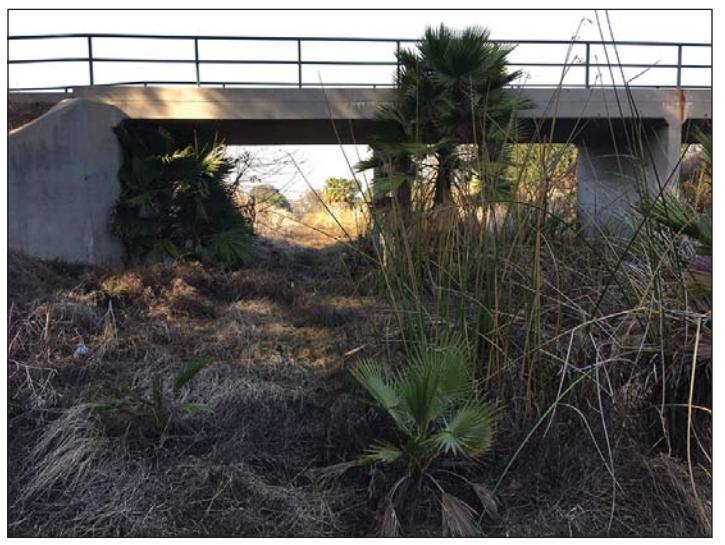
PHOTOGRAPH 8: Taken at DP1, facing southeast. Note native and non-native species.

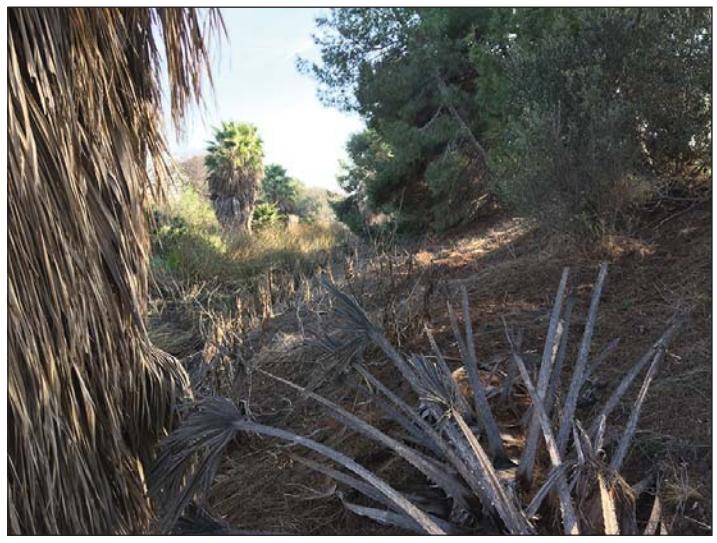
PHOTOGRAPH 9: Taken at DP2, facing northwest. Note upland vegetation on the banks of the channel.

A paired soil pit (DP2) was dug on the adjacent upland slopes on the channel banks to the northeast of DP1. Soil within DP2 contains an organic top layer of leaf litter within the first 3 inches, and within the remaining 12 inches displays a color of 7.5YR 2.5/2 and has a silty loam texture. No redoximorphic features were observed within the soil sample, and no hydric soil indicators were present. Therefore, DP2 lacks hydric soils capable of supporting wetland vegetation and conditions. Additionally, no signs of wetland hydrology were observed within and immediately adjacent to DP2, but hydrophytic vegetation is present with the adjacent pine and fan palm trees that can sometimes occur in wetlands. DP2 only contains one of the three wetland parameters to be considered a wetland, and is therefore, not a wetland.

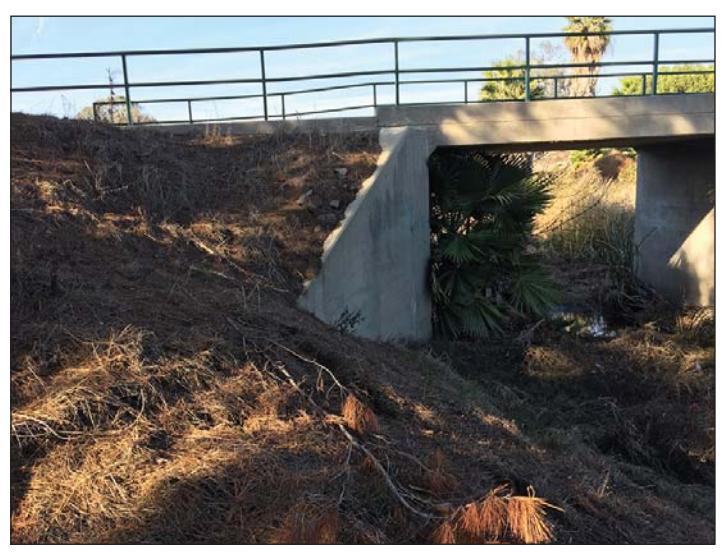
PHOTOGRAPH 10: Taken at DP2, facing southeast. Note disturbed habitat on the upland banks.

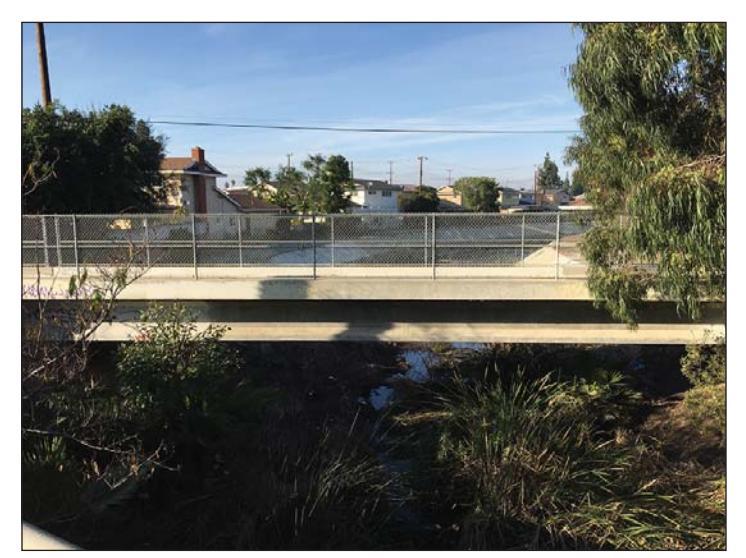
PHOTOGRAPH 11: Taken at the northern survey area boundary, facing northwest. Note concrete-lined channel north of the project site in offsite areas.

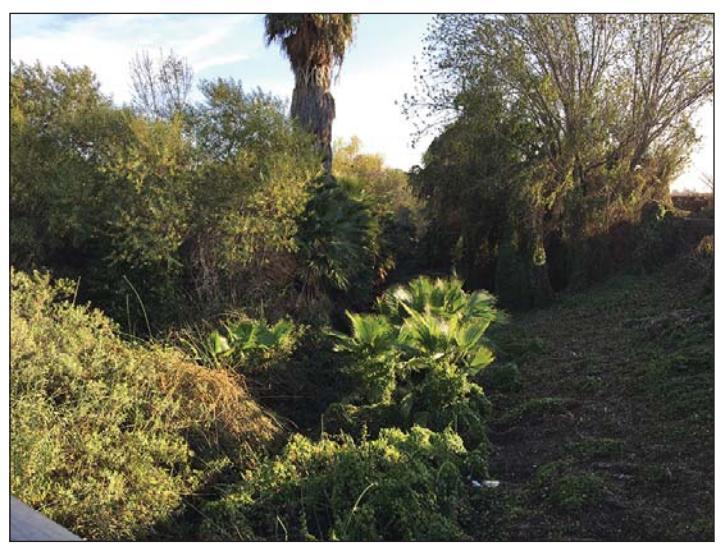
PHOTOGRAPH 12: Taken at the northern survey area boundary, facing southeast. Note non-native woodland dominates the upstream portion of the Drainage Channel within the survey area.
