**PEARSON HOUSE COUNTY LANDMARK DESIGNATION  
PROJECT NO. PRJ2023-000484/ CASE NO. RPPL2023000686  
PROJECT LOCATION: 931 NEW YORK DRIVE, ALTADENA, CA 91001  
(FIFTH SUPERVISORIAL DISTRICT) (3-VOTES)**

**MEMORANDUM FOR THE RECORD**

SUBJECT: Landmark Application Review for 931 New York Drive,  
Altadena, California, 91001

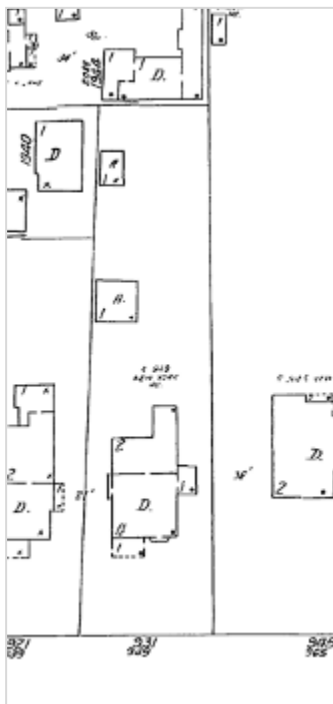
**Figure 1. 931 New York Drive**

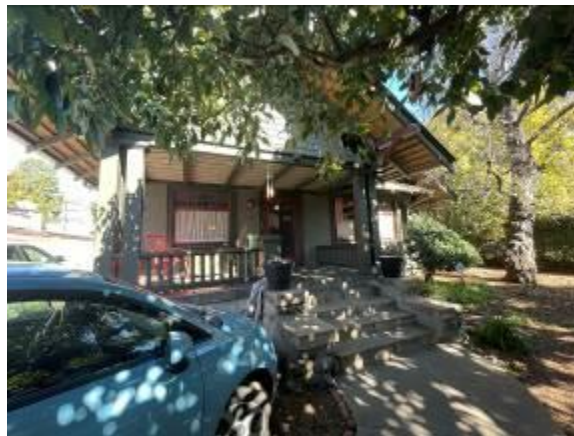
**Figure 3. View of the Primary Façade  
(note the multi-light over one fixed and sash windows)**  
SOURCE: Sapphos Environmental, Inc., 2023

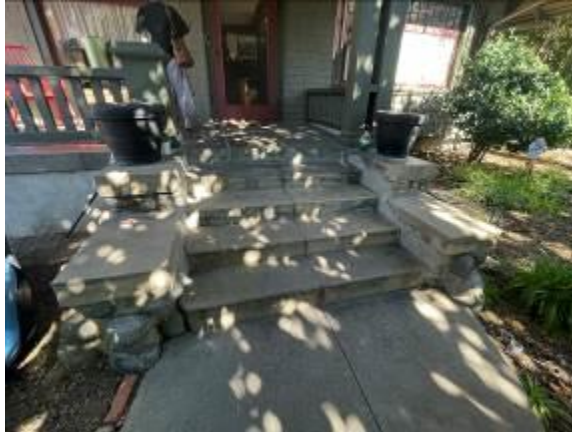
**Figure 4. Detail of Entry Porch, Primary Façade**  
 (cast concrete steps accented with arroyo stone and cast concrete porch deck)  
 SOURCE: Sapphos Environmental, Inc., 2023

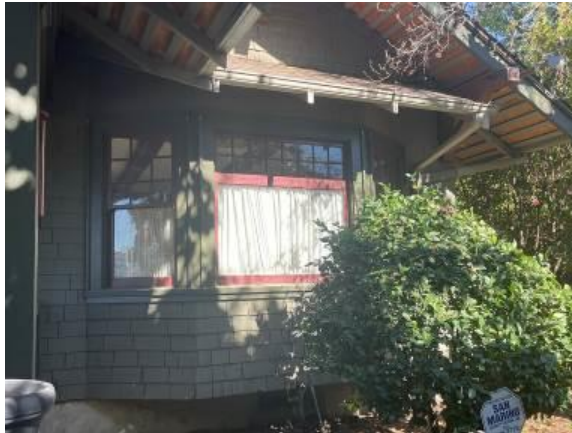
**Figure 5. Detail of Cantled Façade, Primary Façade**  
 SOURCE: Sapphos Environmental, Inc., 2023

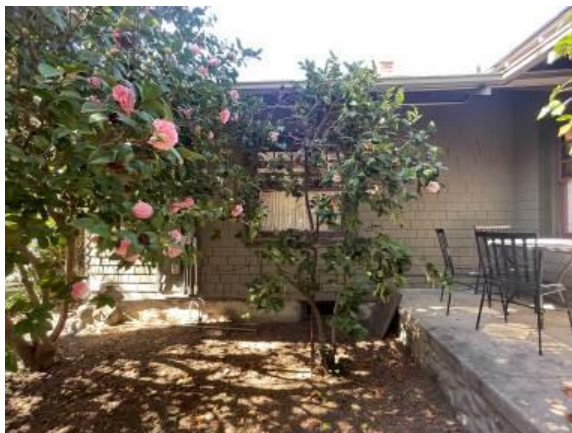
**Figure 6. View of Eastern Façade**  
 (some arroyo stone evident in foundation and porch base)  
 SOURCE: Sapphos Environmental, Inc., 2023

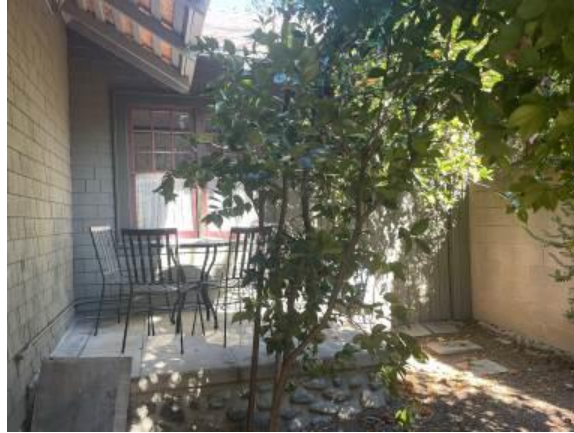
**Figure 7. Detail of Eastern Side Porch  
(cast concrete sill below windows)**  
SOURCE: *Sapphos Environmental, Inc., 2023*

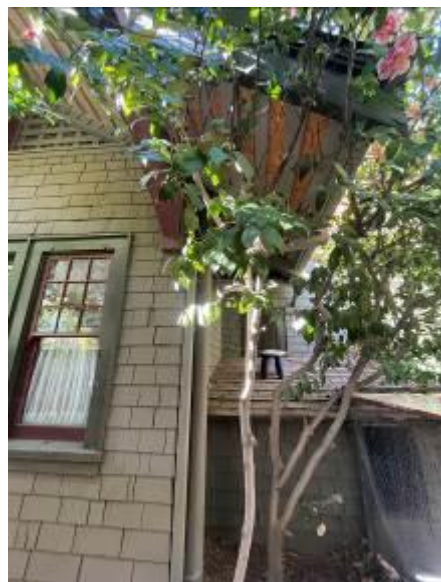
The rear half of the eastern façade is difficult to photograph due to fencing and vegetation. This façade features shingle siding, nine-over-one wood sash windows and cross gables (Figures 8–12). A partial-height enclosure was added at an unknown date, and the enclosure has been converted to a dog house.

**Figure 8. Eastern Façade (rear)**  
SOURCE: *Sapphos Environmental, Inc., 2023*

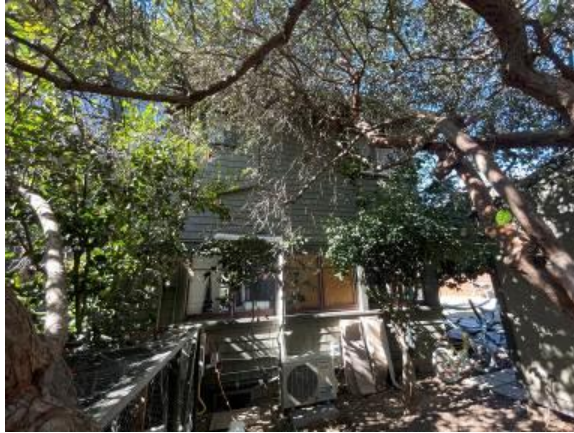
**Figure 9. Eastern Half of the Rear Façade**  
SOURCE: Sapphos Environmental, Inc., 2023

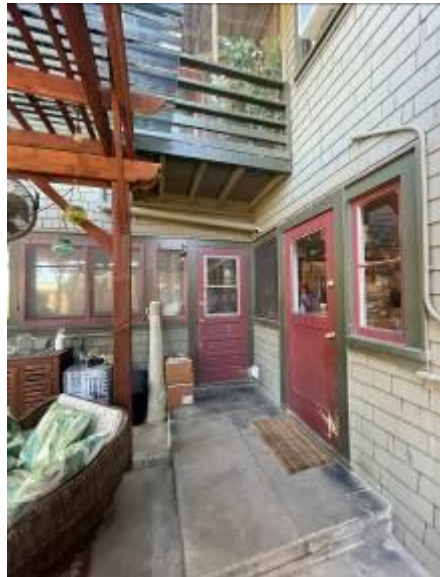
**Figure 10. Western Half of the Rear Façade**  
SOURCE: Sapphos Environmental, Inc., 2023

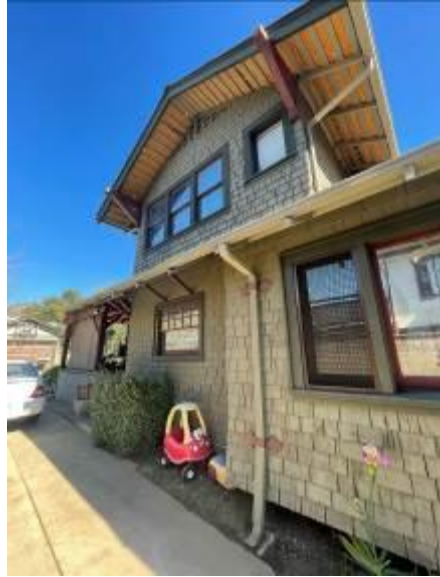
**Figure 11. Western Façade**  
 SOURCE: Sapphos Environmental, Inc., 2023

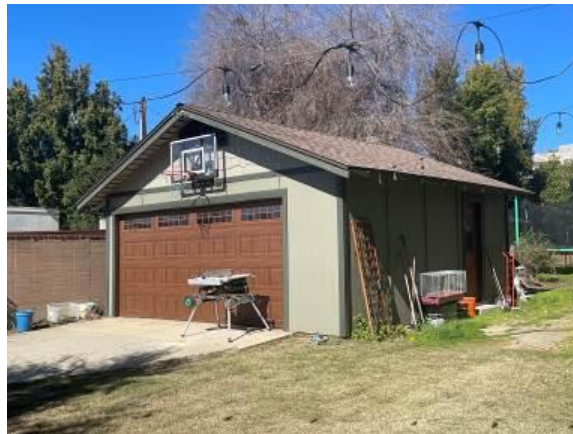
**Figure 12. Extant Garage**  
 SOURCE: Sapphos Environmental, Inc., 2023

The northernmost garage was demolished at an unknown date and does not retain any aspect of integrity. The middle, or extant, garage has been altered with new siding, a modern roll-up door, and the addition of a pedestrian entrance. However, the garage retains its gables (north and south), exposed rafter tails, and a multi-lite window in the northern gable. Therefore, the detached garage is a character-defining feature of the subject property.
